Modern Example Residential Building Survey

GENERAL INTRODUCTION

Firstly, may we thank you for your instructions of XXX we have now undertaken an independent Building Survey (formerly known as a Structural Survey) of the aforementioned property. This Survey was carried out on XXX.

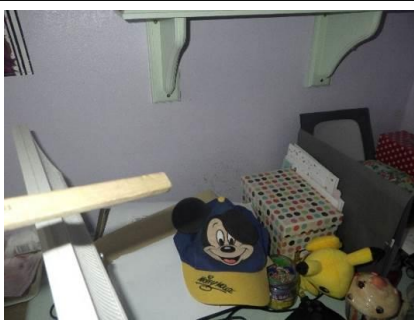
Black mould

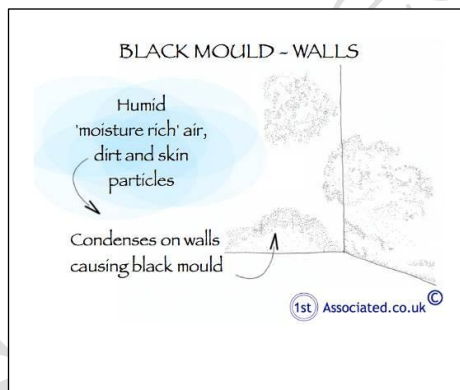
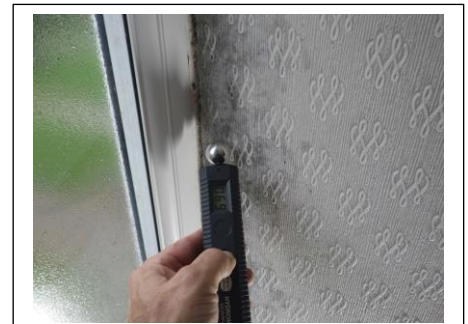
Black mould/dampness

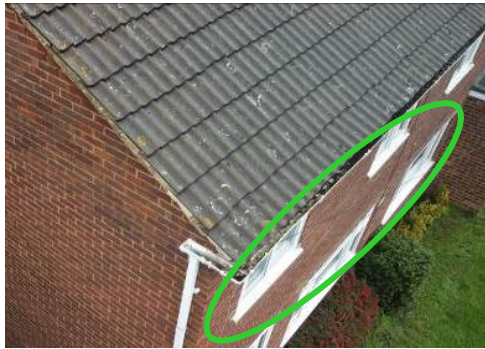
There is some moss on the roof particularly to the rear. The moss can cause accelerated deterioration and also blocks gutters. There looks in turn to have then been overflowing of the gutters which may discharge down the walls of the property making them damp and less energy efficient than dry walls.

Moss to front gutters

ACTION REQUIRED: We recommend removing moss with a soft brush and trowel, we do not recommend high pressure cleaning or chemicals are used on the roof tiles as they can damage the tiles.

You need to regularly clear the gutters and ensure they are free flowing and not blocked with moss.

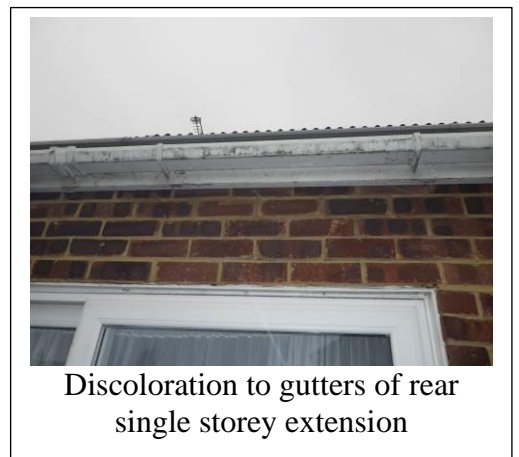
Discoloration to gutters of rear single storey extension

ANTICIPATED COST: £500 - £1,000; please obtain quotations as soon as possible, ideally within two months of this report.

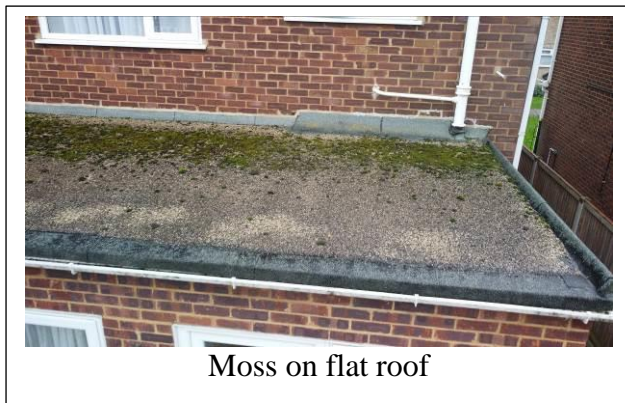
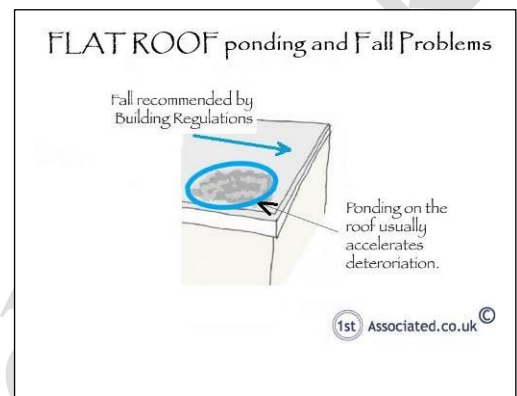
The rear flat roof is flat with minimal fall on it which may seem a strange comment but we would expect a flat roof to have a fall of about fifteen to twenty two degrees and this is why we would term this as a flat, flat roof. We can see moss on the flat roof which may have come off the main pitched roof.

ACTION REQUIRED: We recommend re-roofing with a cut to fall insulation and detailing such as lead flashings, etc.

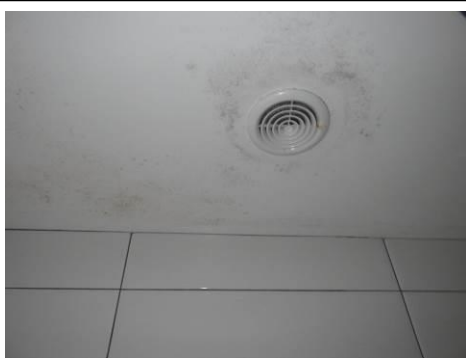
We can see black mould throughout the property and also condensation occurring. This era of property generally has an above average possibility of getting black mould and condensation due to the way it has been constructed and how we have changed how we use properties over the years. However, with care we think you can improve the present conditions.

Bathroom extract with black mould around it

Ensure that any humidity generating areas have good extraction. We would recommend large good quality humidity controlled extract fans are added to the kitchen, the bathroom and any areas that are humidity generating for example areas that are used for drying clothes internally during winter months (we would assume that clothes will be dried externally during the warmer months). By large extract fans we mean 150mm.

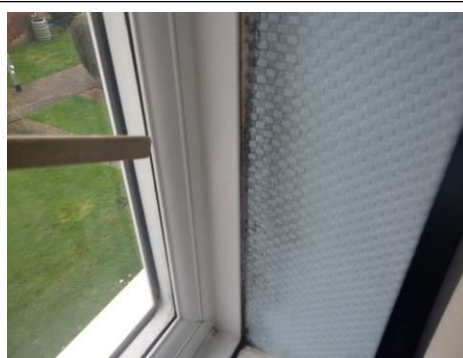
Black mould in front left bedroom

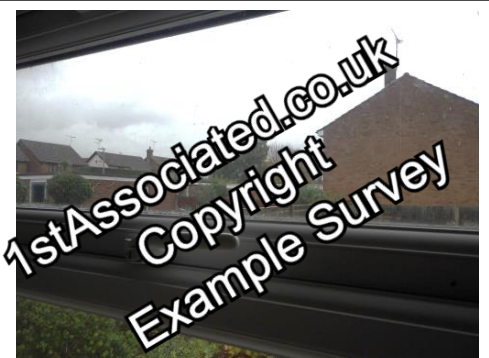
Condensation occurring to end window in kitchen

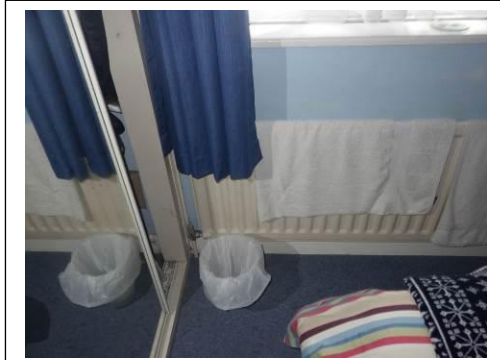
Drying clothes inside

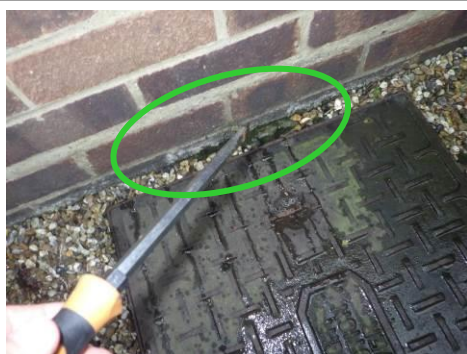
We believe the water table level in the area may be higher than we typically find. When looking at historic maps it looks like the area was quite marshy. We believe that due to this the ground floor slab could be acting like blotting paper absorbing moisture in the surrounding grounds.

In addition to this, it looks like the drains to the front have been blocked and this can lead to further dampness getting in the property. It also should not be discounted there may be leaking supply pipes.

Mould next to building on rear left side

ACTION REQUIRED: You need to carry out further investigation with regard to whether there are any leaking drains or pipes in the area.

We would recommend that ground levels around the property are lowered (a DIY type job). Also, we would recommend cutting the bush away to the front as you would also be able to see whether the vertical crack on the inside of the property is also on the outside and also it would allow sunlight and air movement to get around the property better.

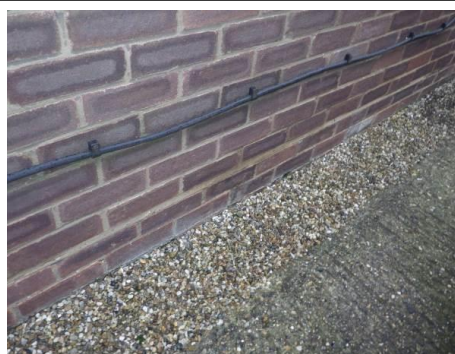
Decorative French drain down left side of property

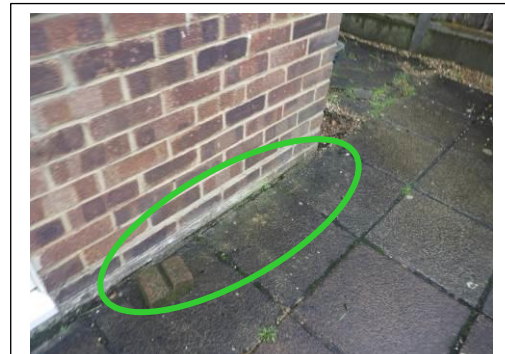
Mould around the base of the single storey extension to rear

If this does not improve following the above recommendations we would then suggest a French drain and/or land drain is added to divert the water around the property and is discharged into a manhole (subject to obtaining approval) and/or a soakaway added (which will be additional cost) which will help reduce some of the effects of the sloping site.

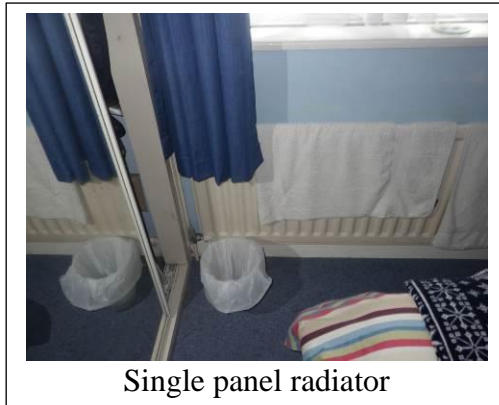
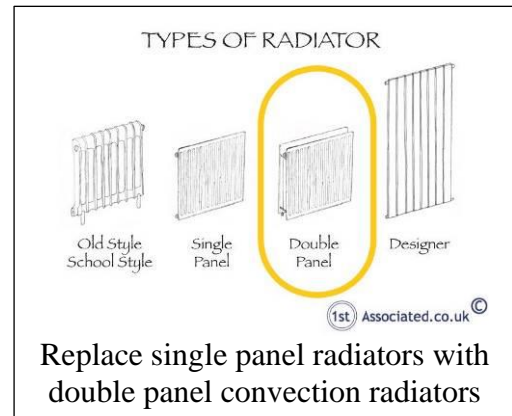
We noted the radiators in some areas are internal/not under the windows which is the usual position. This is often carried out on cheaper central heating systems to save the labour and piping costs of positioning the radiators underneath the windows. However, it then reduces the air movement in the room which can lead to black mould.

ACTION REQUIRED: We recommend you move the radiators underneath the windows as this gives a better circulation of air and reduces the chance of condensation.

You may wish upgrade to double panel convection radiators.

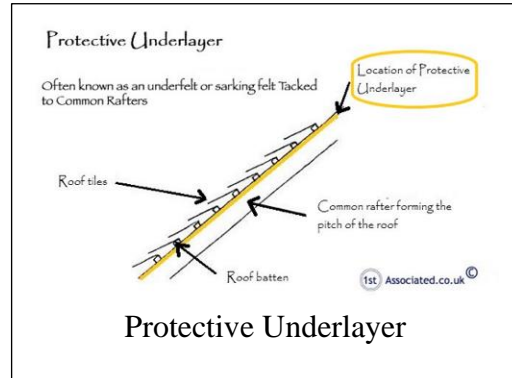
When we inspected the loft space, we found a Hessian based bitumen membrane. This type of membrane has been used since the 1960s. We generally found it to be in average condition with damage in some areas/areas that were not fitted particularly well, which is what we typically find.

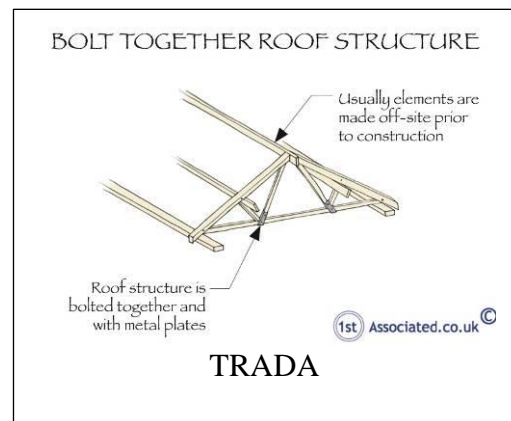
This type of roof structure has what is known as a TRADA style roof truss. These are bolted together and are relatively unusual. The Timber Research and Development Association (TRADA), originally based at Princes Risborough but partly relocated to Watford, were the forerunners of the modern day pre-fabricated truss. We have never come across any problems, with the exception of the bolts rusting.

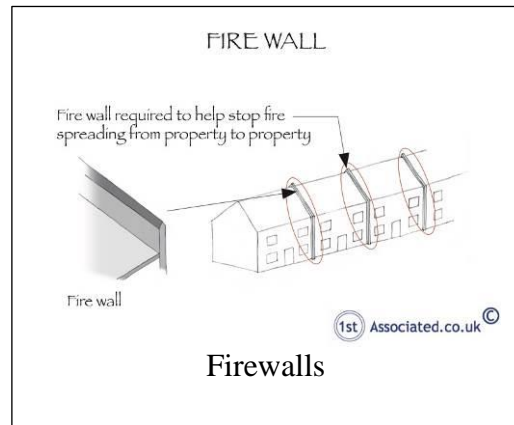
The property has one firewall located to the right side (all directions given as you face the property). The firewall is also a Party Wall. There looks to have been some repair work carried out, you may know about this as you have been in the property a long time.

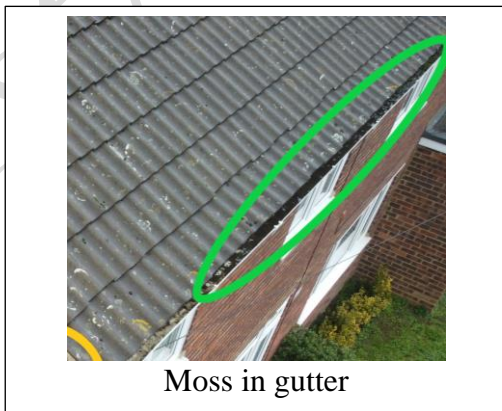
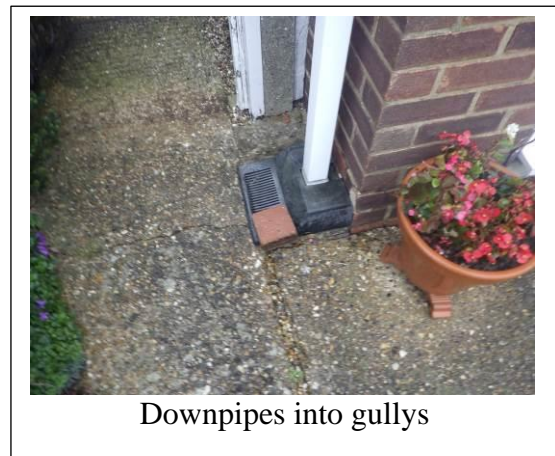
The property has profile plastic gutters and downpipes. They are in average condition for their age, type and style however have moss within the gutters.

There may be some minor leaks but most people would be happy to live with these providing repairs are carried out within the next six to twelve months.

ACTION REQUIRED: We would recommend you stand outside the property next time it rains heavily and see how well the drains cope with the rainwater particularly looking at the guttering and the joints.

We also recommend that the gutters and downpipes are cleaned out, the joints are checked and the alignment checked to ensure that the gutters fall towards the downpipes.

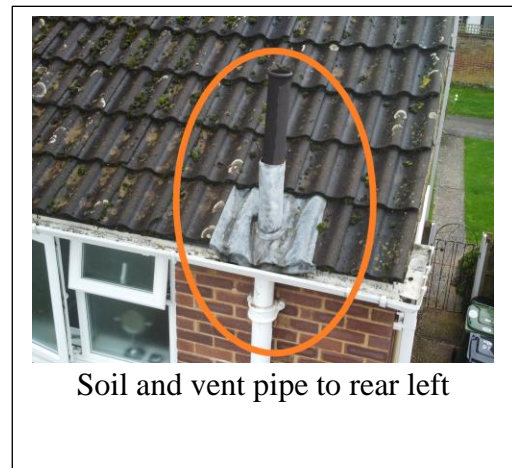
The property has cast iron soil and vent pipes which need redecoration. The cast iron may be saveable but it may be more economical to replace, we always recommend trying to save if at all possible.

ACTION REQUIRED: Redecorate in the warmer months of XXX. Please see our comments in the Flues Section.

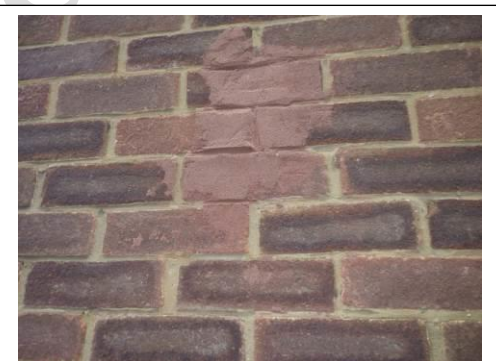
Repairs to the brickwork/blocking up of an opening

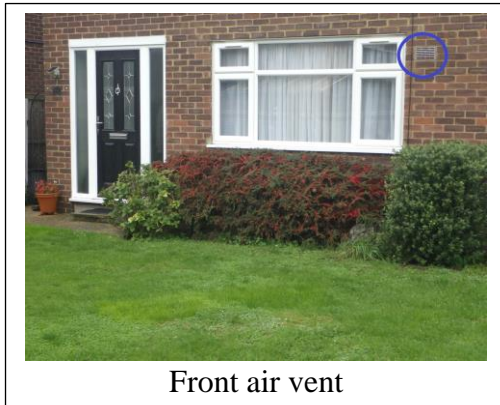
Front air vent

High level air vents are to help air circulation within the property. In this case, there is an air vent to the front which you advised that you had blocked up with an open/closable vent. It would be better if it was in use.

ACTION REQUIRED: Ensure the air vents are clear and useable.

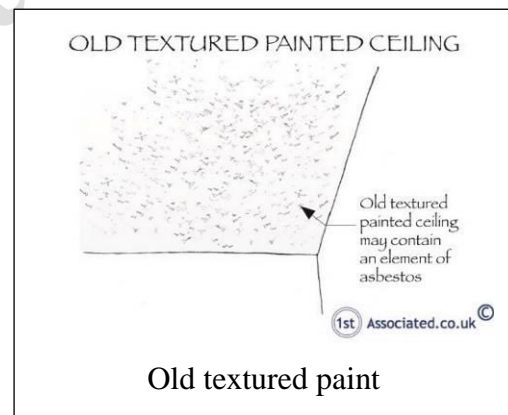
Some of the ceilings have a textured paint finish (commonly known as Artex). You should be aware that Artex is generally used where there are uneven walls or possibly even where dampness is coming in through the walls. Care should be taken with Artex as Artex prior to 1984 may contain an element of asbestos.

ACTION REQUIRED: We would advise to take care and do not rub down or sand the textured paint in case it does contain asbestos.

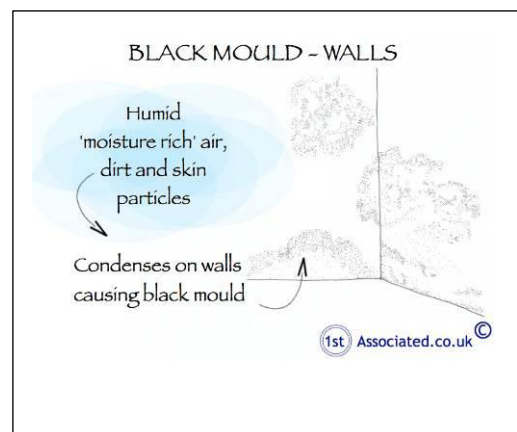
Black mould

As we have mentioned elsewhere within the report there is dampness in the property in the form of black mould which we believe is being caused by a combination of reasons such as condensation and possibly some rising damp although it is difficult to distinguish between the two.

ACTION REQUIRED: Please see our comments in the Executive Summary.

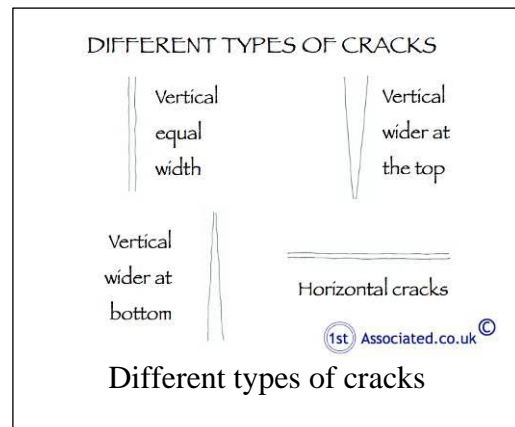
You advised us of some cracking in the plaster. We could not see any equivalent cracks on the outside with the exception of over some windows.

ACTION REQUIRED: You need to monitor and draw to the attention of your insurance company if the cracking continues.

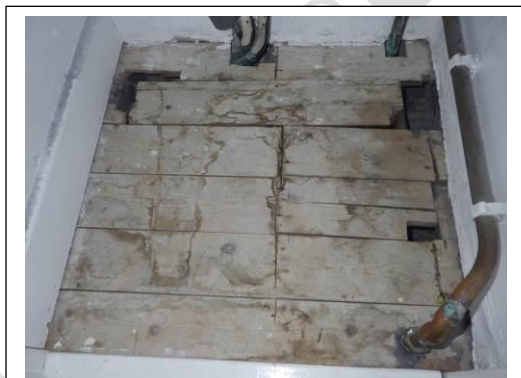
Floorboards in front right bedroom

We have assumed that the first floor construction is joist and floorboards on joist hangers, as this is typical in this age of property.

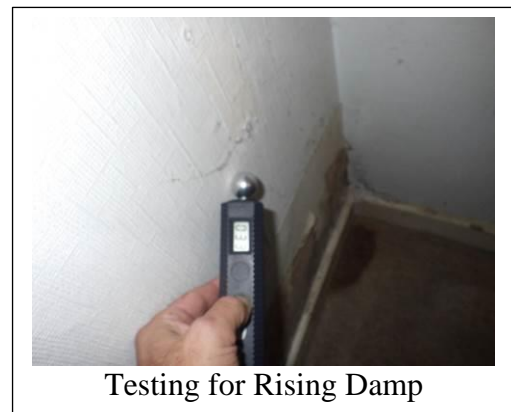
A visual inspection and tests with a moisture meter have been taken to the perimeter walls. In this particular case, we have found dampness that we think may be condensation, possibly rising damp.

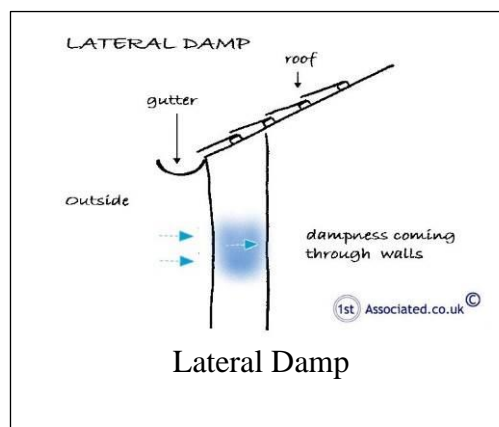
We used a resistance meter on the external walls. We have found significant lateral dampness near the window which again we believe is likely to be condensation.

ACTION REQUIRED: We would recommend large good quality humidity controlled extract fans are added to the bathroom, shower room, kitchen and any humidity generating areas:

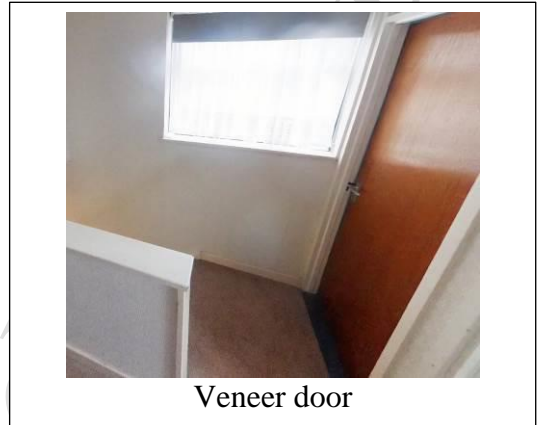
Veneer door

The property has veneer doors which were typical of this era of property.

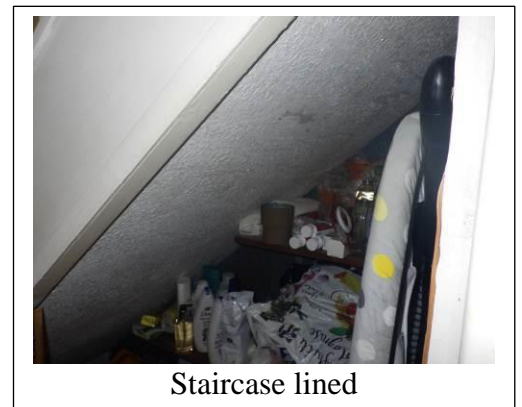
Staircase lined

We were unable to examine the underside of the stair timbers due to it being lined where we could see it, which precluded our inspection, so we cannot comment further upon the stair structure. We can, however, say that the lining gives a resistance to the spread of fire if such circumstances were to occur.

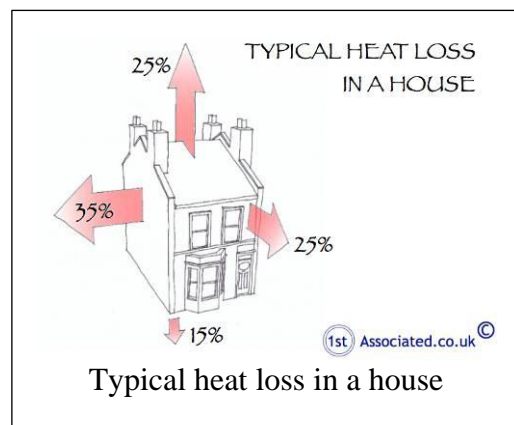
Some roof insulation was present although not to current Building Regulations requirements of 300mm. In this instance, we would estimate there is approximately 200mm.

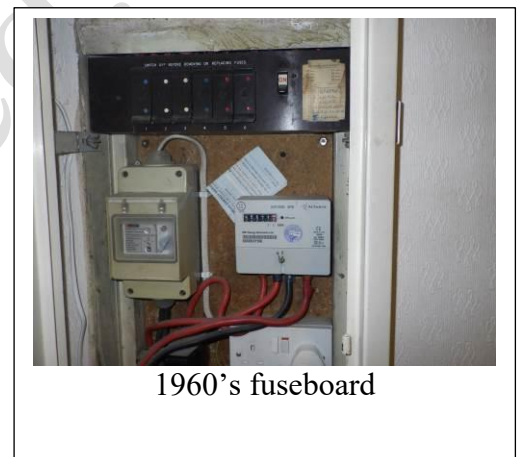
1960's fuseboard

The fuse board looked 1960's and better are now available.

ACTION REQUIRED: We recommend a new fuse board with a metal casing; modern standards require half hour to one hour fire resistant casing around a fuse board.

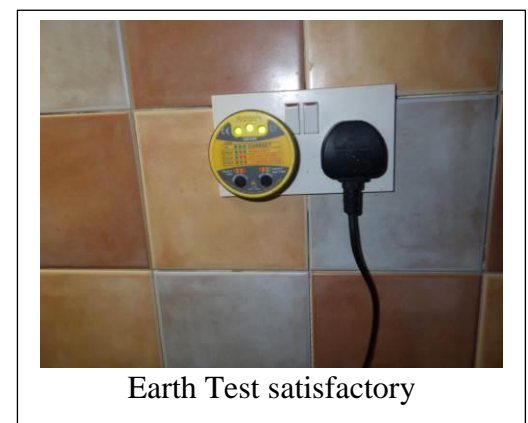
Earth Test satisfactory

We carried out an earth test in the kitchen area to the socket point that is normally used for the kettle; this proved satisfactory.

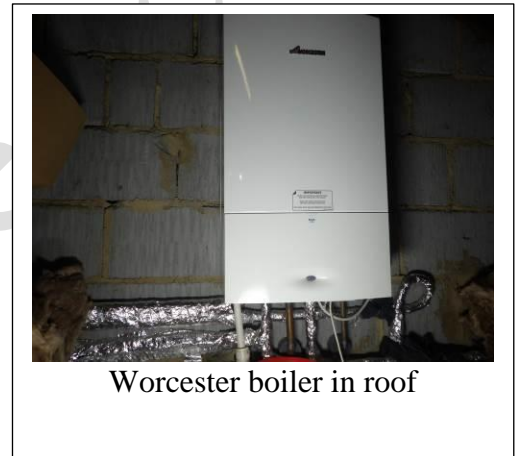
There is a wall mounted Worcester boiler located in the roof space.

Our limited inspection of the hot water and central heating system revealed no evidence to suggest any serious defects but we would nevertheless recommend that the system be tested and overhauled and that a regular maintenance contract be placed with an approved heating engineer.

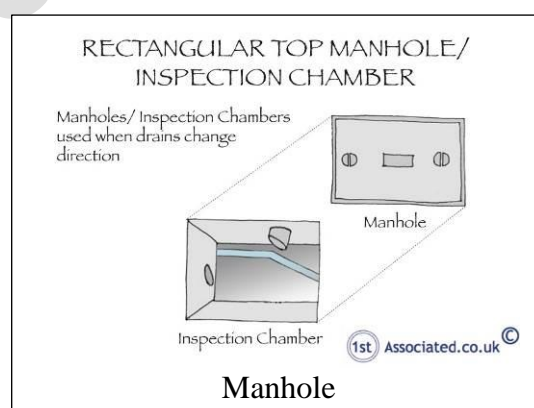
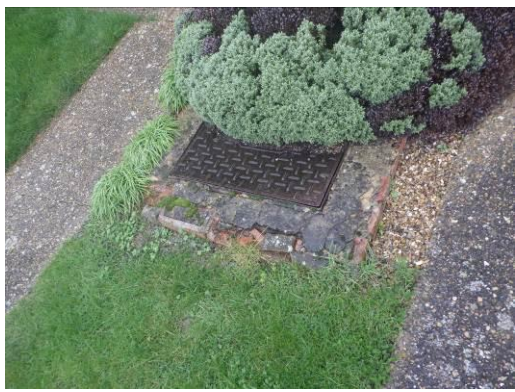
Front manhole

Inspection Chamber/ Manhole One - located to the front left

We duly lifted the cover and found it to be blocked at the time of our inspection.

ACTION REQUIRED: Unblock the manhole. Please see our comments in the Executive Summary.

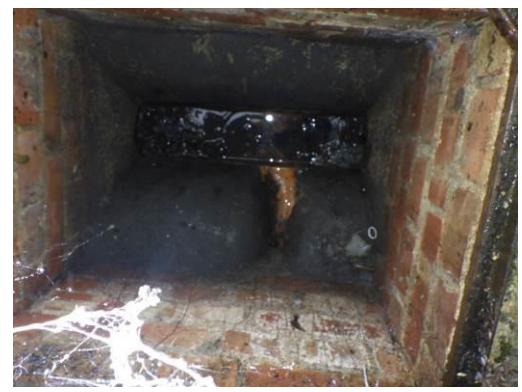
Front manhole blocked
