Post War Example Residential Building Survey

INTRODUCTION

Firstly, may we thank you for your instructions of xxx we have now undertaken an independent Building Survey (formerly known as a Structural Survey) of the aforementioned property. This Survey was carried out on xxx.

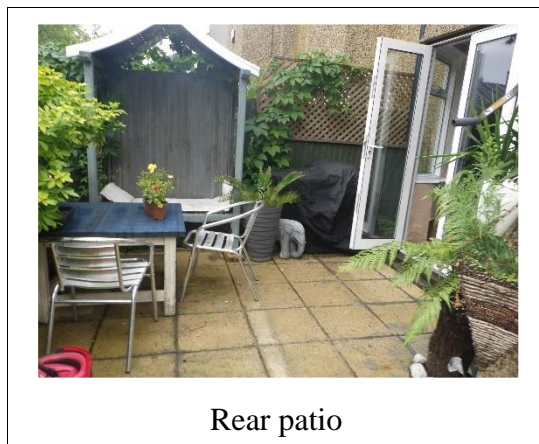
Rear patio

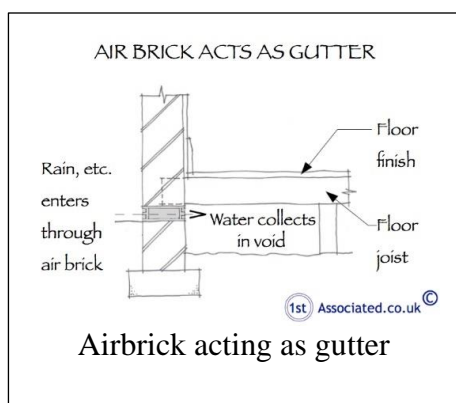
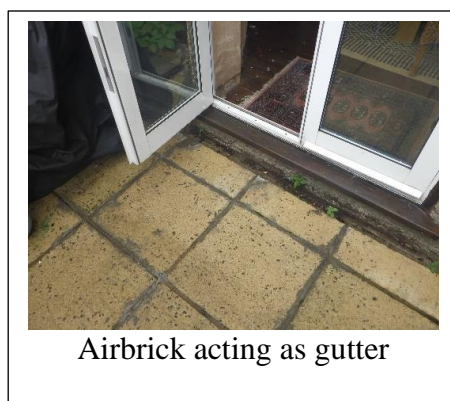
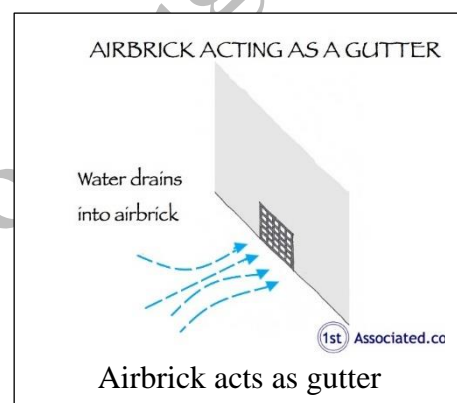
Suspended timber floor and dampness?

To the rear of the property there is a broken downpipe and also a gully that is allowing dampness into the property. The owner is aware of the problem and has tried to resolve it by adding a gully. Unfortunately, this has then allowed dampness to go under the building.

The property has a suspended timber floor which needs an airflow underneath it to help reduce the possibility of wet rot, dry rot and woodworm. The airbricks which should ventilate the floor unfortunately are so low they are acting as gutters. As mentioned, the owner does appreciate there is a problem and has added a gully to the rear but we believe some investigation is required and also a French drain to take the water away from the building.

What seems to have happened over the years is the rear patio has been built up higher than it should and has originally covered the airbricks which then the owner revealed. We have come across cases in the past where there has been wet rot, dry rot and woodworm under the floor because of this.

ACTION REQUIRED: If you wish to improve this then you need to open up the floor before you legally commit to purchase the property or to be more exact to get the existing owner to open up the floor; we would recommend opening it up in three areas – front, rear and rear adjacent to the kitchen floor, with the two latter being the most important as they are the most likely areas for wet rot, dry rot or woodworm.

We would recommend a French drain discharged into a manhole (subject to obtaining approval) and/or a soakaway added (which will be additional cost) to divert water away/around the property which will help reduce some of the effects of the sloping site.

ANTICIPATED COST: Budget £2,500 - £5,000 for a French drain to the rear of the property. Please obtain quotations before you legally commit to purchase the property.

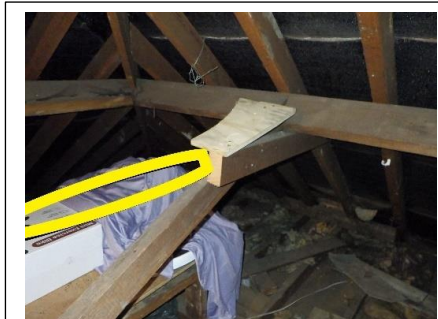
Internally we can see there have been alterations in the roof by removing the cross brace although we cannot see any major movement to the purlins within the roof structure.

We spoke to the owner specifically about the alterations in the roof and he advised that he thought that the cross brace was cut about twenty years ago (we understand they have lived in the property since 2002). It may have contributed towards the movement that we can see in the roof and also the cracking to the bay window to the front – see our comments on this in the Cracking section of the report.

Cut cross brace

ACTION REQUIRED: We have taken photographs of the condition at the time of our survey of the purlins, joists and cross brace which should be monitored. You will have a better view when the roof has been emptied when we would suggest you take photographs again. If movement does occur over time we would then recommend adding the cross brace back in. You should also monitor the position of the front purlin to see if it moves away from the chimney and add a strut if any movement in the roof is seen at all.

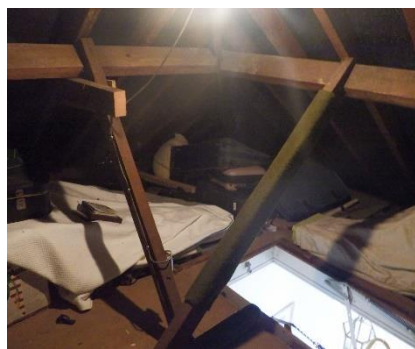
Purlins to front left hip

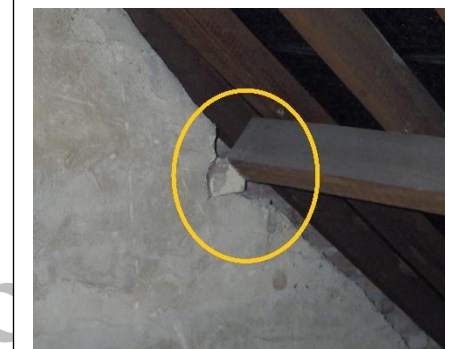
Purlin needs to be monitored

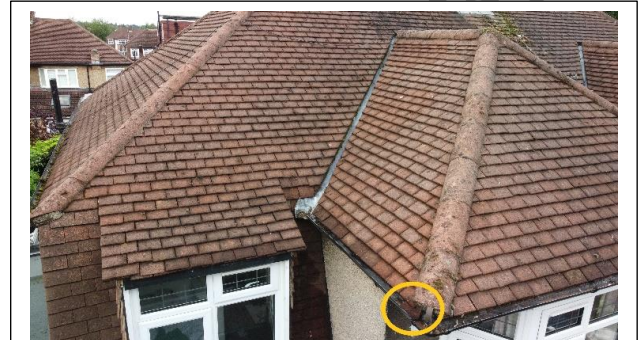
Tile in front gutter
~ Aerial View ~

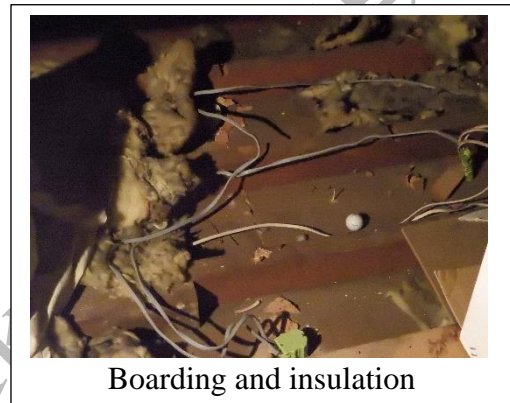
Boarding and insulation

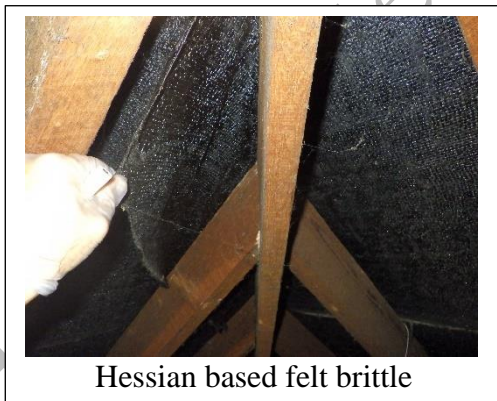
The hessian based protective underlayer felt very brittle to touch and we believe is starting to deteriorate. You need to be careful when you increase the insulation as you may cause condensation so you need to increase the ventilation as well.

Hessian based felt brittle

ACTION REQUIRED: If you increase the insulation then you need to increase the ventilation in the roof. This can be achieved in various ways such as

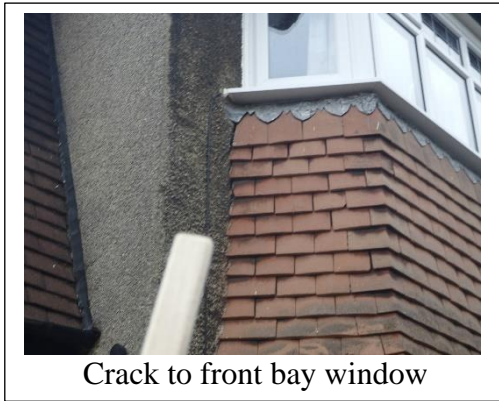
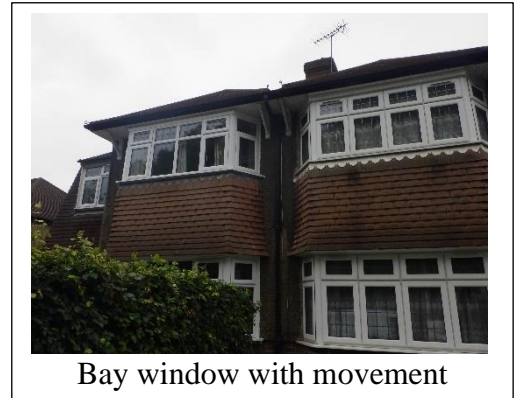
The front bay can be seen to be moving and there is a crack to the left side. The upper bay, we believe, is quite a lightweight construction with a vertical tile. Generally these type of bays did not have a foundation, the movement could be because of this and also the amendments to the roof.

ACTION REQUIRED: Fill with a good waterproof builder's mastic and monitor.

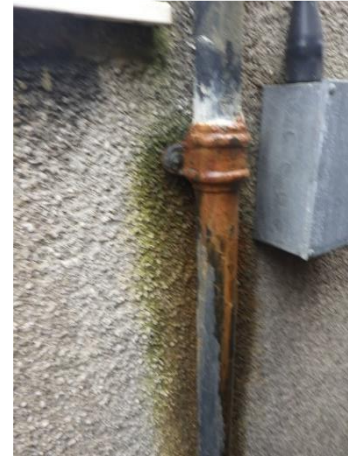
Soil and vent pipe leaking next to electrics

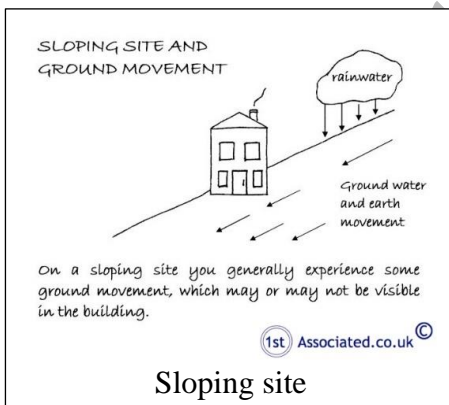
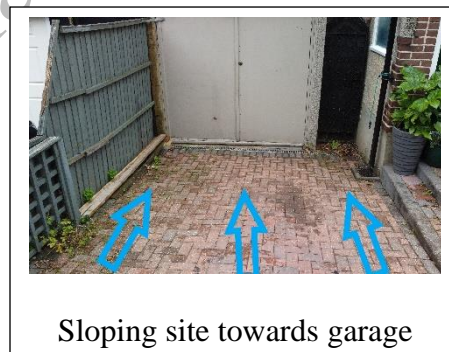
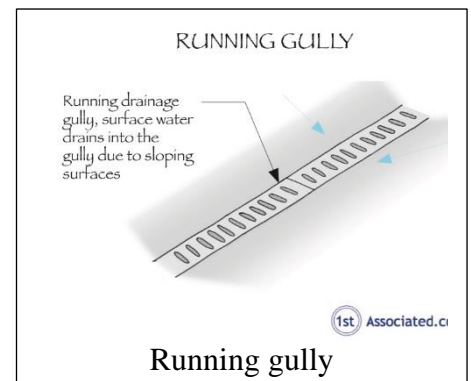
The property sits on a sloping site at the front towards the garage and because of this rainwater and ground water need to travel from the top of the site to the bottom with the building in the way. We can see there is a running gully to try and stop the water getting into the garage. We understand you want to store items in the garage and use it for a business you have, it may be necessary to replace the running gully with a deeper drain such as a French drain.

ACTION REQUIRED: Monitor the slope to the front of the property to see if the existing ground is sufficient or whether you need to replace it with a French drain

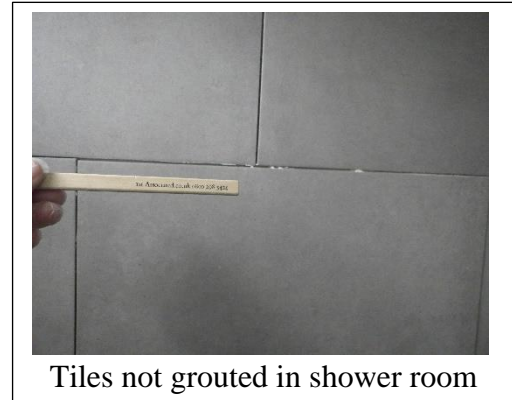
Tiles not grouted in shower room

ANTICIPATED COST: £1,000 would probably get the bathroom finished off to a reasonable standard; please obtain quotations before you legally commit to purchase the property.

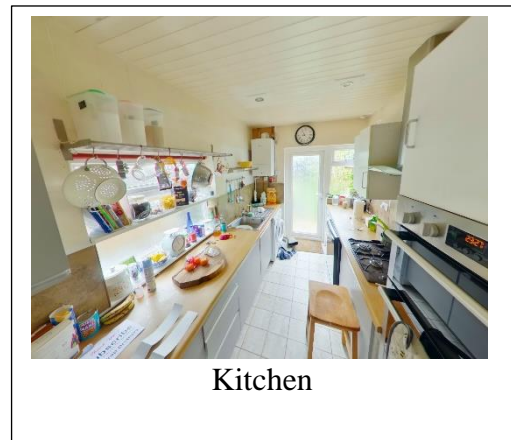
Kitchen

We also spoke about light in the kitchen. You could improve the natural light by enlarging the window although as mentioned the view is of your sheds. Alternatively, you could add better lighting within the kitchen area. Remember this kitchen will be much darker during the winter months (which are fast approaching).

ACTION REQUIRED: You need to think carefully about alterations in the kitchen.

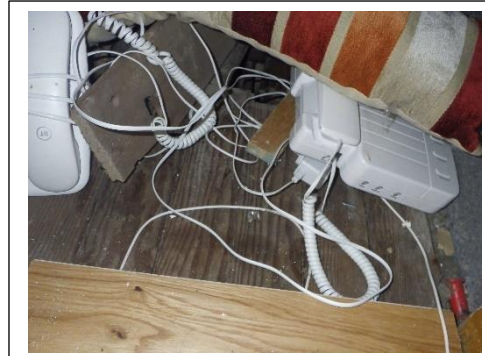
Floorboards visible under the stairs

ACTION REQUIRED: You may want to look at exposing the floorboards. We would recommend exposing a small area and do a test, for example under the stairs and see what you think.

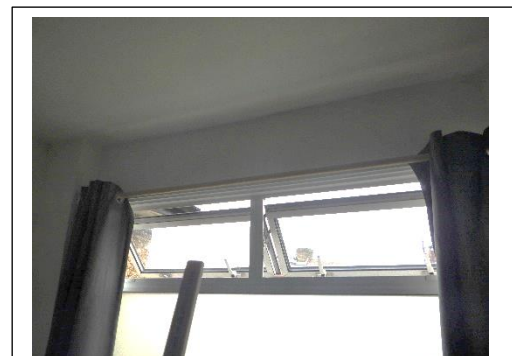
A number of the windows have misted over. There is also an unusual opaque plastic covering that has been added to the rear right bedroom that is currently being used more like a lounge.

Misting to rear right window

ACTION REQUIRED: It is a choice as to whether you replace the glass sealed units or whether you look for a complete new window. It may be more economical to do one rather than the other.

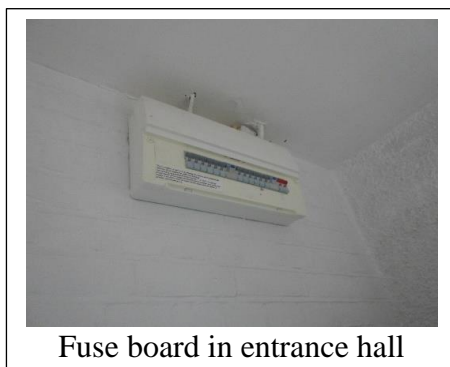
Fuse board in entrance hall

As mentioned, it seems unusual that they have not used a metal fuse board. We can also see a number of sockets have been added into the property therefore it is worth having an independent check.

ACTION REQUIRED: Your legal advisor needs to check and confirm if there is a Institution of Engineering and Technology (IET) certificate carried out by an NICEIC registered, or equivalent, approved electrical contractor or similarly approved.

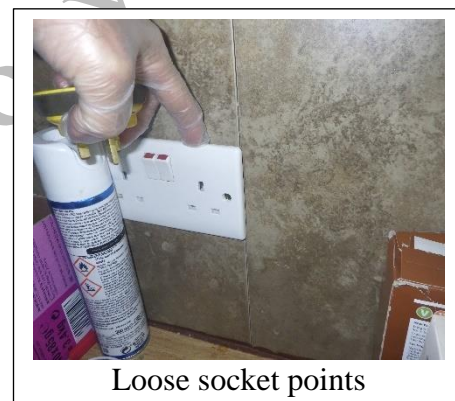
Loose socket points

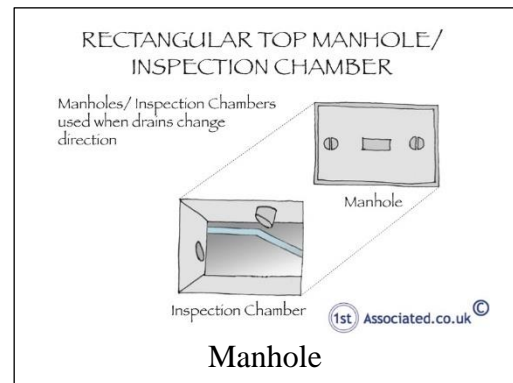
16.0) No manhole found

ACTION REQUIRED: We would recommend a closed circuit TV camera report of the drains.

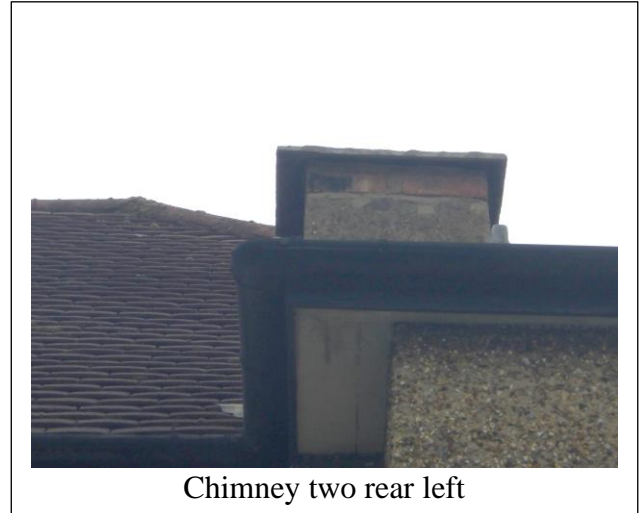
Chimney two rear left

This chimney is rendered finished with a lead flashing. From what we could see from ground level it looked in below average condition considering its age, type and style.

Poor rendering to rear chimney and flashing coming away
~ Aerial View ~

ACTION REQUIRED: Please see our comments in the Executive Summary.

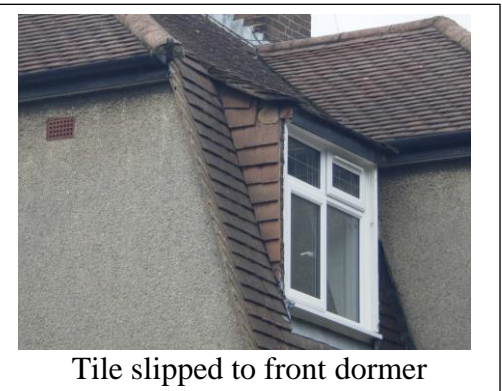
Tile slipped to front dormer

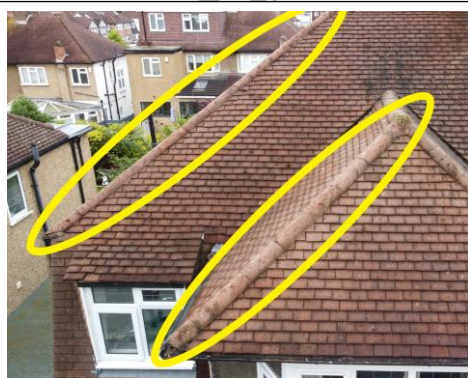
Hairline cracking to the hip of the roof

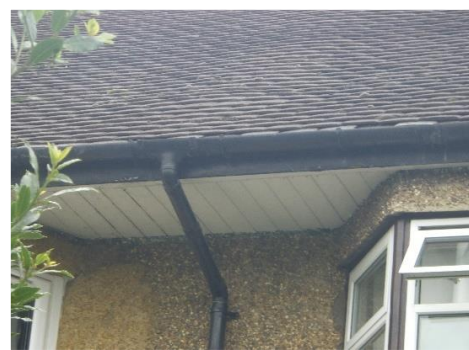
The roof is clad with a small concrete tile and, from ground level, this looks in below average condition considering the roofs age, type and style.

Rear tiles deteriorating

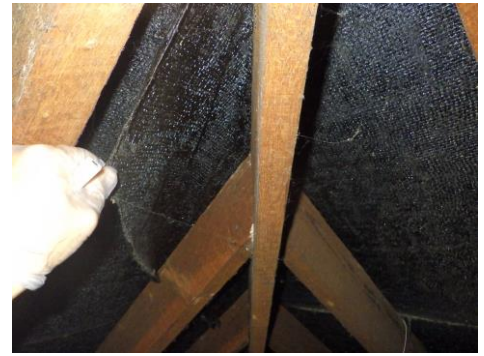
When we inspected the loft space, we found a Hessian based bitumen membrane. This type of membrane has been used since the 1960s. We generally found it to be in below average condition and brittle to touch.

This photo shows the common rafters (the ones that form the pitch of the roof) and area between is the protective underlayer.

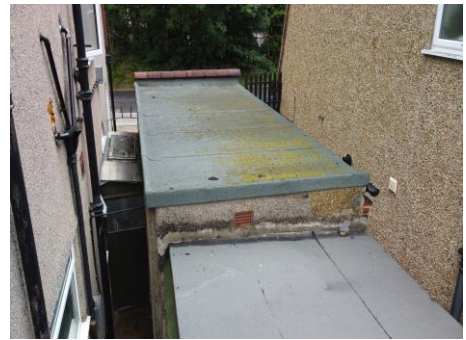
Garage flat roof with cement flashing and flat roofs behind

ACTION REQUIRED: These are flat, flat roofs so may need repairing. The roof has a cement flashing; we would prefer a lead flashing.

ANTICIPATED COST: Set aside the sum of £500 - £1,000 for basic repairs and then expect to do the occasional repair; please obtain quotations before you legally commit to purchase the property.

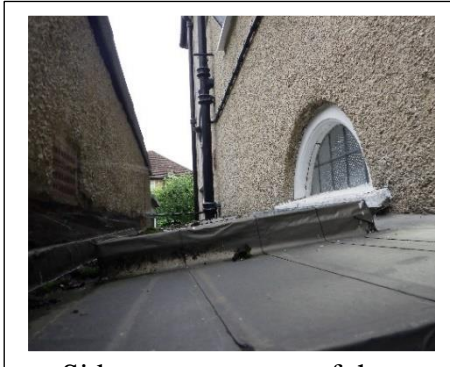
Side passageway roof that needs removing

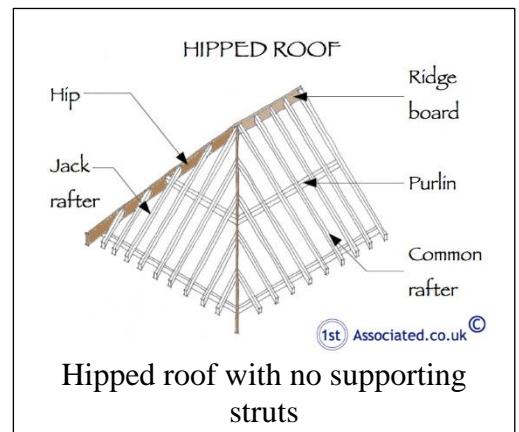
Hipped roof with no supporting struts

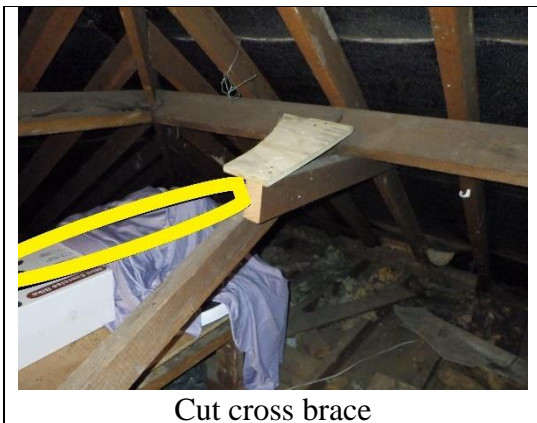
Our examination was limited by the general configuration of the roof, the insulation, boarding and stored items. What we could see was generally found to be in below average condition due to the alterations that have taken place of the cross brace removed. We would prefer for the purlin to have more support and this indicates there has been some movement in the roof. We would recommend monitoring this and add another strut, the sooner the better. The strut should copy the existing struts.

Cut cross brace

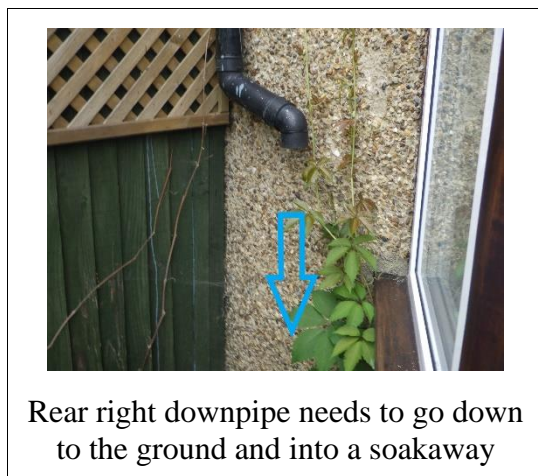
Rear right downpipe needs to go down to the ground and into a soakaway

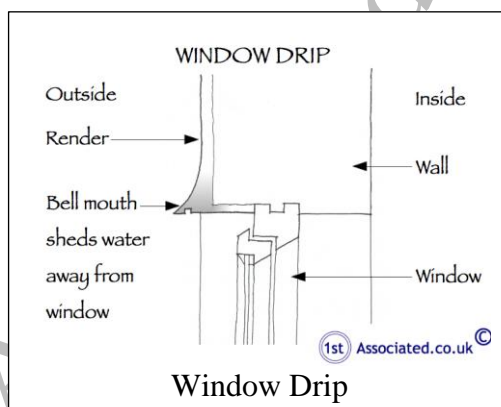
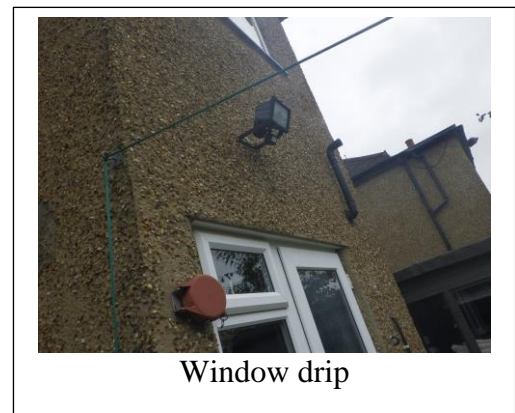
Bell mouth to base of property

To the base of the render there was no bell mouth detail.

ACTION REQUIRED: It may help with dampness to the base of the property if a bell mouth is added to the base of the render. We would expect this to be fairly expensive so we would recommend you try the other options that we have spoken about earlier in the report before you add a bell mouth.

ANTICIPATED COST: In the region of £2,500 - £5,000 for a bell mouth detail; please obtain quotations before you legally commit to purchase the property.

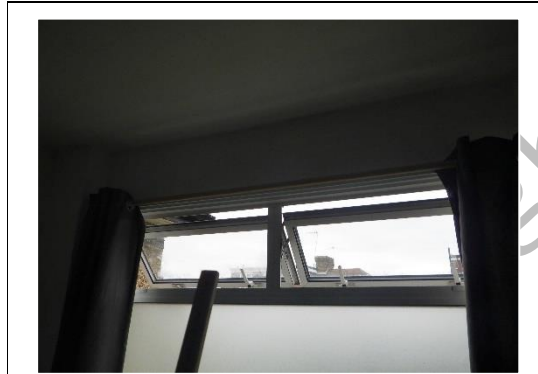
Misting to rear right window

ACTION REQUIRED: You need to decide whether to replace the misting windows or to replace whole windows. Sometimes, depending on what the market is doing in double glazing, it may be more economical to replace the whole window. Make sure you have trickle vents on them.

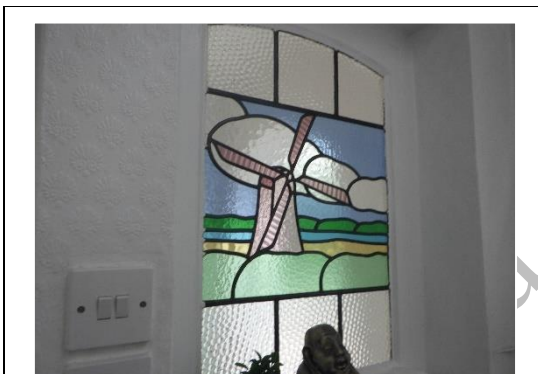
Art Deco glazing

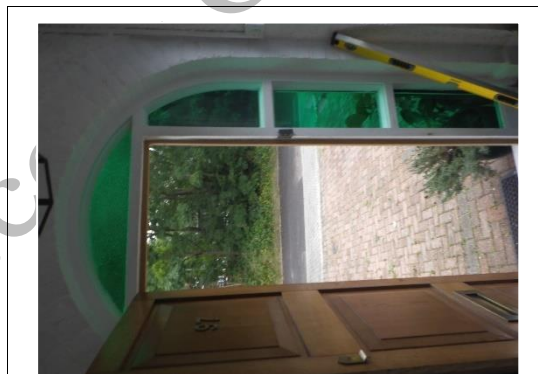
Art deco glazing around entrance door

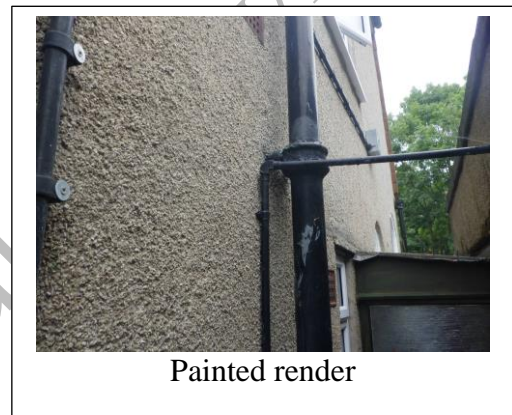
The external decorations are generally in dated condition and in need of carrying out work. We are advised the property was last decorated externally three years ago but it does look more dated than this particularly to the gutters, downpipes and soil and vent pipes. We would recommend painting this summer.

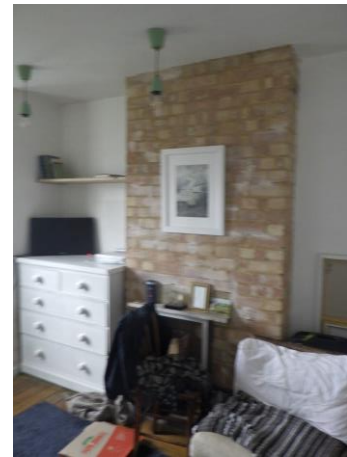
Chimney breast in rear bedroom

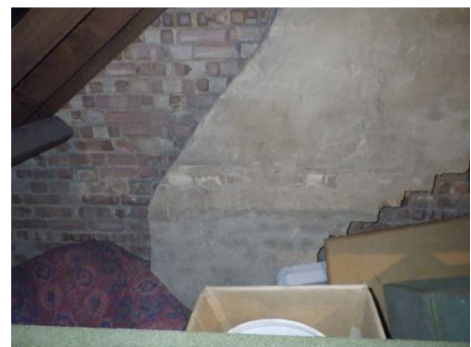
Front chimney viewed within roof space

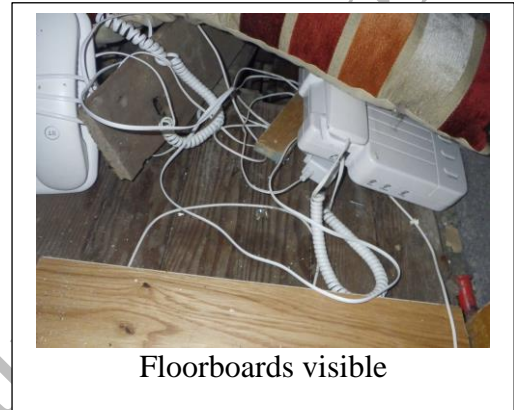
There is a mixture of a suspended timber floor to the front of the property, which require air movement underneath to minimise wet rot, dry rot and woodworm, and a concrete floor to the rear.

Floorboards visible

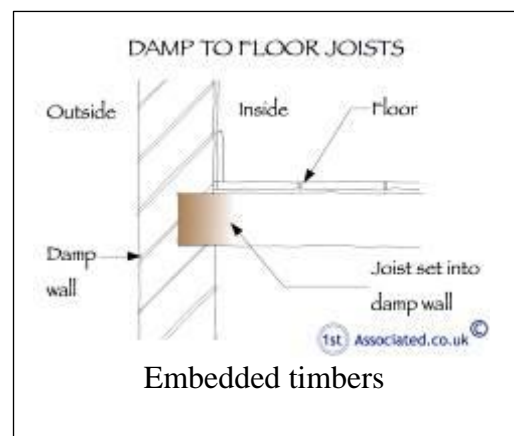
We have assumed that the first floor construction is joist and floorboards with embedded timbers, as this is typical in this age of property.

Embedded timbers

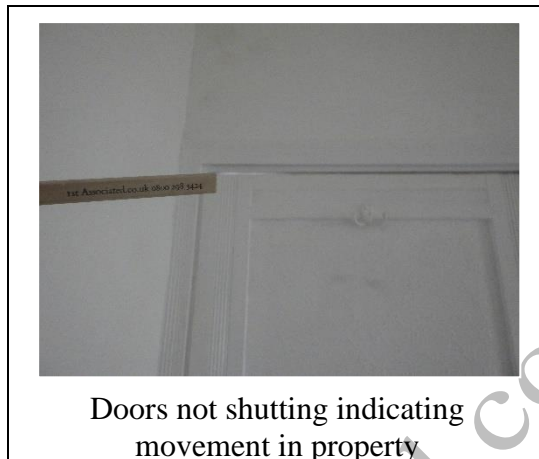
The property has painted panel doors. Some of the doors do not shut properly indicating there has been some movement in the property.

Doors not shutting indicating movement in property

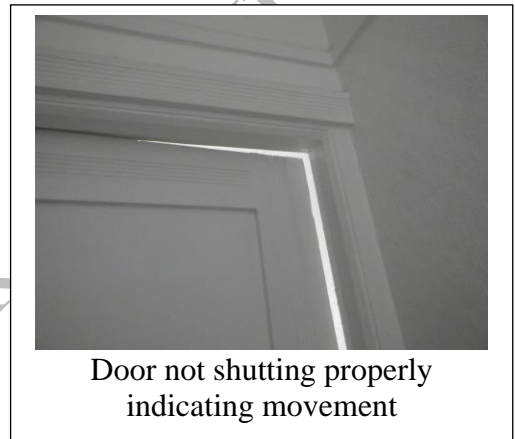
Door not shutting properly indicating movement

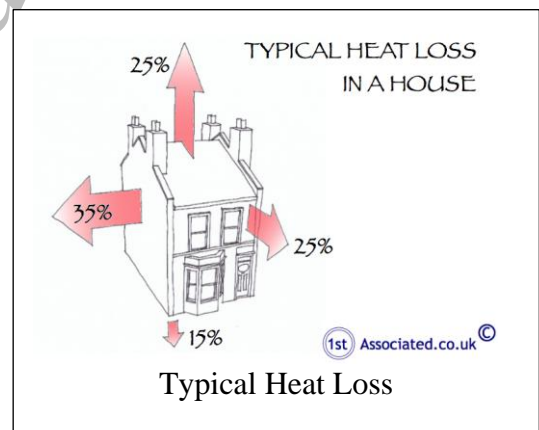
Some roof insulation was present although not to current Building Regulations requirements of 300mm. In this instance there is 100mm.

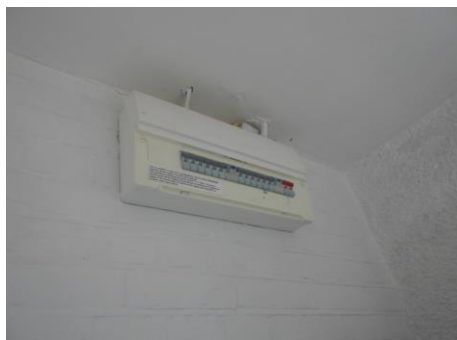
Before we begin, we want to explain the discussion we had with the owner that a relative had wired the property. We found the old fuse board under the kitchen units which looks to be from the 1960's and a 'new' fuse board in the entrance hall but this looked to be a 1980's/2000 fuse board; today a new fuse board would mean a metal fuse board.

Fuse board in entrance hall

ACTION REQUIRED: You need to have an independent Institution of Engineering and Technology (IET) test and report and any recommendations carried out by a NICEIC registered, or equivalent, approved electrical contractor or similarly approved.

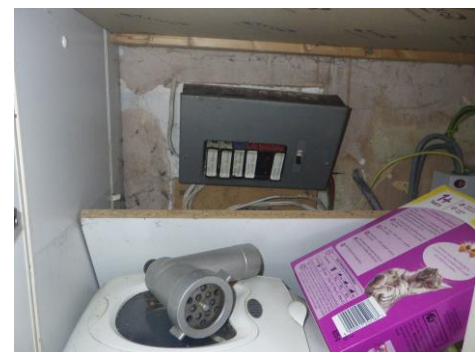
Old fuse board in kitchen cupboard

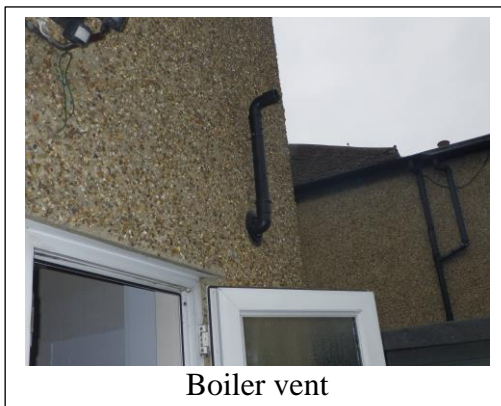
Boiler vent

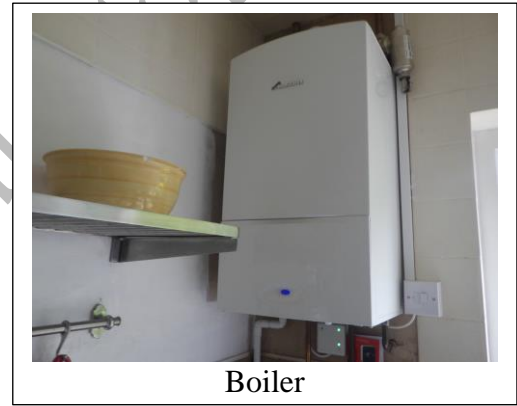
Boiler

Our limited inspection of the hot water and central heating system revealed no evidence to suggest any serious defects but we would nevertheless recommend that the system be tested and overhauled before exchange of contracts and that a regular maintenance contract be placed with an approved heating engineer.

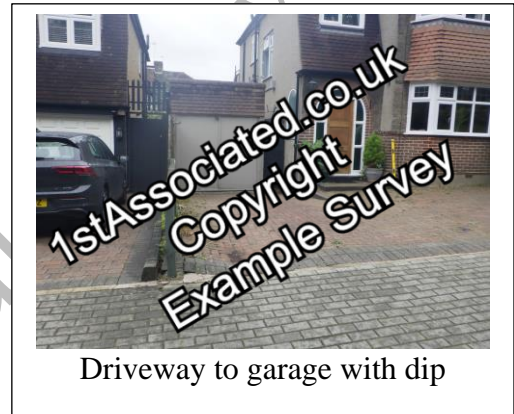
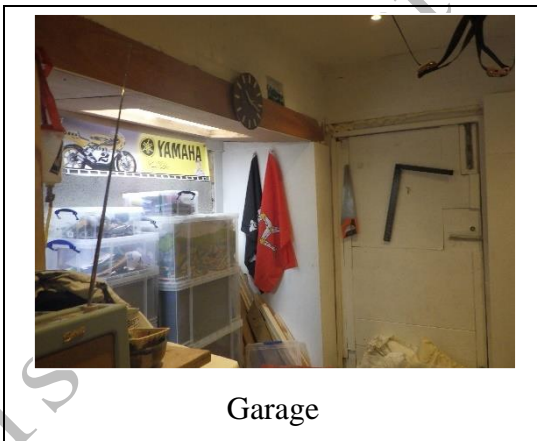
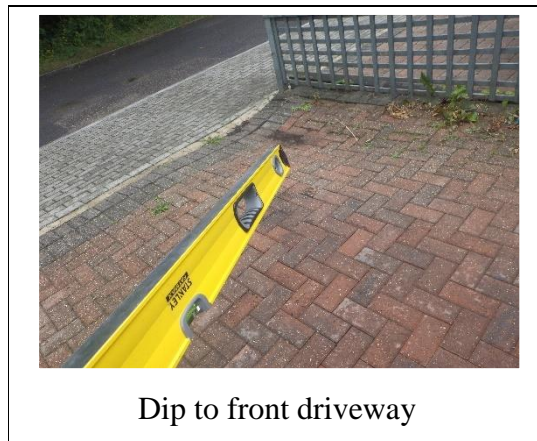
The property benefits from off-road parking. There is a dip in the driveway which needs to be levelled if it bothers you.

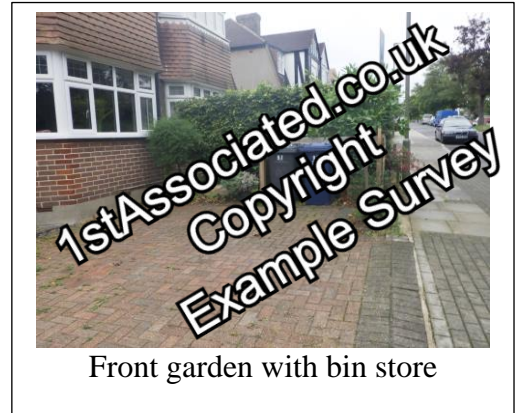
Front garden with bin store

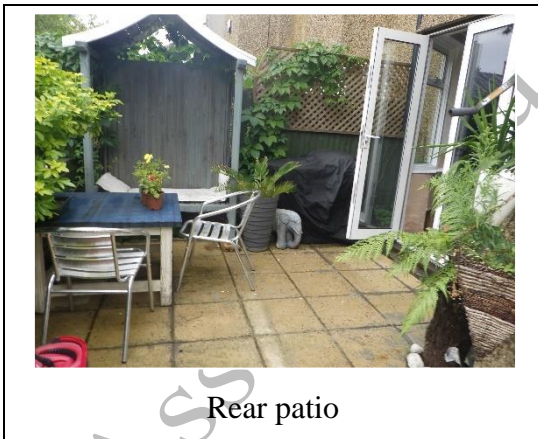
Rear patio

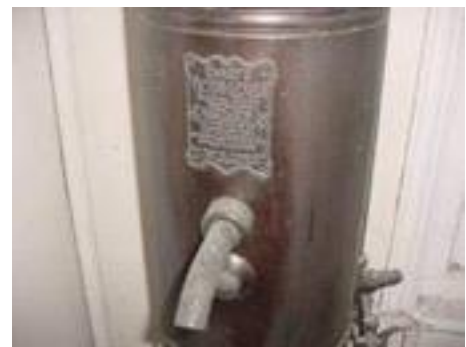
Very old Victorian water heater

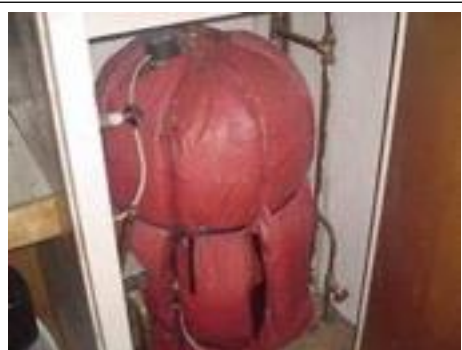
Older style cylinder with loose insulation jacket

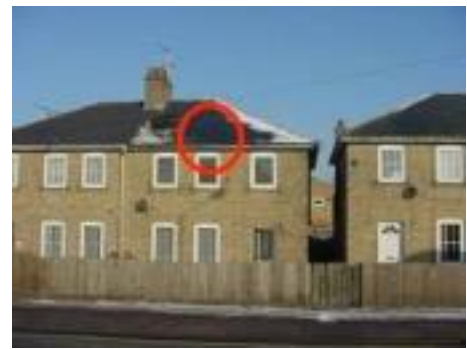
Inappropriate double glazed windows change the look of the property
Red circle is insulated roof indicated as snow is not visible

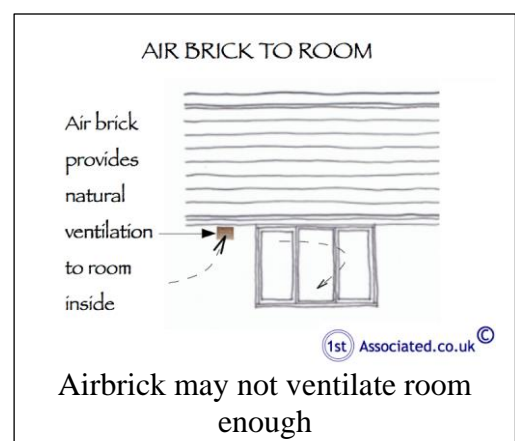
Airbrick may not ventilate room enough

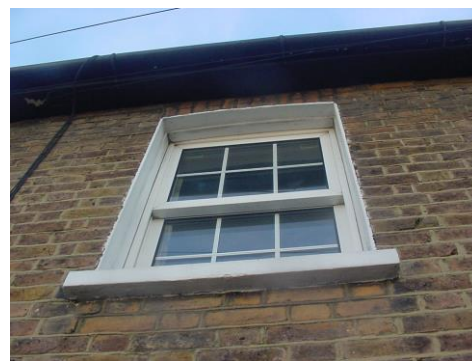
Sliding sash windows can swell in the winter months
