# War Years Example Residential Building Survey

## **GENERAL INTRODUCTION**

Firstly, may we thank you for using our services once again and your kind instruction of XXX we have now undertaken an independent Building Survey (formerly known as a Structural Survey) of the aforementioned property. This Survey was carried out on XXX.

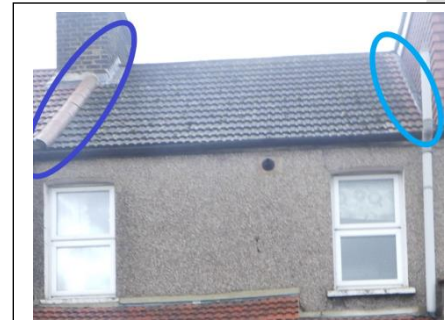
To the rear left of the main roof there looks to be a long term roof leak, which has resulted in re-felting of the area, also a new base of the common rafter. There look to be other leaks to the roof, such as dampness getting into the rear right.

Roof to rear where there have been new tiles on left side (blue) and dampness getting in to rear right (purple) (all directions given as you face the property from the front)

**ACTION REQUIRED:** Information to be obtained from the owners as to when these repairs were carried out.

**ACTION REQUIRED:** We would allow for more general repairs to the roof.

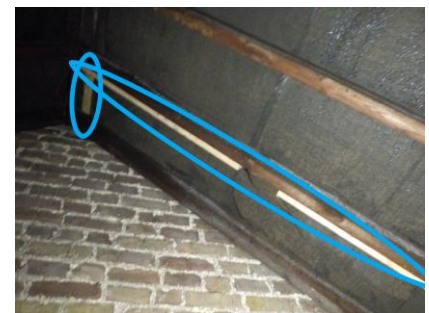
Rear left side with felt, plus newish batten which is highlighted in blue

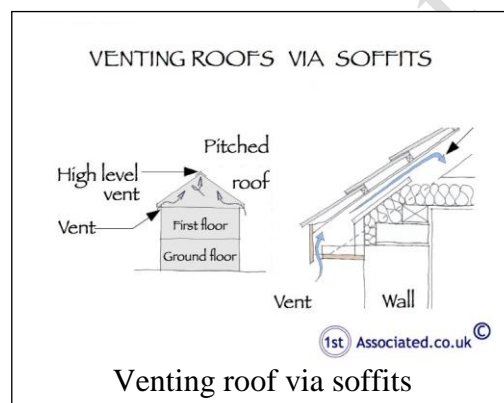
Generally within the roof we found soft timbers and areas of mould, which indicates to us dampness is getting in. We sometimes find mould in roofs where the property has been warmed quite well and there has been a lack of ventilation in the roof space, meaning moisture gets in in the form of a leaking roof and /or condensation occurring; we think probably both in this case.

The roof could also be suffering from condensation over the years. This sometimes happens where properties are heated and the roofs do not have ventilation.

**ACTION REQUIRED:** We recommend the roof has some general repair work to the tiles as needed, unless the existing owners can provide evidence that they have already carried out roof repairs in the form of receipts and/or specifications.

We would also recommend adding air vents to give a through flow of air to help reduce any problems with condensation, which could be added via the soffit boards.

**ANTICIPATED COST:** In the region of £2,500 to £5,000; please obtain quotations before you legally commit to purchase the property.

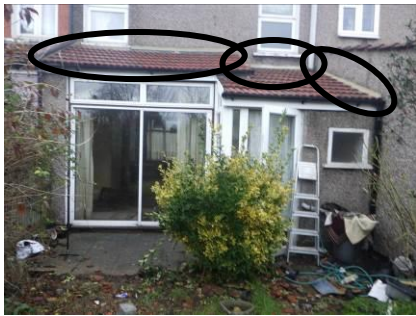
We noted the rear single storey roof has a cement flashing. These tend not to work very well as the cement cracks and cannot move and adjust with the seasonable movement of this type of house. We generally find that lead works much better as it is more flexible.

This is where cement has been used to cover up or fill the junctions between two areas, for example between a roof and a wall to help prevent dampness. Cement is a brittle material and prone to cracking which in turn allows dampness into the structure. We would always recommend the use of lead flashings.

Rear single pitched roof with cement flashing

Also please note this rear roof is a relatively shallow pitched roof. Normally we recommend 15 to 22 degrees for a pitched roof, however this looks to be less and as such can be susceptible to wind driven rain.

**ACTION REQUIRED:** We recommend you make the roof watertight and replace the cement flashing with a lead flashing.

We also recommend an access hatch is added to allow you to view within the roof structure.

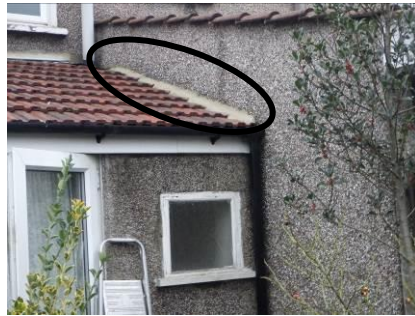
Cement flashing to rear left

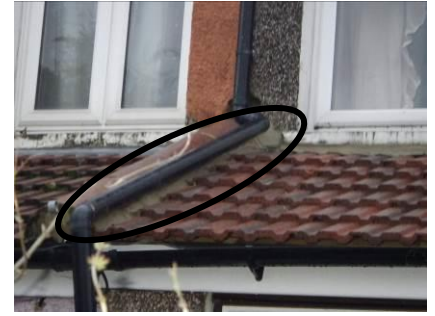
Cement around rear right bedroom

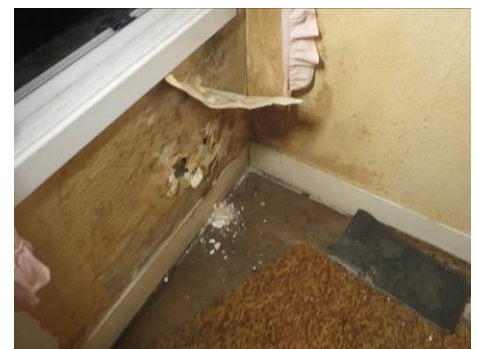
There is dampness coming in through the rear right bedroom window area, which we believe relates either the main roof, where we can see dampness coming in, or the low level single store roof.

Dampness coming in around rear right bedroom window

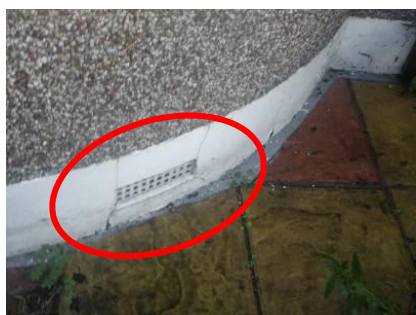
We noted a number of cracks in the property, such as cracking around the front bay window around the air vent, cracking to the rear bedroom, plus cracking between the main house and the rear lobby.

Cracking around air vent to front bay

3. The front bay is unlikely to have had foundations in this era of property meaning they move.
4. The single storey extensions to the rear is unlikely to have had a good quality foundations and they too have moved.

If you are cautious then we would recommend the existing owners take out an insurance claim, advising that the cracking has been noted by a structural surveyor (this should cost them nothing other than time to write the letter/email). This usually means that the insurance company will carry out a monitoring exercise (the Building Research Establishment recommend monitoring any cracks for a minimum of one year) to establish if there is any progressive movement. Your future liability should be limited to the cost of the excess on the insurance providing the insurance company is happy for you to take over the insurance claim.

We also recommend your legal adviser specifically asks the owners in writing whether they have any proof that the cracks were there when they moved into the property and that the cracks are longstanding. The proof can be in the form of original survey with photographs of the cracks, or their own photographs of the cracks. Again we would remind you that the Vendor Questionnaire has not been returned to us so we do not have any of this kind of information.

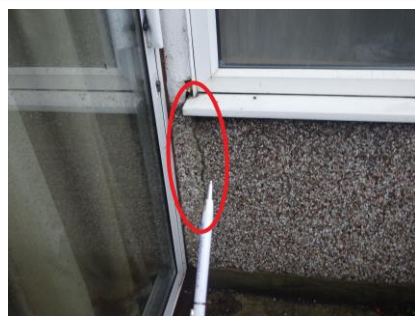
Cracking around rear right lobby

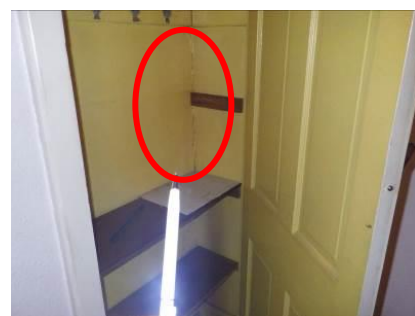
Cracking in cupboard in rear bedroom

We think this is due to a number of reasons:

1. We think there is likely to be clay soil condition.
2. The house has been amended and extended over the years;

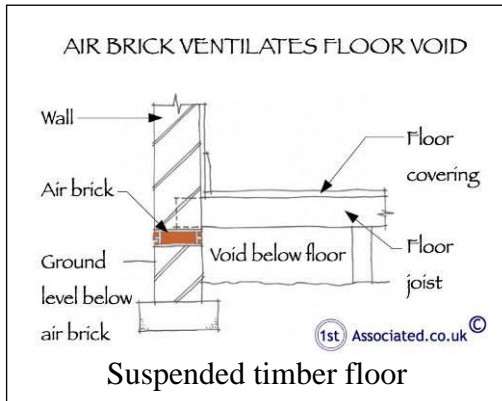
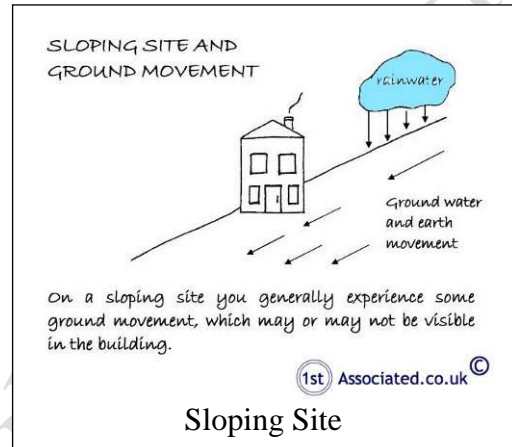
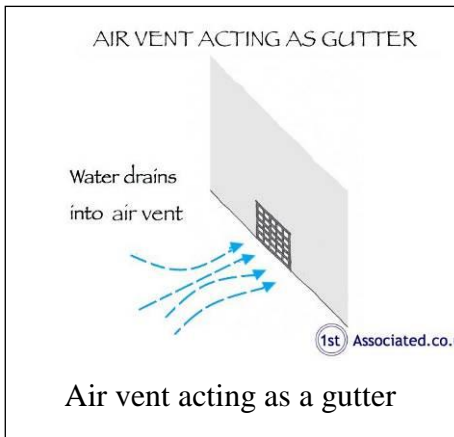
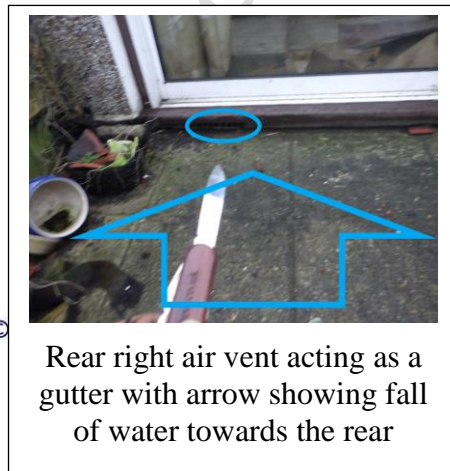
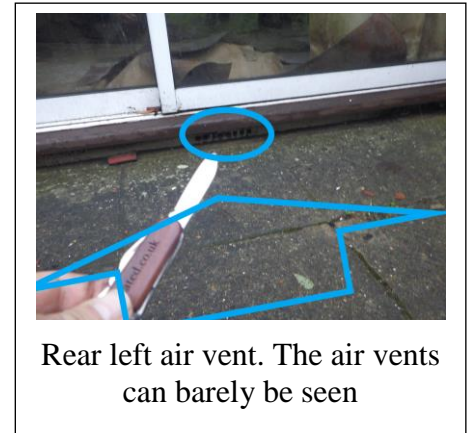
**4.0) Sloping site and air vents acting as gutters and deflection to through lounge**

The property sits on a slight slope. It predominantly has a suspended timber floor and the air vents to the rear are acting as gutters, allowing water to get under the floor.

We feel there is some deflection to the floor. The problem is also likely to be exacerbated by the rear lobby area and toilet having a concrete floor where we obtained high damp readings and this we believe is acting like blotting paper and likely to be causing deterioration to the suspended timber floor.

We would also add that there is a concrete element to the rear of the floor which is very damp. We find with this type of arrangement that the dampness held within the concrete can add to the deterioration in the timber floor.

**ACTION REQUIRED:** Ideally open up the floor before you legally commit to purchase the property. We are concerned there could be wet rot, dry rot and/or wood destroying insects under the floor, particularly to the rear where there appears to be more deflection than we typically come across. If you recall, we did an impact test in this area.

We recommend lifting up the paving slabs and adding a Land drain and/or French drain, with a perforated pipe to the base. This is likely to need a soak-away.

**ANTICIPATED COST:** To open up the floor costs in the region of £250 to £500 per opening and to replace. If the present owners will not allow you to open up the floor then we think it is best to assume there are problems. Adding a land drain or French drain in the region of £4,000 to £6,000.

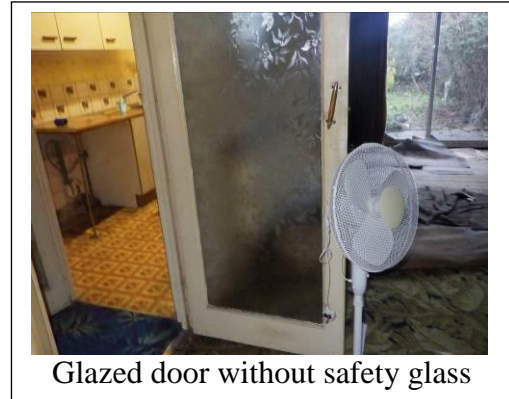
There are some glazed doors in the property which do not look to have safety glass as we were unable to see the British Standard safety kite mark. It is the old sort of glass which we think is quite dangerous if it shatters.

**ACTION REQUIRED:** We recommend these are replaced with ones with safety glass or a timber door.

**ANTICIPATED COST:** Doors can cost anything from £75 up to around £300, depending on the quality you want. Please obtain quotations before legally committing to purchase the property.

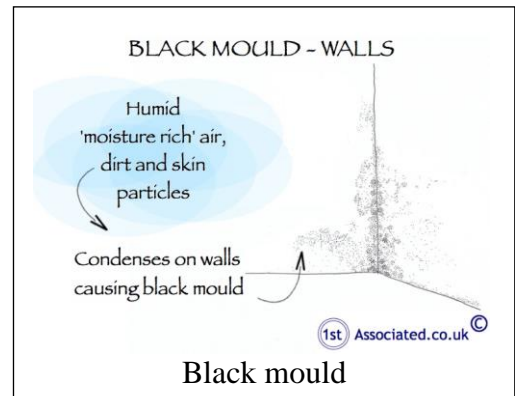
## **6.0) Higher than average chance of getting condensation/black mould**

We did not note any good quality extraction in the kitchen or bathroom (the latter having no extraction at all), and we feel this property will be prone to condensation/black mould. Typically this occurs in the corners of properties.

**ACTION REQUIRED:** We would recommend large good quality humidity controlled extract fans are added to the kitchen, the bathroom and any humidity generating areas for example rooms that are used for drying clothes internally during winter months (we would assume that clothes will be dried externally during the warmer months). By large extract fans we mean 150mm.

**ANTICIPATED COST:** We would anticipate costs between £250 - £500 per extract fan depending upon the wiring required. We always recommend quotes are obtained before work is agreed/commenced and before legally committing to purchase the property.

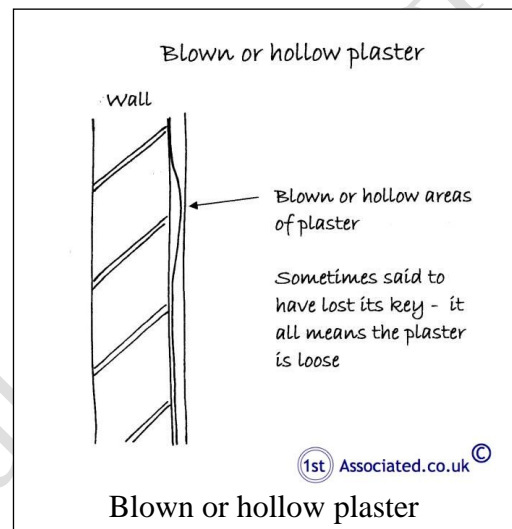
### 7.0) Internal decoration – nicotine stained

We have identified elsewhere within the report dampness is getting into the wall structure and there are some blown or hollow areas, which will need re-plastering once the cause of the problem has been resolved.

**ACTION REQUIRED:** Repair, prepare and redecorate.

**ANTICIPATED COST:** We estimate the removal of the nicotine and patch repairs to the plaster would add approximately £1500 to £3,000 to the cost of the work. Please obtain quotations before legally committing to purchase the property.

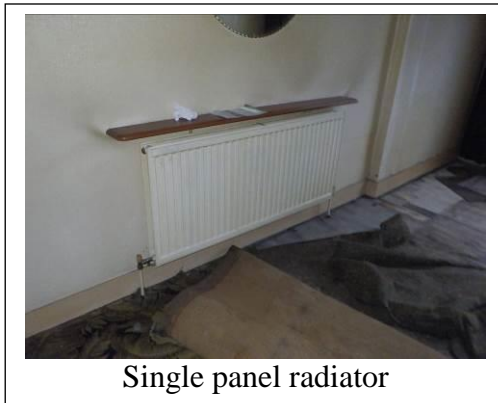
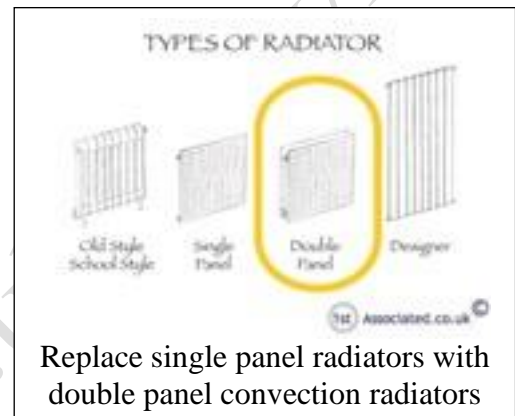
### Single panel radiators

The radiators are single panel radiators, generally we would expect double panel radiators. We did note it has under floor heating but this was not tested at the time of the survey, although you advise that the heating was on in the floor of the bathroom.

**ACTION REQUIRED:** We recommend you upgrade to double panel convection radiators, ideally positioned under windows where possible.

**ANTICIPATED COST:** In the region of £100 - £200 per modern double panel convection radiator; please obtain quotations before legally committing to purchase the property.

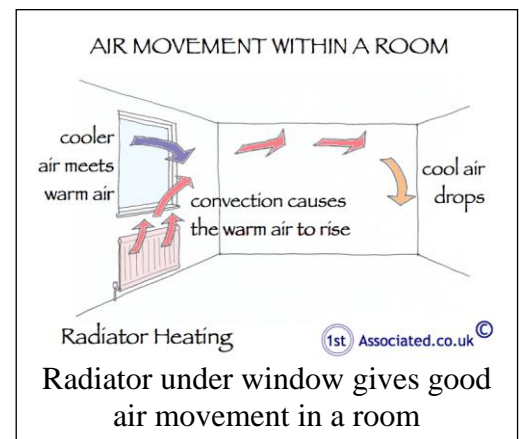
### Internal Radiators

We also noticed some internal radiators; we much prefer to see them located under windows for better air flow to reduce the chances of condensation.

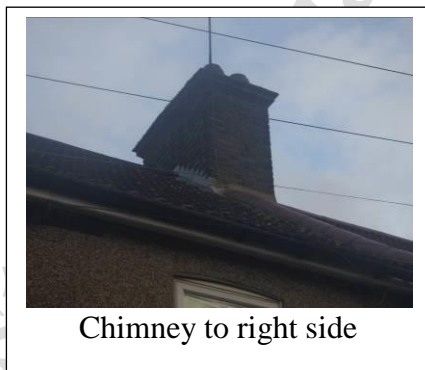
Chimney to right side

This chimney is brick finished with a lead flashing and we think it has about eight chimney pots (four each side), although it was difficult to view from ground level. From what we could see from ground level it looked in average condition considering its age, type and style.

We noted an aerial attached to the chimney which we are not keen on as it can destabilise the chimney.

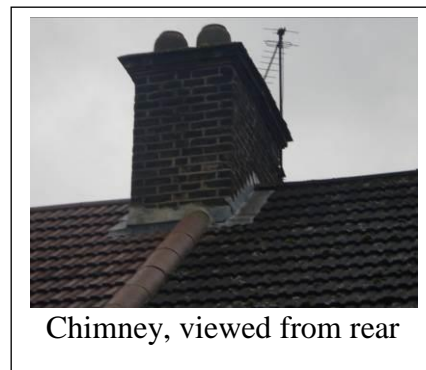
Chimney, viewed from rear

From within the roof it look like it may be allowing some dampness in via the chimneys (see our photo in the chimney breast section of the report).

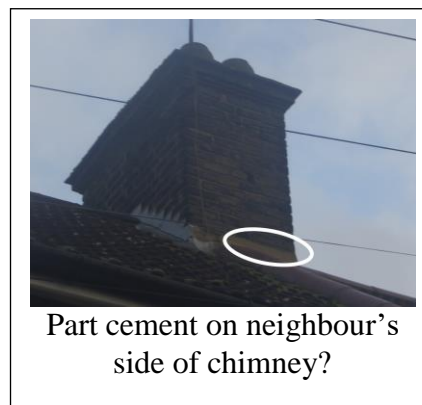
Next door's chimney looks like it may have a cement mortar flashing, which could be the reason why dampness is getting in, visible on the chimney breast. Unfortunately we did not have the benefit of aerial photography.

Unfortunately, we were unable to see the top of the chimney properly, known as the flaunching, we therefore cannot comment upon them.

**ACTION REQUIRED:** When carrying out roof work we recommending you check the chimney and make it watertight plus ad hoc repointing.

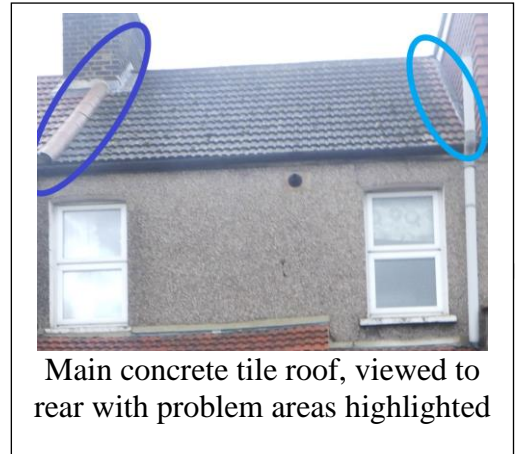
The roof is pitched and has been re-roofed with as large concrete tiles, originally it was likely to have had a different tile. It looks in below average condition considering the roof's age, type and style.

**ACTION REQUIRED:** Please see our comments in the Executive Summary.

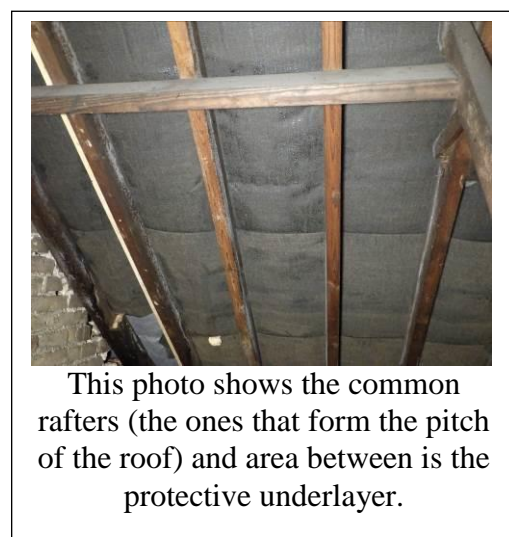
When we inspected the loft space, we found a Hessian based bitumen membrane. This type of membrane has been used since the 1960s. We generally found it to be in below average condition due to the repairs that have been carried out;

*For example: to rear left side.*

**ACTION REQUIRED:** Please see our comments in the Executive Summary.

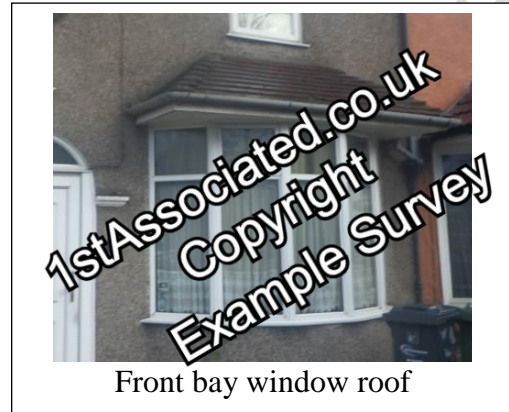
We would comment it is in average condition.

**ACTION REQUIRED:** Periodic inspection. Add a lead flashing.

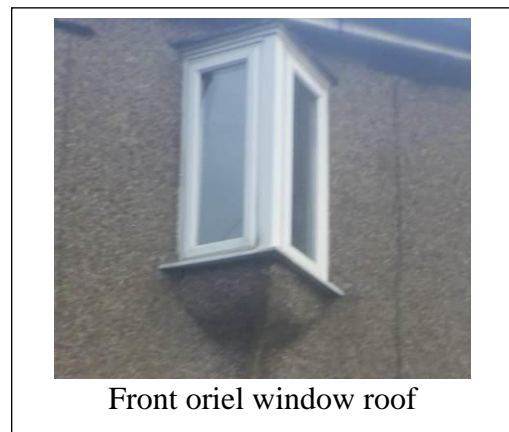
### FRONT HIGH LEVEL ORIEL WINDOW ROOF

We were unable to see the small roof over this window so cannot comment on its condition. Typically these would be either a small clay tile or a metal roof.

**ACTION REQUIRED:** Periodic inspection.

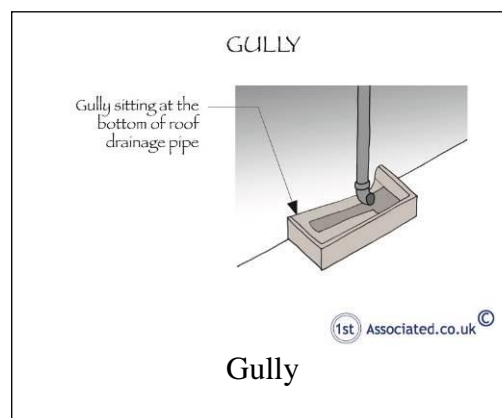
*For example: the rear gully is on the neighbouring property's land.*

We do like to have a proper gully so that you can clear it easily if it gets blocked with leaves, etc,

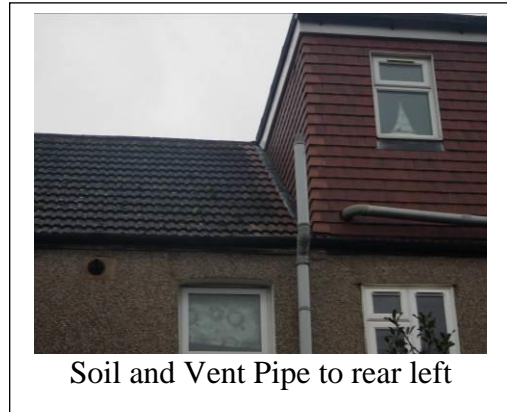
Soil and Vent Pipe to rear left

The property has plastic soil and vent pipes to the rear left, which is partly internal at ground floor level. Originally it is likely this was cast iron.

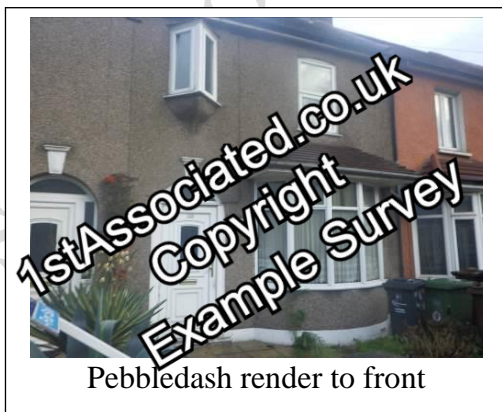
The external walls are finished in a pebbledash render. Typically this type of finish was used from 1960's-1980's.

Pebbledash render to front

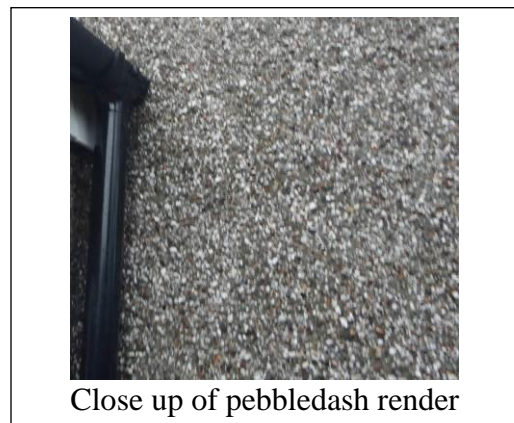
Close up of pebbledash render

We have carried out a tap test (literally hitting the render with the back of our hand) and the render was in average condition, although hard renders like this do tend to get cracking over time as the original building moves seasonally.

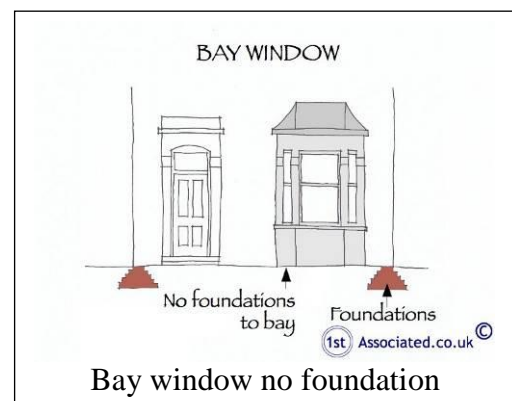
Bay windows in this era of property typically do not have foundations underneath them and have been subject to movement. We are aware that some insurance companies underpin bay windows with a modern foundation. We think this is often excessive and unnecessary and would be happy to comment further on this if you ever find yourself in this situation.

There is some cracking to the base of the bay window around the air vent.

The cracking around the air vent to the front bay, the cracking in the cupboard in the rear bedroom and cracking in the building in the park across the road all indicate there is likely to be clay in the area.

You should ensure that the Building Insurance Policy contains adequate provision against any possibility of damage arising through subsidence, landslip, heave etc.

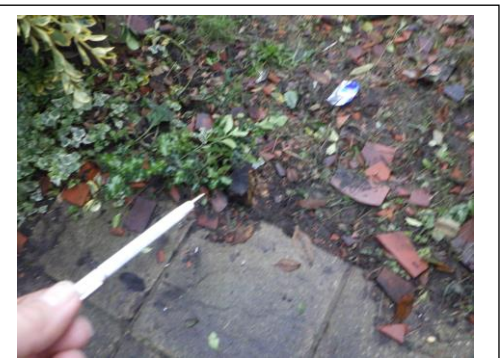
We did note some bushes have been cut back. Remembering this is a sloping site, this can mean there is more water is travelling towards the rear, where the air vents are acting as gutters.

Bushes cut back

**ACTION REQUIRED:** Please see our comments in the Executive Summary regarding the air vents and sloping site.

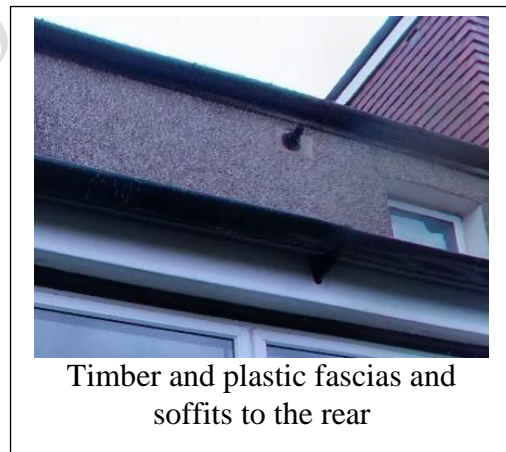
Timber and plastic fascias and soffits to the rear

**ACTION REQUIRED:** We think repairs will be necessary where the fascias are timber. You also need to double check where the plastic has been added that the original timber has not been left to rot away behind.

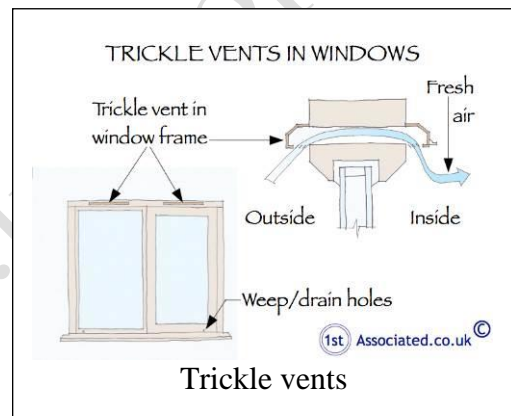
Generally, we would comment the timber windows are in below average quality for their age, type and style, with deterioration and flaking paint and the plastic windows need cleaning.

**ACTION REQUIRED:** Clean, repair, prepare and redecorate where appropriate. However, we would budget for replacement of the windows; the sooner the better.

**ANTICIPATED COST:** In the region of £1,000 to £2,000 for basic cleaning and repairs and redecoration and replacement windows around £5,000 to £10,000, depending on the quality of window. Please obtain quotes before you legally commit to purchase.

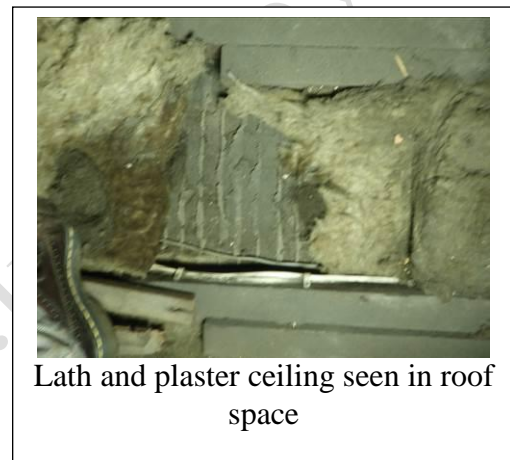
Lath and plaster ceiling seen in roof space

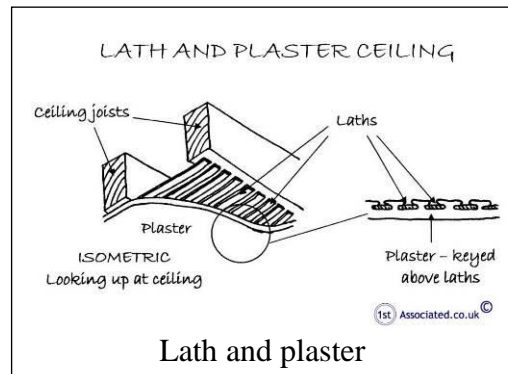
Lath and plaster

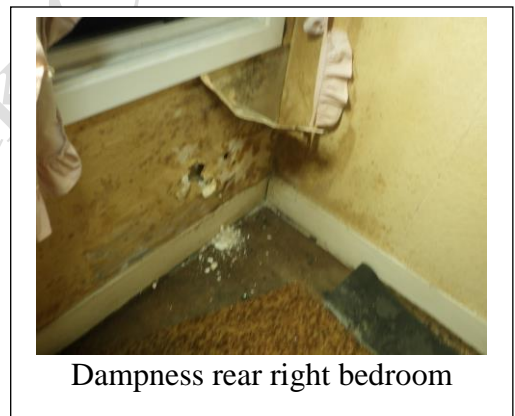
We noted dampness coming through in the rear right bedroom.

**ACTION REQUIRED:** Please see our comments in the Executive Summary.

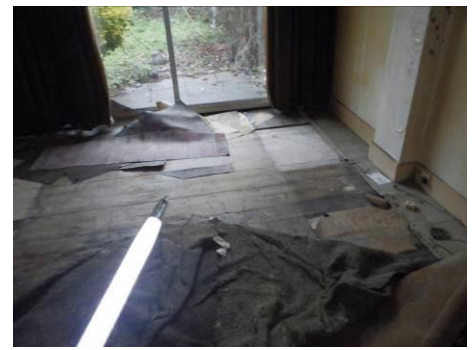
We noted deflection and dampness in the through lounge to the rear.

Dampness and deflection in through lounge to rear

**ACTION REQUIRED:** Please see our comments in the Executive Summary.

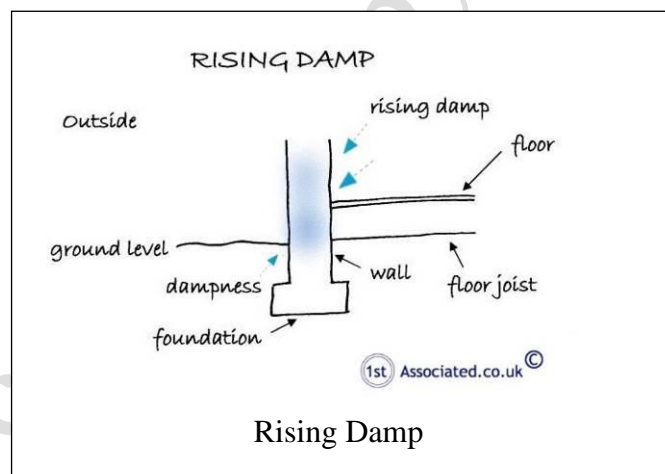
A visual inspection and tests with a moisture meter have been taken to the perimeter walls. In this particular case, we have found significant rising damp to the rear.

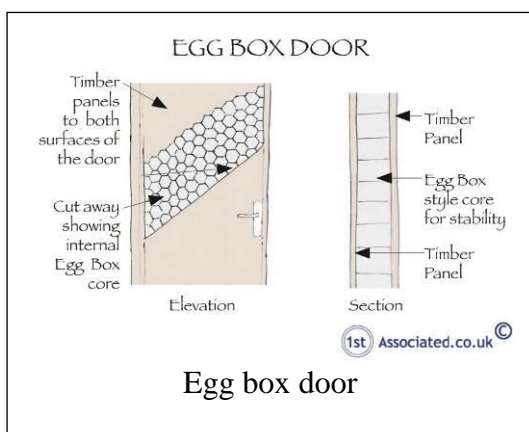
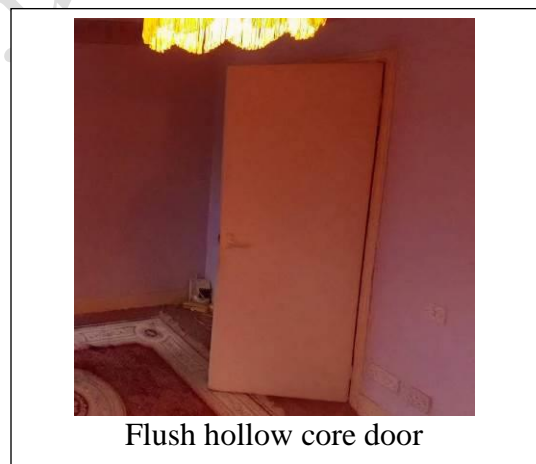
There are painted flush hollow core doors in the property, often known as egg box doors. The glazed doors in the property do not have safety glass.

**ACTION REQUIRED:** Please see the Executive Summary regarding the glazed doors.

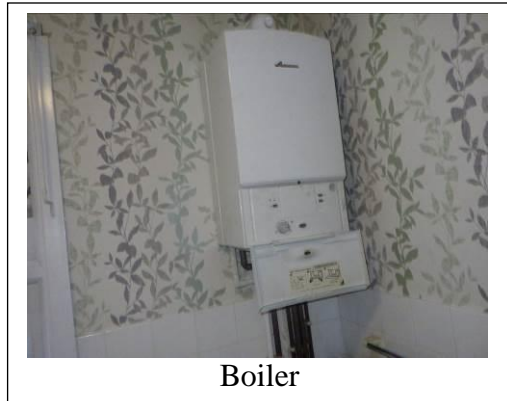
Boiler

The wall mounted Worcester boiler was located in the bathroom.

Our limited inspection of the hot water and central heating system revealed no evidence to suggest any serious defects but we would nevertheless recommend that the system be tested and overhauled before exchange of contracts and that a regular maintenance contract be placed with an approved heating engineer.

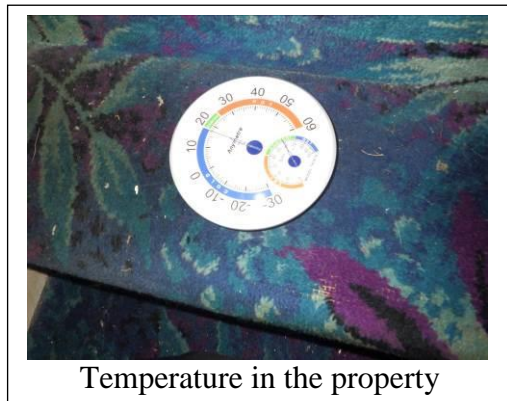
There was no owner / occupier at the property and therefore we do not turn the heating on in case there is a problem with it.

Temperature in the property

**ACTION REQUIRED:** We recommend you return to the property with the estate agent to turn the heating on to ensure it is working.

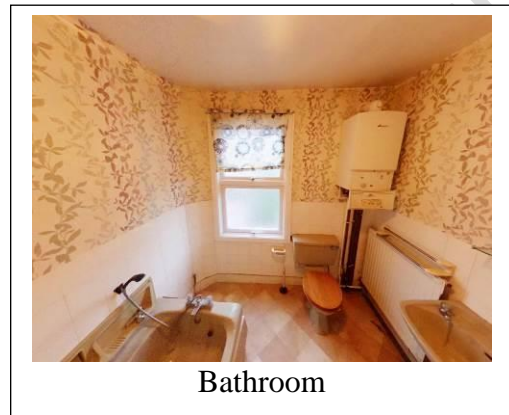
The property has a three-piece avocado coloured bathroom suite, consisting of a bath, wash hand basin and WC, which looks in dated condition.

Bathroom

**ACTION REQUIRED:** We recommend you upgrade the bathroom.

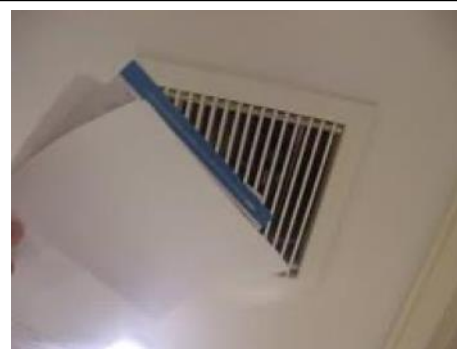
Testing the extract fan which in this case had poor extraction

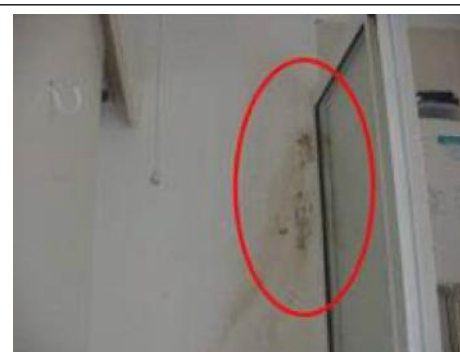
Condensation from a shower where nearby window was never opened
