# Timber Frame Example Residential Building Survey

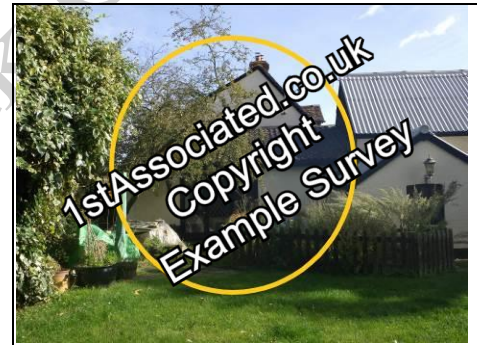
Old photo of what used to be the right gable, which has now been built in front of

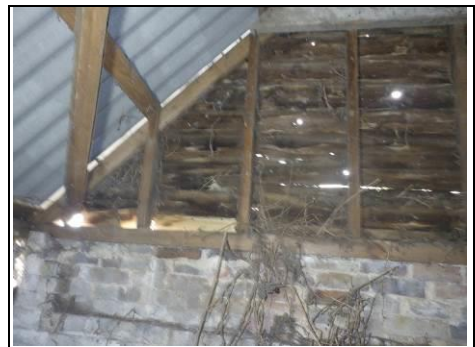
Rear gable end not viewable externally. This is the inside viewed from within roof, where vegetation is growing through

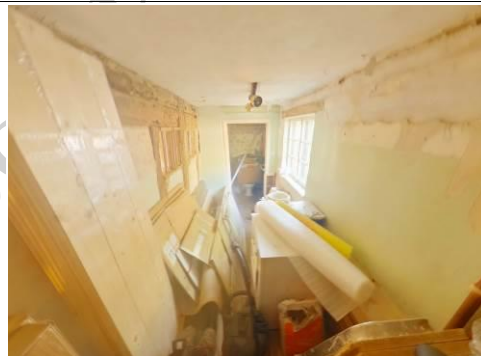
Unfinished Cloakroom to front

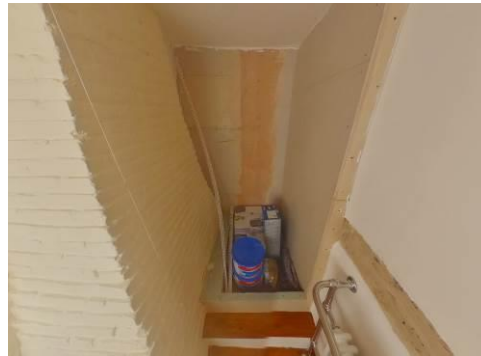
Unfinished en-suite shower room

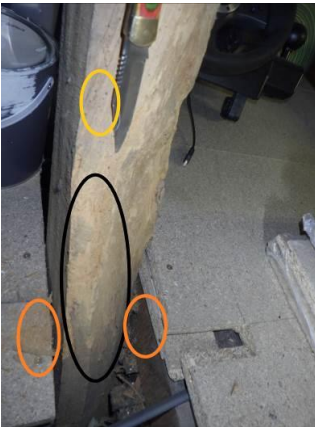
The roof was very crowded with stored items at the time of our inspection and also has floorboards secured down with screws. We anticipate quite a bit of wood destroying insects are hidden.

Signs of damage from wood destroying insects in main roof

**ANTICIPATED COST:** Budget for £2,500 to £5,000 to carry out repair works to the timbers. Please obtain quotations before you legally commit to purchase the property.

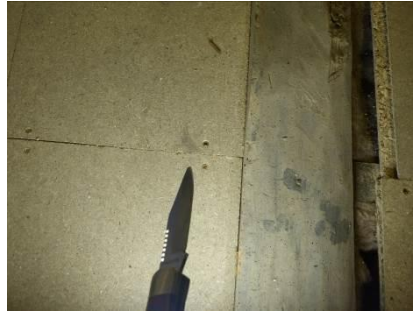
Signs of wood destroying insects to timbers. Our view was very limited due to the screwed down floorboards

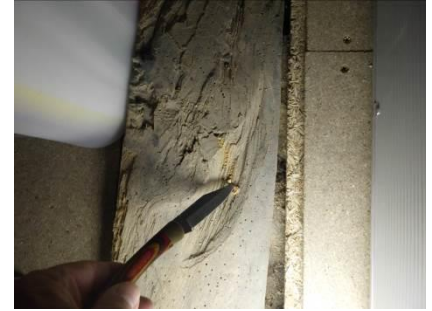
Timber with frass

Key for above photo	Showing a sample of the problem areas
Holes caused by wood destroying insects	Yellow oval
Signs of frass	Orange oval
General deterioration to timber	Black oval

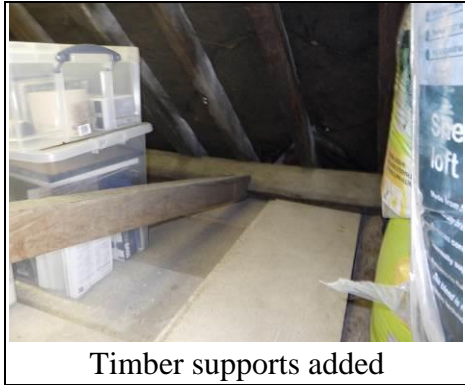
We noted additional supports have been added to cross-brace the main roof. Typically this is carried out when there is roof spread or some other problem with the roof.

Timber supports added

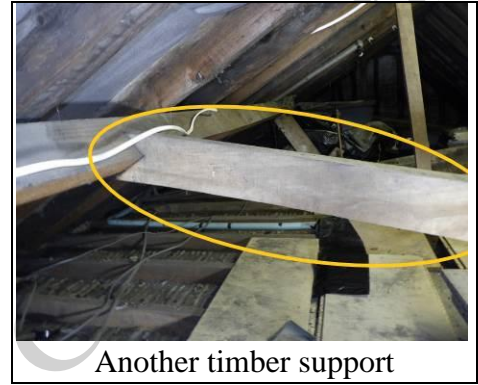
Another timber support

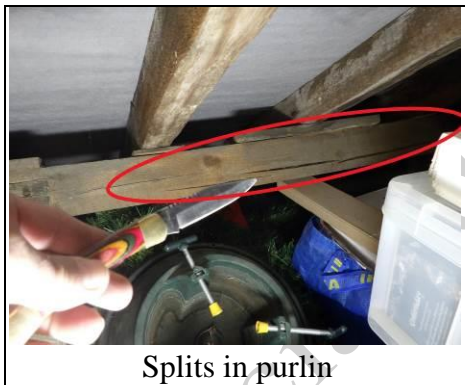
Splits in purlin

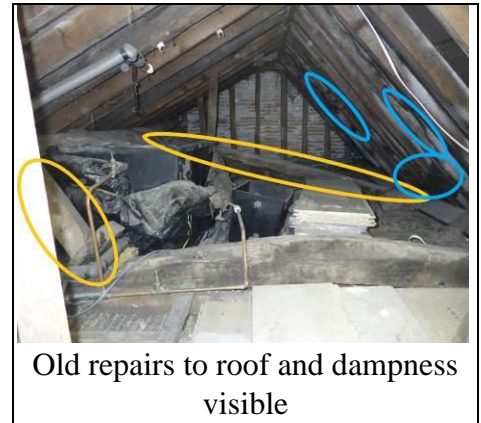
Old repairs to roof and dampness visible

Key for above photos	Showing a sample of the problem areas
Timber supports	Yellow ovals
Damp in roof	Blue ovals
Splits/shakes in purlin	Red oval

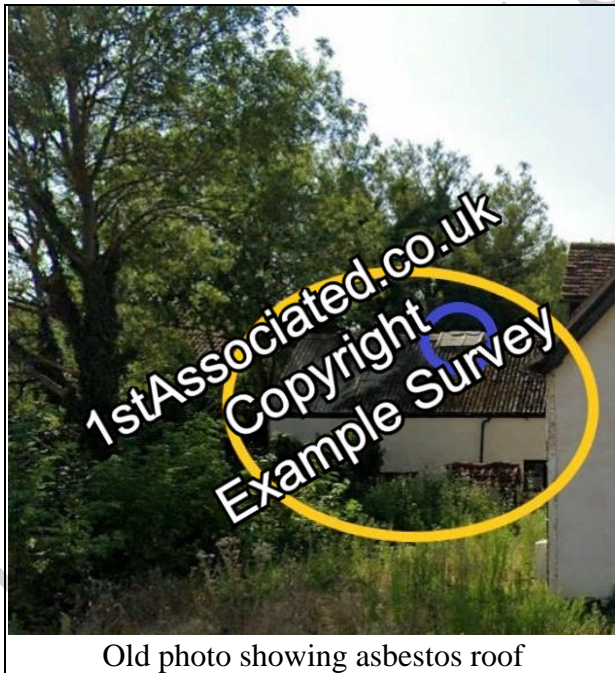
This roof was originally asbestos, it looks to us like the asbestos has been removed from the roof and it has been re-roofed with a modern corrugated roof material to both the kitchen and utility area and the pantry/larder.

Old photo showing asbestos roof

**ACTION REQUIRED:** Your legal adviser to request details of the asbestos removal and specifications/quotations of the work carried out for replacement of the roof.

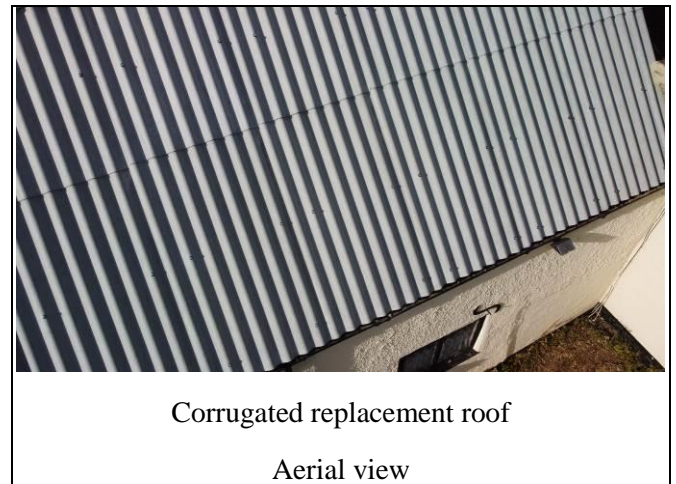
Corrugated replacement roof

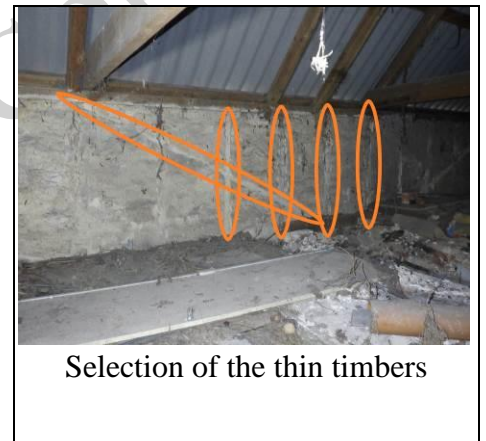
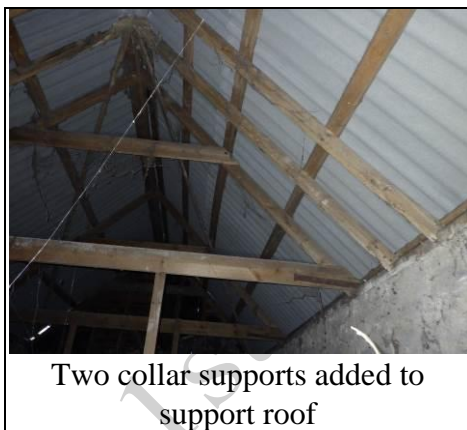
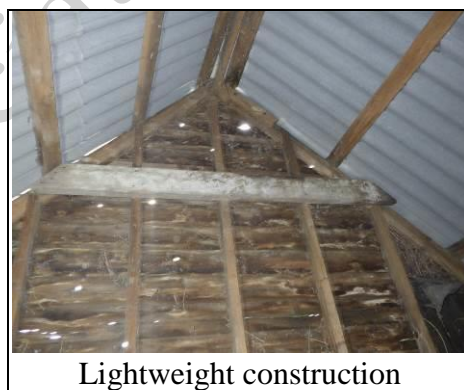
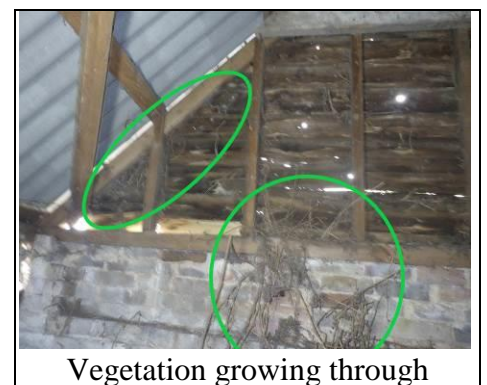
The entirety of this building is a relatively lightweight construction. If you recall, we could see cracking on this building externally and we can also see the timber frame from within the roof where relatively thin timbers have been used.

Historically this would have been a barn type store and we suspect it may not even have originally been built for human habitation and has been used and abused over the years.

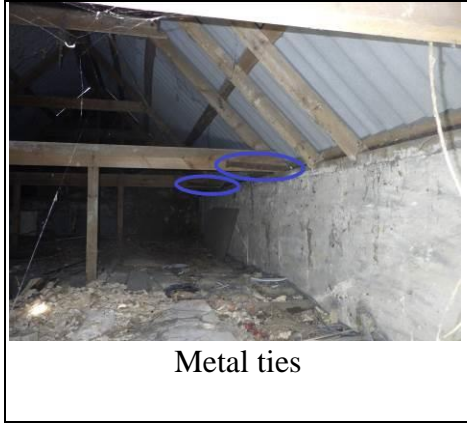
We can see a lot of movement in this building from the cracks externally which are visibly clear to see, to the historic repairs we can see in the building, with metal ties holding the roof together and tie bars (which we talk about later on in the report). We can also see that the rear left corner has come away from the main structure. This building therefore desperately needs some work.

Metal ties

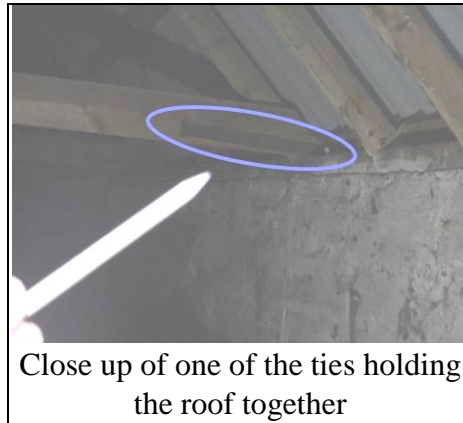
Close up of one of the ties holding the roof together

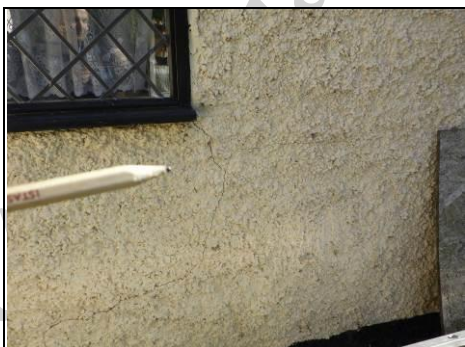
Crack to rough cast cement render on kitchen wall

If you remember, we believe this rough cast render is cement based, which is inappropriate for this era of building and unfortunately with the seasonal movement of the timber frame in the kitchen/utility area you are bound to get cracking.

**ACTION REQUIRED:** The cracks need to be sealed, probably a mastic would be the best way forward, although it does look unsightly.

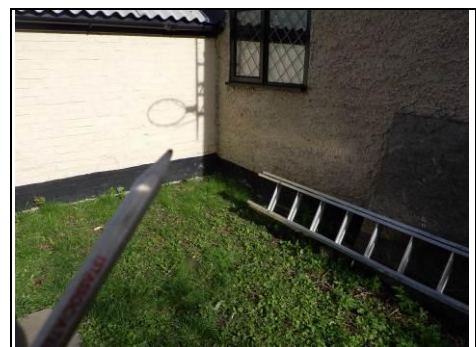
Crack where kitchen building meets pantry/store

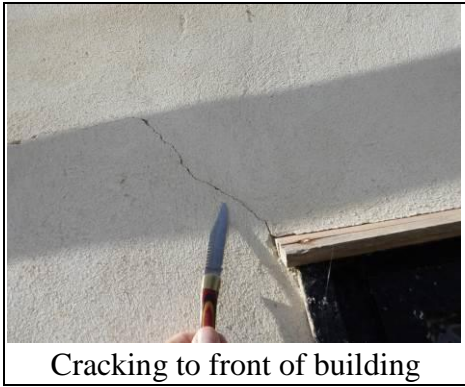
Cracking to front of building

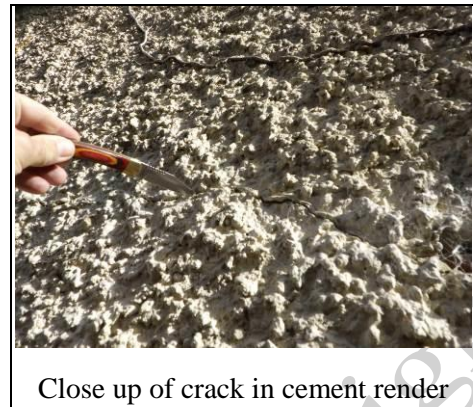
Close up of crack in cement render

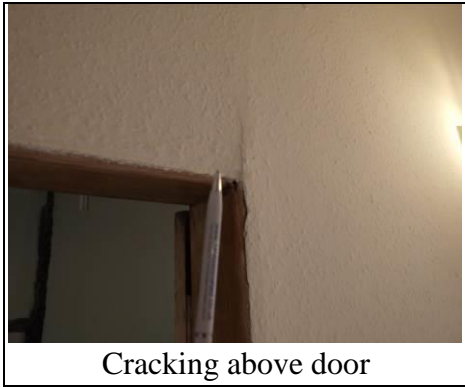
Cracking above door

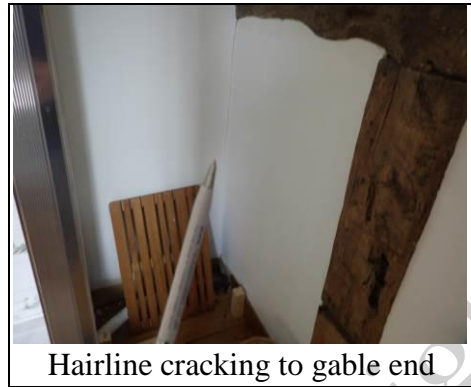
Hairline cracking to gable end

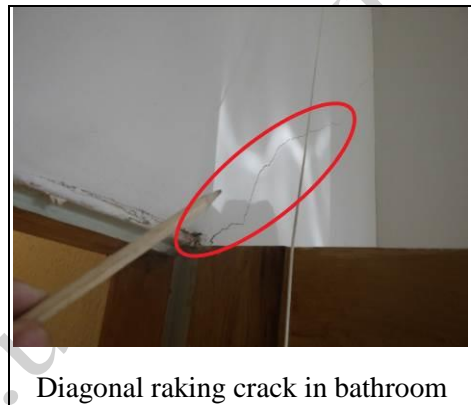
Diagonal raking crack in bathroom

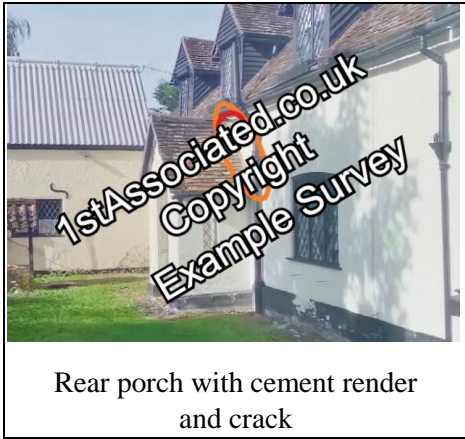
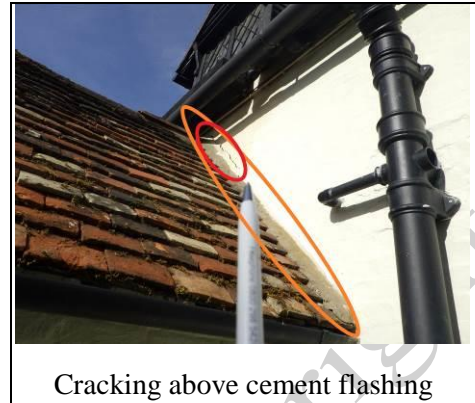
Externally to the main building is not as clearly obvious that there was movement (but you need to bear in mind this was redecorated relatively recently), other than we could see some cracking around the rear porch, which we believe is incorrectly detailed with cement mortar flashing when it should have a lead flashing.

Key for above photos	Showing sample of problem areas
Cement flashing where porch meets main wall	Orange oval
Cracking to wall	Red oval

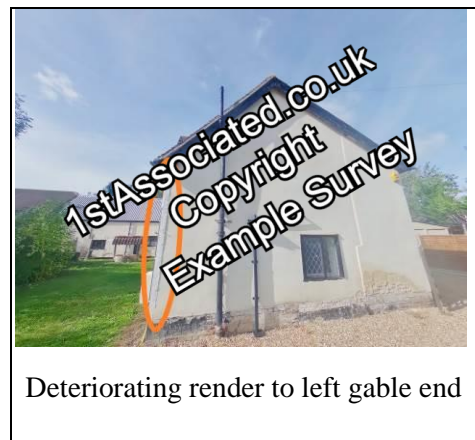
We also noted some render deterioration to the left hand gable end. See our comments with regard to possible roof movement/roof spread and how it is affecting the rear and side walls.

**ACTION REQUIRED:** Your legal adviser needs to establish whether any of this movement has been looked at by the insurance company.

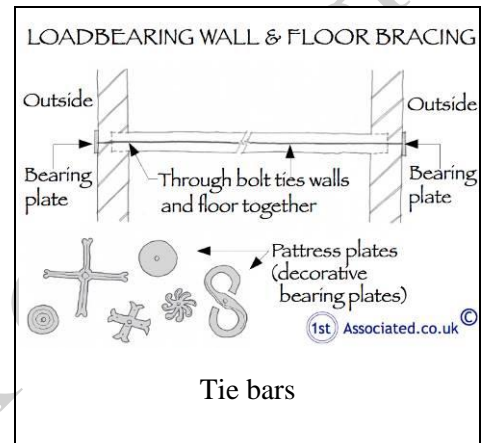
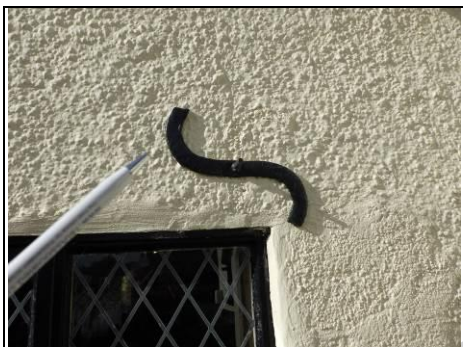
In addition to this we can see that tie bars have been added to help give support to the kitchen/utility building.

S-shaped tie bar

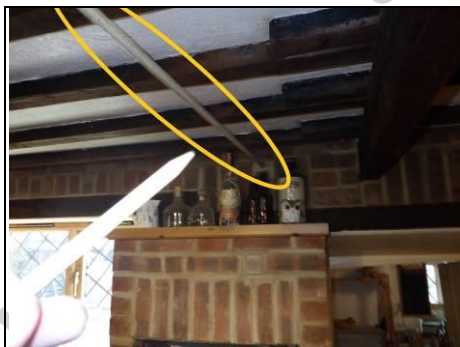
Tie bar running through internally

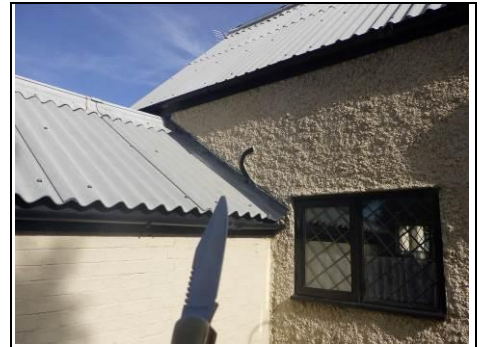
Other side of tie bar

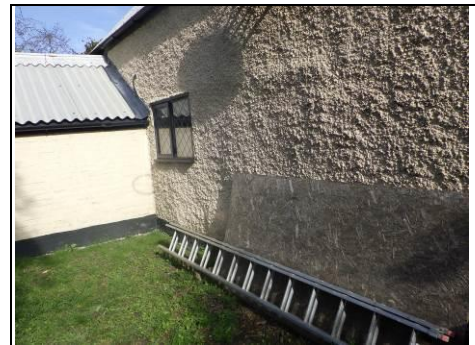
From what we can see, the render is generally in poor condition. There is old cement based render which is cracking/coming off the walls;

Cement render to right side of ancillary building

**ACTION REQUIRED:** We recommend you start again with the render. We would get a specialist contractor in who is used to carrying out work on old properties and using appropriate lime. You do need to get the building ‘breathing’ again so it helps reduce any damp damage to the timber frame within this building.

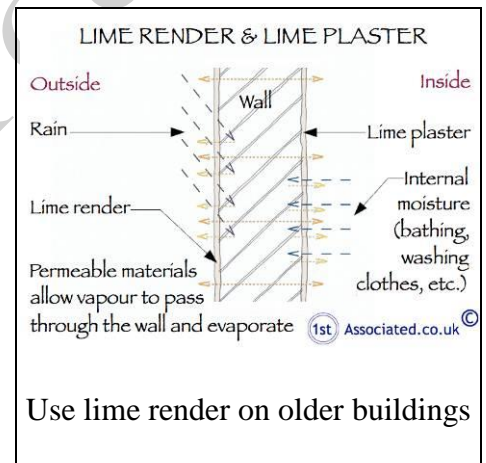
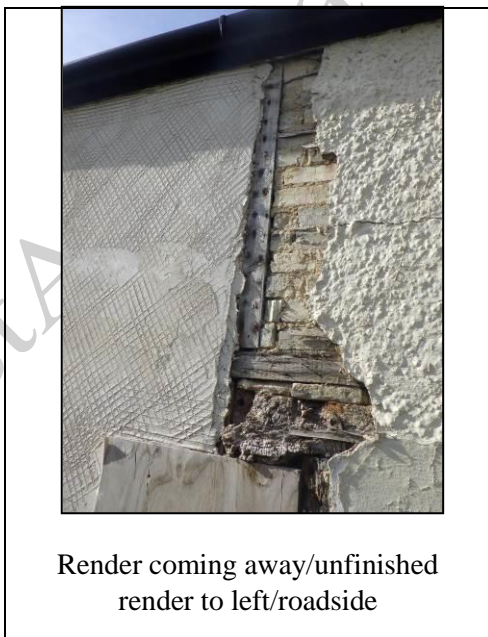
There is also modern render, which is deteriorating to the left hand gable. Unfortunately it does not look to us to be lime plaster but a modern render which has been carried out not particularly well.

Render coming away/unfinished render to left/roadside

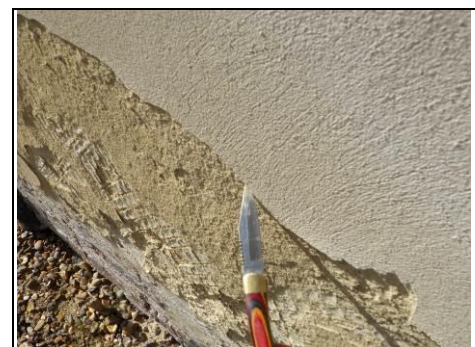
Render coming away to gable end

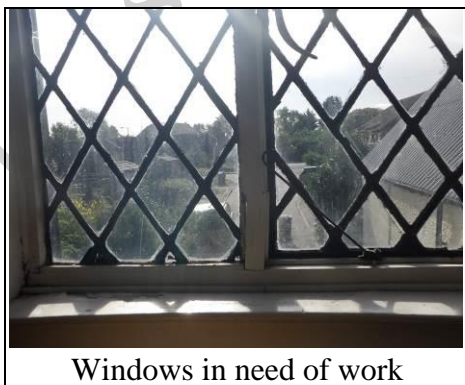
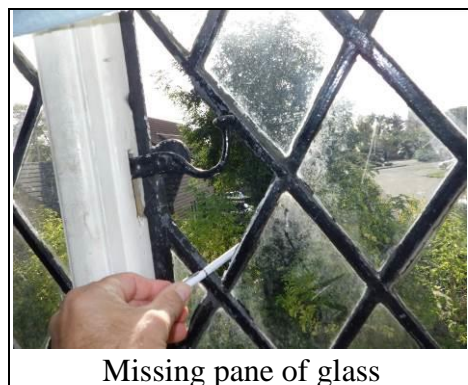
We can also see some older glass is present. There is some glass missing and also glass that has been replaced wrongly.

**ACTION REQUIRED:** We recommend you speak to someone who is used to dealing with historic buildings to repair, prepare and redecorate the windows.

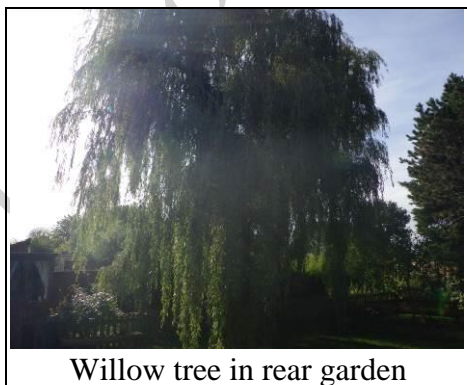
As you are aware, a lot of trees have been cut down around the property which we understand from the owner that many of these were conifers, but there may also have been other trees. There are still a number of significant good sized trees remaining in the garden, including a Willow tree and we would always say that where there are Willows generally there is water, which is why we consider this to be quite a wet site.

Willow tree in rear garden

We recommend an Arboriculturalist report (not a tree surgeon), giving a 10 year plan for maintenance of the trees and advice on planting new trees to help drain the area better. These need to be trees that will not damage the property.

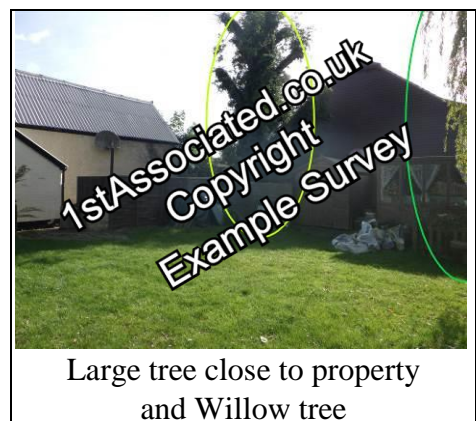
Large tree close to property and Willow tree

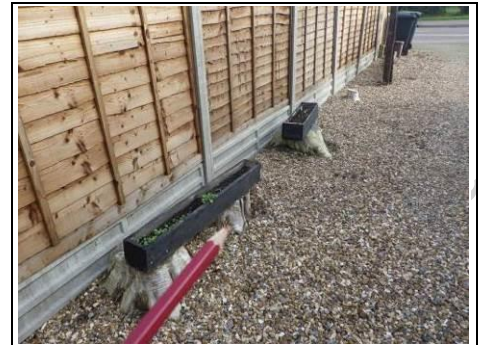
These trees would have been taking water away from the site and unfortunately their removal would not have helped the dampness in the area in general.

Trees cut down to front driveway

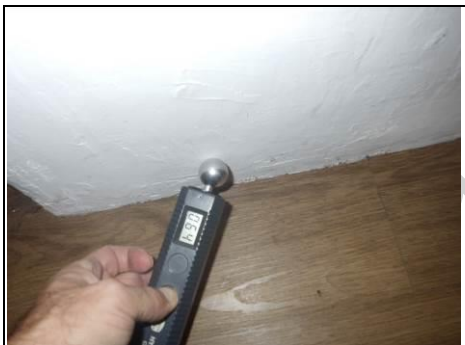
We did obtain high damp meter readings inside the property and you do need to remember this is likely to have affected the floors, many of which are timber. As mentioned the floors are now a variety of different materials; we think there may be some poor quality repairs to the timber floors over the years.

High damp reading in hallway

Further investigation is required regarding the floors, we recommend they are opened up to inspect their condition. The dampness will be better understood once it is under control.

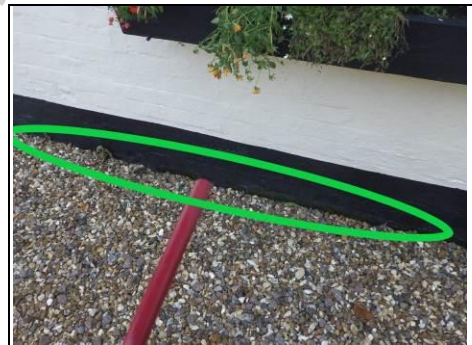
Moss growing to base of wall due to dampness

We would also recommend you add a land drain or French drain around the entirety of the property, ideally with a perforated pipe, going into a soak-away or main drains (subject to permission).

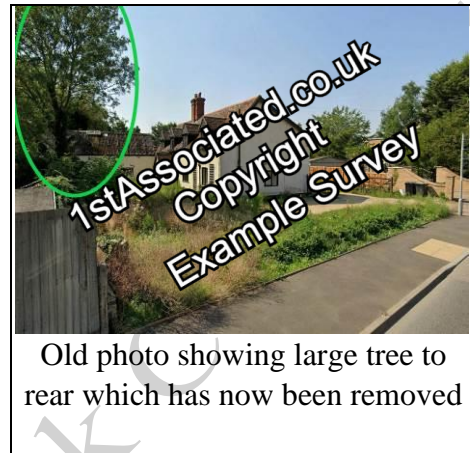
Old photo showing large tree to rear which has now been removed

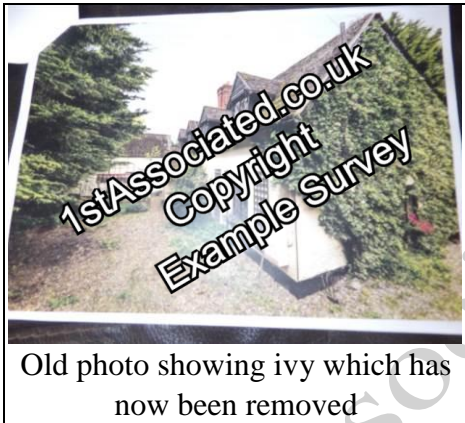
Old photo showing ivy which has now been removed

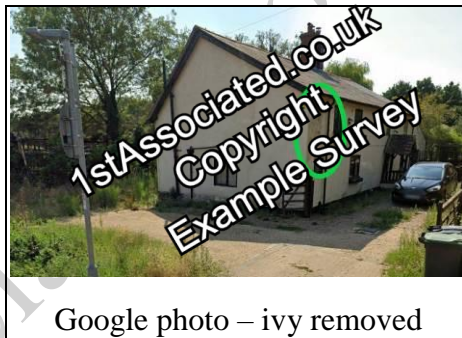
Google photo – ivy removed

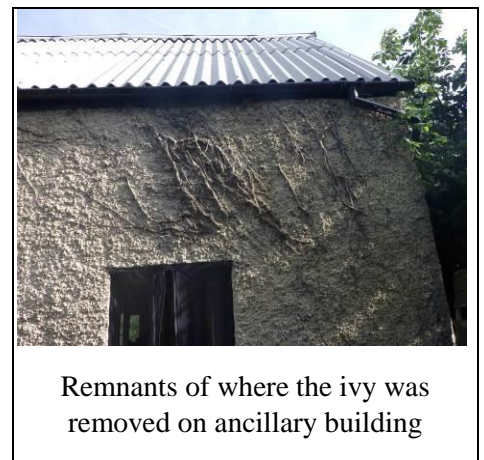
Remnants of where the ivy was removed on ancillary building

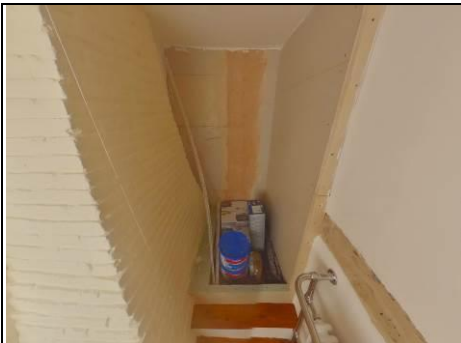
Unfinished shower in first floor en-suite shower room

**ACTION REQUIRED:** You may wish to speak to the owners again to understand exactly what work they were intending to carry out before you legally commit to purchase the property. Also, specifically ask them about the protruding manhole in the rear garden.

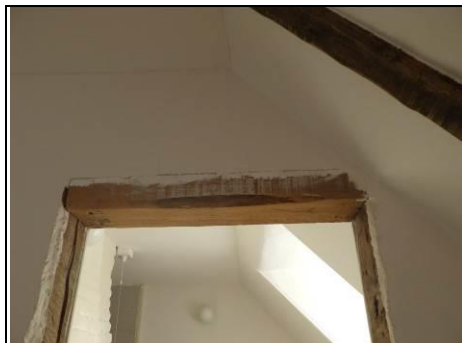
'Lintel' that is not actually a lintel over the en-suite shower room door

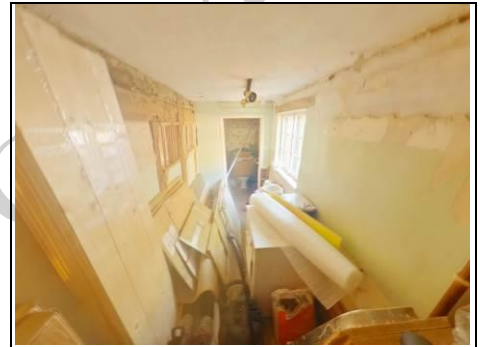
Unfinished cloakroom

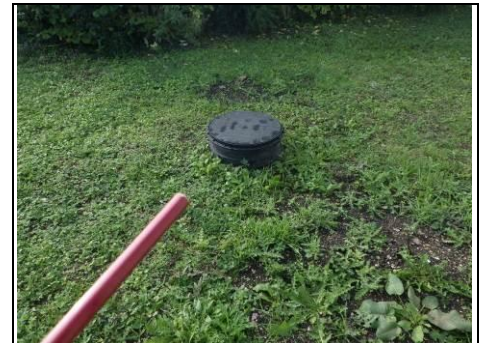
Also the manhole in the rear garden is sticking up, which could be a trip hazard.

Manhole sticking up is a trip hazard

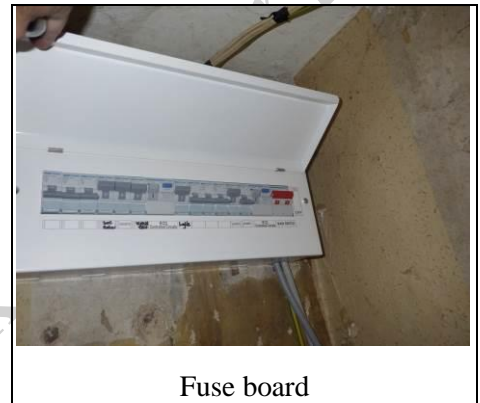
The property has a 2000's plus metal fuse board located in the hallway.

**ACTION REQUIRED:** We recommend as the property is changing hands, as does The Institution of Engineering and Technology (IET), a test and report. The test and any recommendations should be carried out by an NICEIC registered and approved electrical contractor or equivalent.

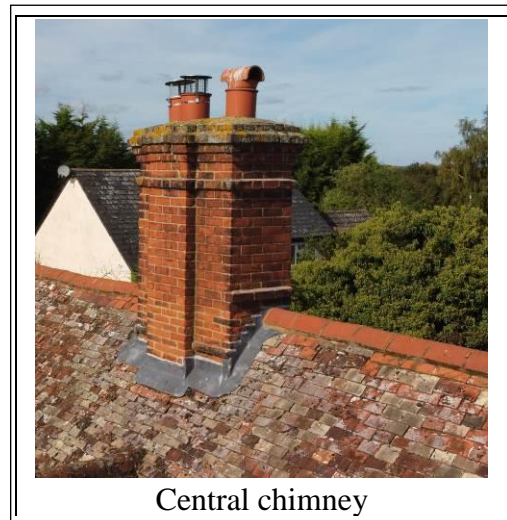
This is a large chimney, brick finished with a lead flashing and three chimney pots. From what we could see from ground level it looked in average condition considering its age, type and style.

Central chimney

**ACTION REQUIRED:** Periodically inspect the chimney.

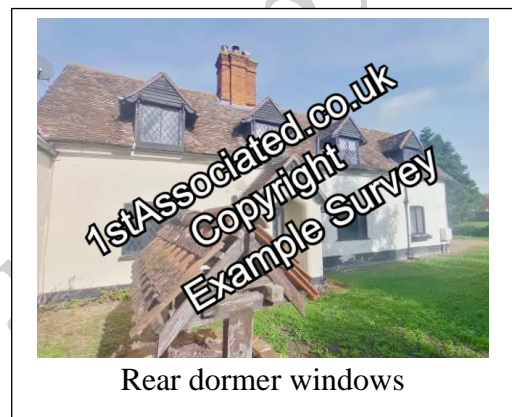
There are four dormer windows to the rear. The roofs are the same material as the main roof the cheeks of the dormer are timber cladding and the windows are timber framed with single glazing. Generally, we would comment for their age, type and style they are in below average condition with weathered timber frames.

Rear dormer windows

**ACTION REQUIRED:** Repair, prepare and redecorate.

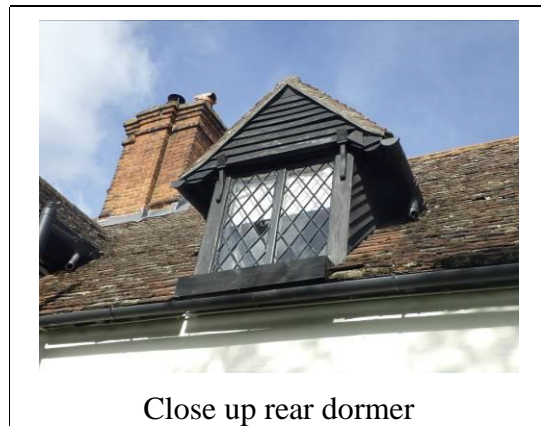
Close up rear dormer

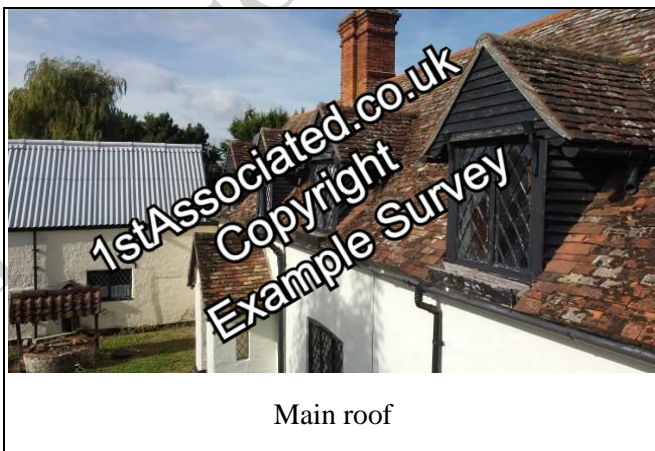
The roof is pitched and clad with clay tiles and, from ground level, this looks in below average condition considering the roof's age, type and style, with slipped tiles and we can see dampness visible inside.

Main roof

**ACTION REQUIRED:** Please see our comments in the Executive Summary. We do think you will need a roofer for about a week to carry out work to the roof and make it watertight, depending how the roof is once you have started to carry out the repairs.

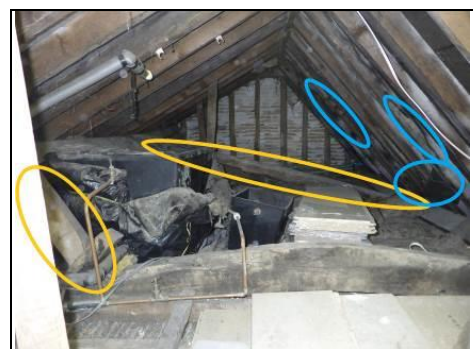
Dampness in roof space  
(blue ovals) and timbers supports  
added (yellow)

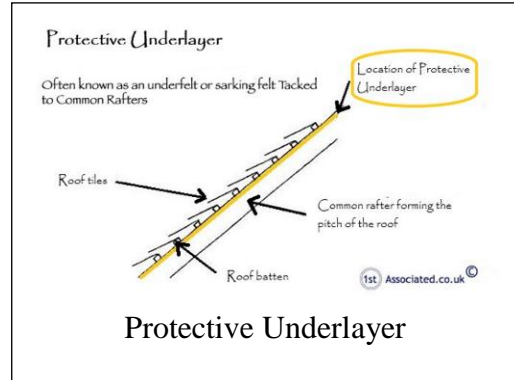
When we inspected the loft space, we found a Hessian based bitumen membrane. This type of membrane has been used since the 1960s. We generally found it to be in average condition with damage in some areas which is what we typically find.

Note, some dampness does seem to be getting in.

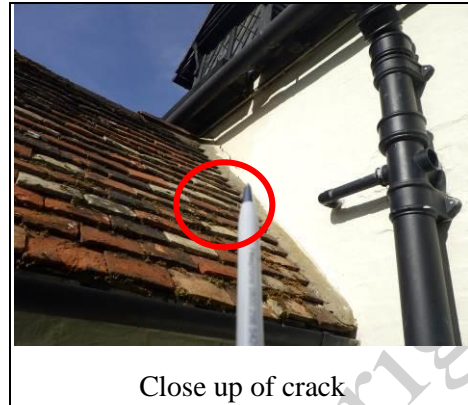
Close up of crack

**ACTION REQUIRED:** Replace flashing with lead flashing, subject to permission.

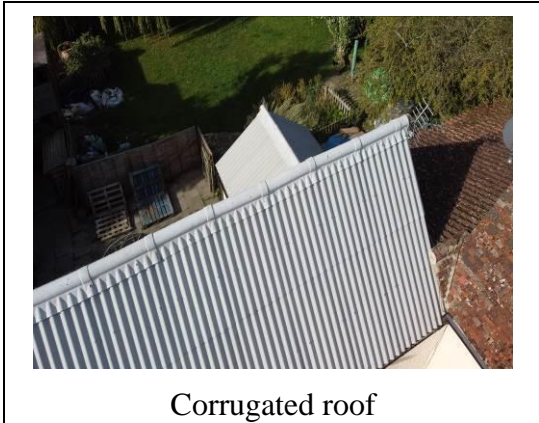
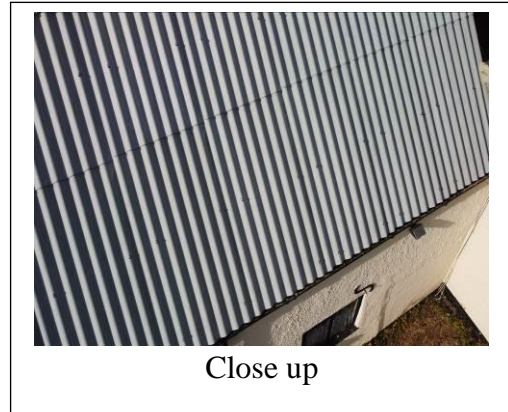
This roof is pitched and clad with corrugated sheets. We assume these are pretty new as on the Google maps programme we can see an asbestos roof is in place.

We assume when the roof was replaced there was some form of guarantee for the new roof and that there is an asbestos certificate showing an asbestos test has been carried out throughout the building and all asbestos has been removed.

**ACTION REQUIRED:** Your legal adviser to check and confirm the above.

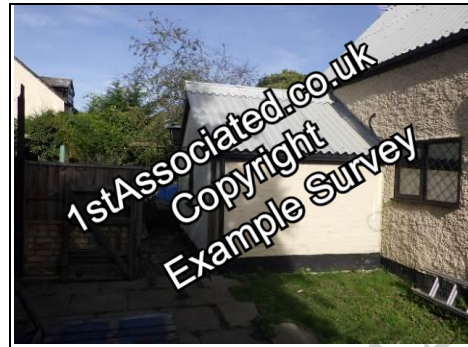
This roof is pitched with corrugated sheets. It is in average condition for its age, type and style.

Corrugated sheet roof over pantry/larder

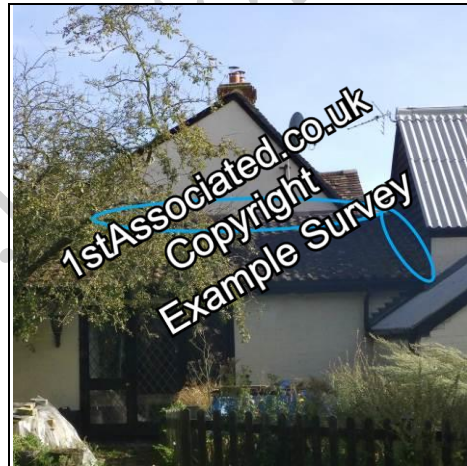
This is a single pitched roof, clad with relatively modern concrete tiles in a Roman style. We noted it has a tile on edge as a flashing where it meets the right gable end of the property.

Tile on edge flashing to right side roof

**ACTION REQUIRED:** We recommend you replace the flashing with a lead flashing.

Where it meets the gable end of the kitchen/utility building, which has boarding on it, the flashing needs to be checked in this area as well.

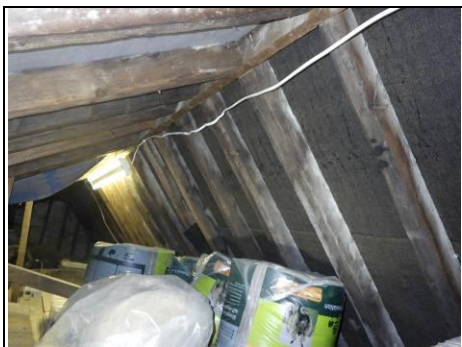
Main roof, mass of stored items

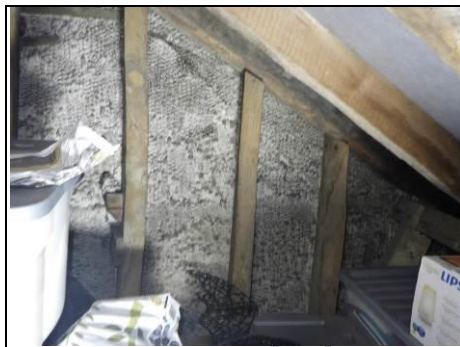
Chicken wire and cement to right side  
– generally post war to about 1970s

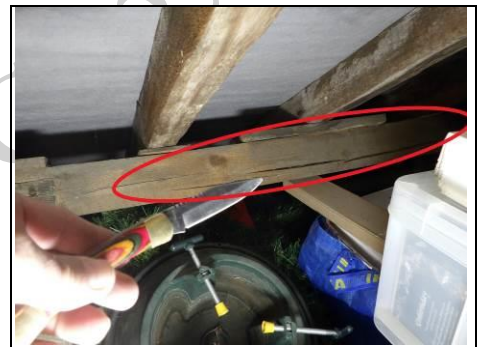
Split in purlin

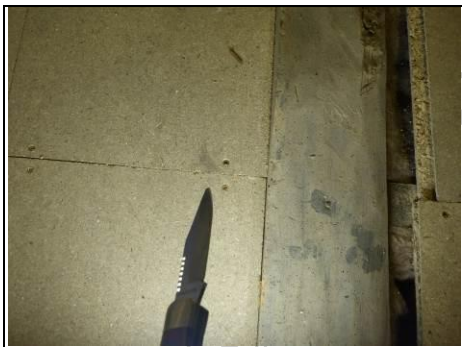
Floorboards screwed down

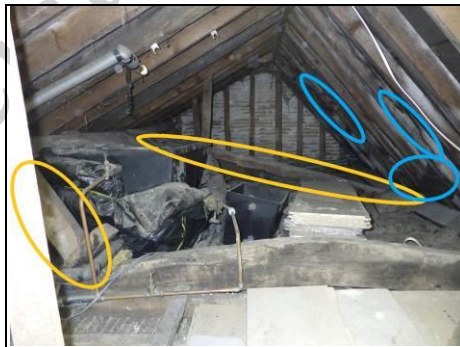
Our examination was limited by the general configuration of the roof, the insulation and mass of stored items, plus the floor boards are screwed down limiting our view considerably. Where we were able to inspect the roof we found that dampness is coming in; please see our comments about needing work to the roof. We could see that this then in turn has led to dampness in the timbers and also wood destroying insects which looks to be active.

Damp to timbers and extra supports  
added

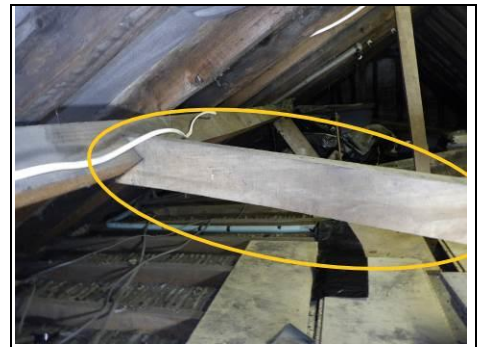
Collar support added

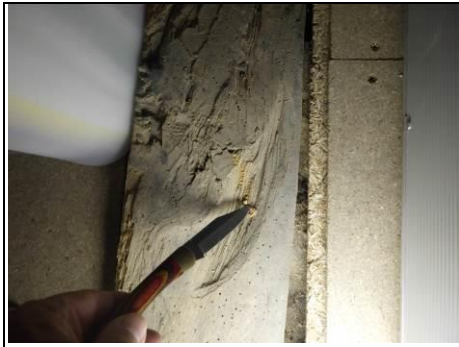
Frass from wood destroying creatures

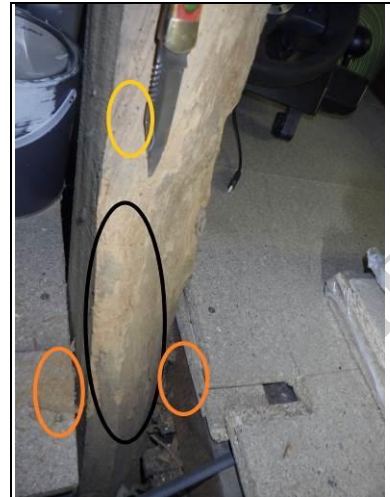
More signs of wood destroying insects

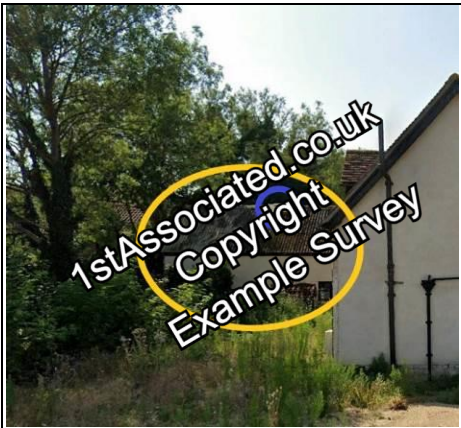
Old photo showing this was once an asbestos roof, we believe allowing water in

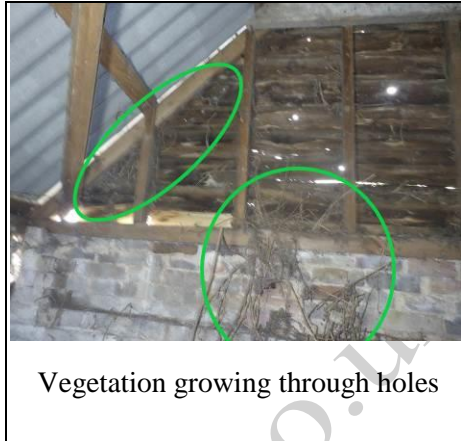
Vegetation growing through holes

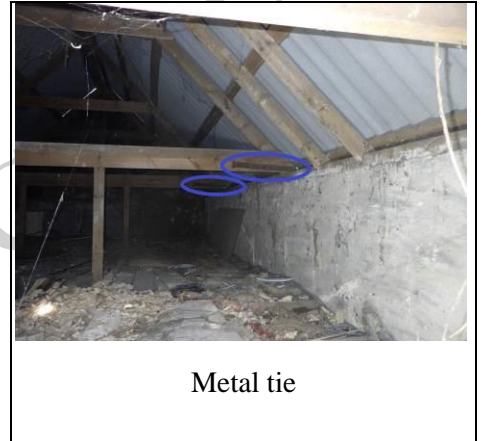
Metal tie

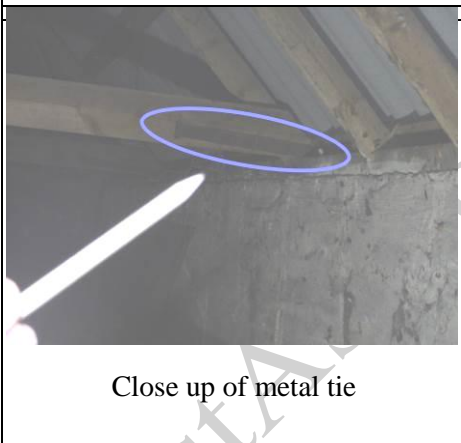
Close up of metal tie

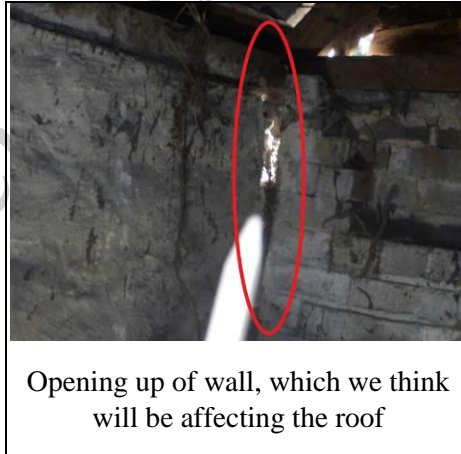
Opening up of wall, which we think will be affecting the roof

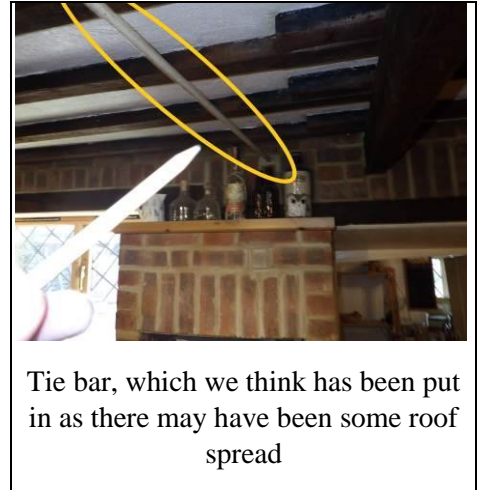
Tie bar, which we think has been put in as there may have been some roof spread

**ACTION REQUIRED:** Please see our comments in the Executive Summary.

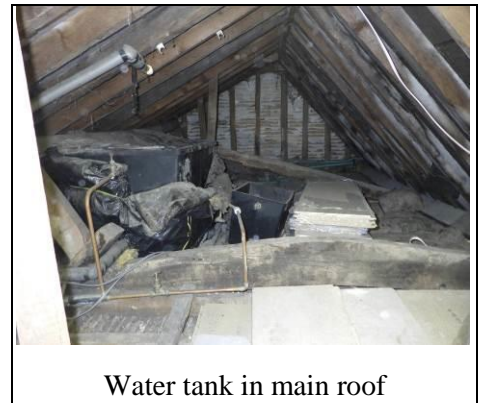
There are plastic water tank located to the left side of the main roof. We noticed damp to the timbers in this area which could relate to condensation from the water tank as well.

Water tank in main roof

**ACTION REQUIRED:** We would always recommend that water tanks be drained down and cleared of any debris etc. (we have seen dead birds and other unmentionable things in these tanks). As you are often cleaning your teeth with this water it is best that it is as clean as possible!

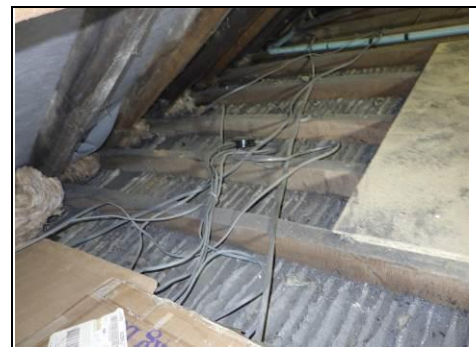
We can often identify the age of an electrical installation by the age of wiring found in the roof. In this case we saw a mass of cables, including old Bakelite fittings.

Old electrics in main roof including Bakelite

**ACTION REQUIRED:** We would comment that we do think there is a fair amount of electrical work required in this property.

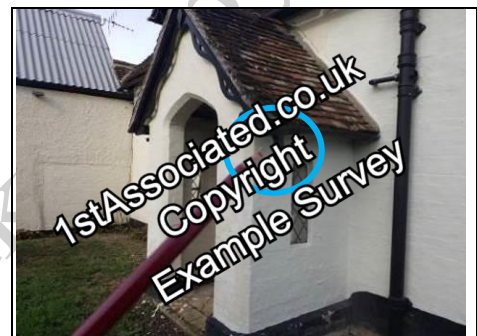
There is an unusual detail to the rear porch where the rainwater downpipe is cut short and seems to discharge onto the ground from a height.

Downpipe on rear porch cut short

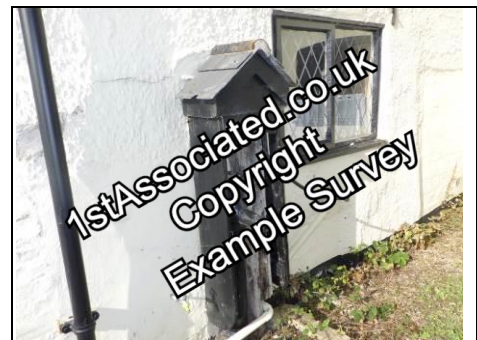
Downpipe close to door

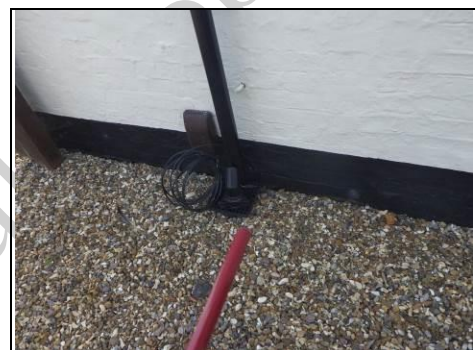
Some of these gullies have for some reason been put high (it was cheaper to do it that way?). We think these need amending, as do the manholes. If at all possible to bring them level with the ground.

Looks like gullies have been added, which owners advise was in xxxx

**ACTION REQUIRED:** It would be worth your solicitor asking the existing owners who carried out the work and speaking to them to ascertain why the guttering and downpipe work was carried out like this.

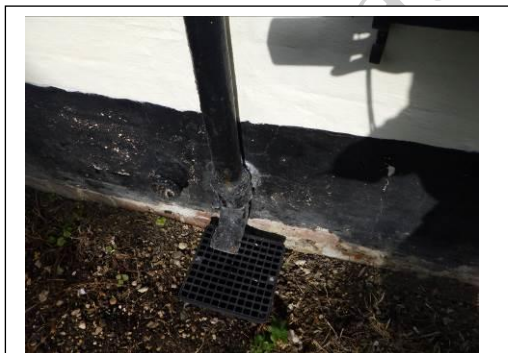
Downpipe discharging quite high, close to property

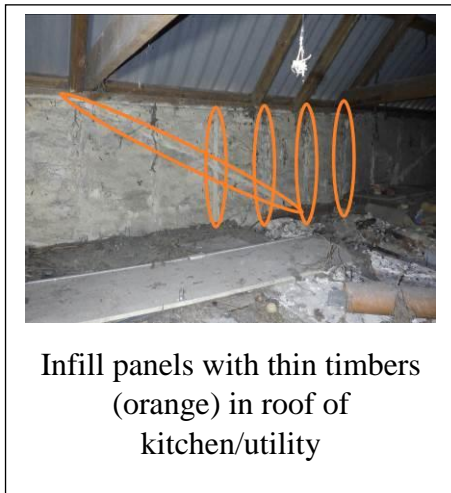
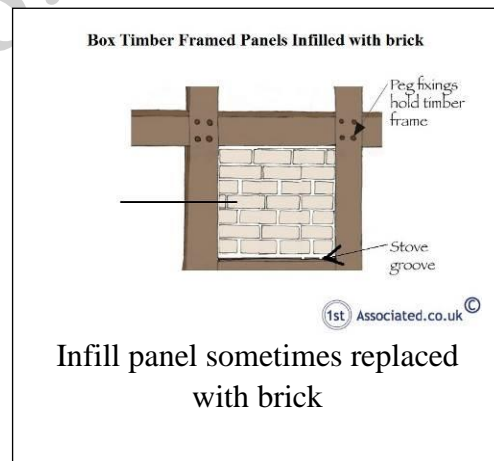
We can also see within the kitchen/utility area we can see the timber frame but we are still not sure what the structure is beneath. Often the infill has changed over the years as it deteriorates/the property has altered.

**ACTION REQUIRED:** We recommend opening up the structure to check and confirm what is beneath.

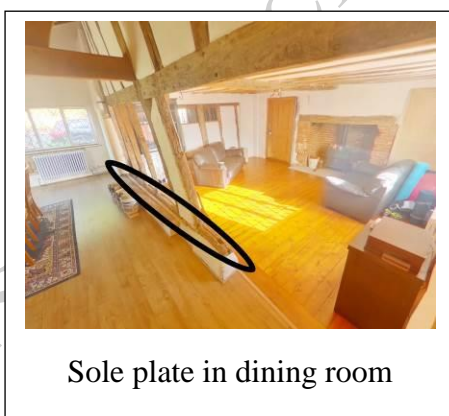
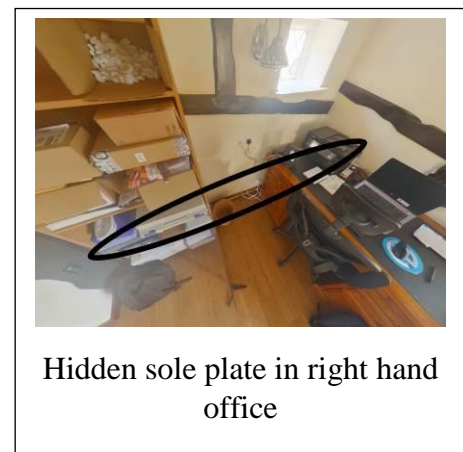
In this case, we think there may have been a lot of deterioration to the sole plate due to the water at ground level. As is often the case the sole plate is hidden, for example in the office area, however it can be seen on the right hand gable. However, we are lucky in this instance that we can see it on the right hand gable in the dining room area, which shows it sits on a plinth.

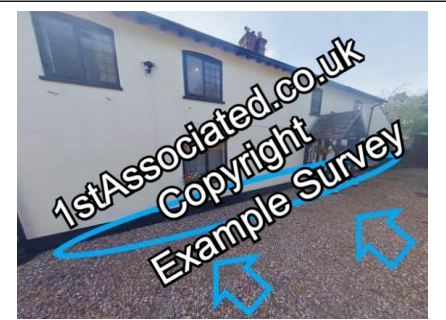
We do, however, think there will be a fair amount of deterioration to the sole plate due to the amount of dampness to base of this property. We think it is likely to have been replaced/repaired over the years.

Front sole plate, with the arrows showing how we think water will have degraded it over the years

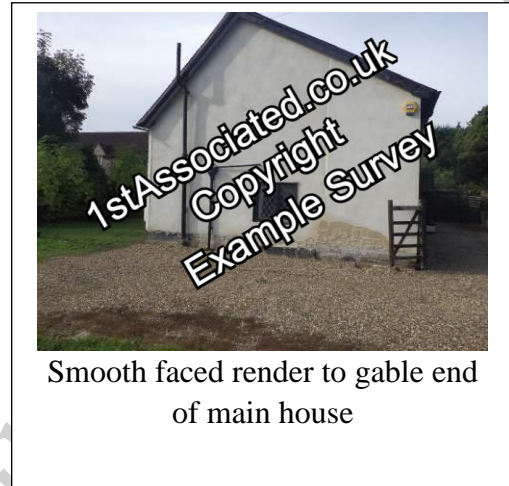
Smooth faced render to gable end of main house

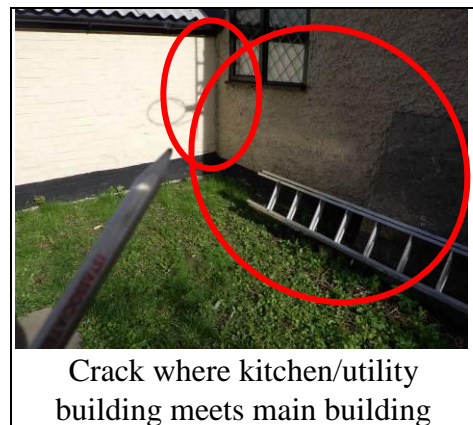
The use of cement render is inappropriate for a property of this age as it prevents it from 'breathing'. We noted numerous cracks to the rough cast cement render cracking on the kitchen/utility building and also some to the smooth render.

Crack where kitchen/utility building meets main building

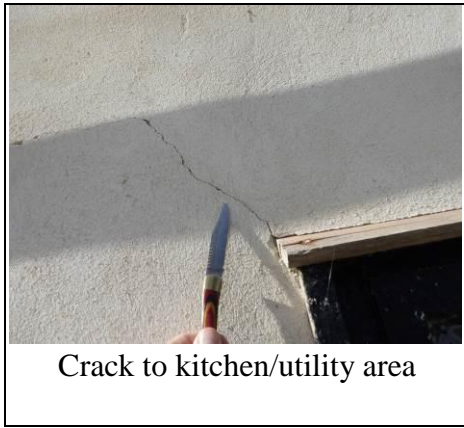
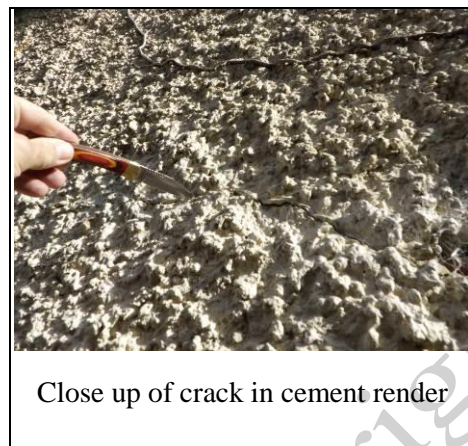
### **Cement render inappropriate for this age of property**

As there is a timber frame underneath the render it needs to 'breathe', unfortunately cement renders do not allow this and can cause deterioration.

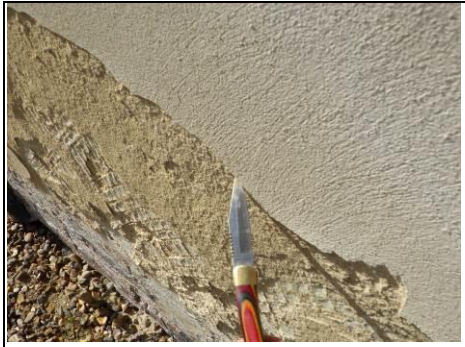
You need to be aware that we believe that the new rendering which has been carried out is low quality and we understand the owner is not getting any response from the builder who carried out the work. There are areas of half finished render work, obviously with winter coming it is important you get the property as watertight as possible and as quickly as possible.

Poor quality render

You really will have to start again with regard to the render. This can be very expensive and it is very hard to give an estimate of costs and you should obtain quotations for the work. We recommend as soon as you have read this report that you look into getting quotations from contractors who carry out this type of lime render work in older/listed properties.
