# Timber Frame Example Residential Building Survey

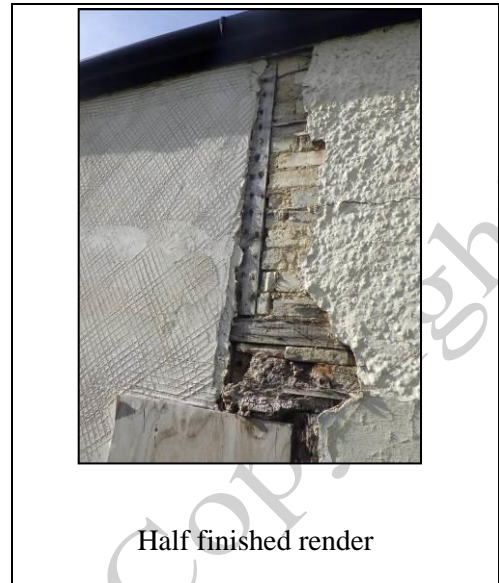
You need to be aware that we believe that the new rendering which has been carried out is low quality and we understand the owner is not getting any response from the builder who carried out the work. There are areas of half finished render work, obviously with winter coming it is important you get the property as watertight as possible and as quickly as possible.

Half finished render

You really will have to start again with regard to the render. This can be very expensive and it is very hard to give an estimate of costs and you should obtain quotations for the work. We recommend as soon as you have read this report that you look into getting quotations from contractors who carry out this type of lime render work in older/listed properties.

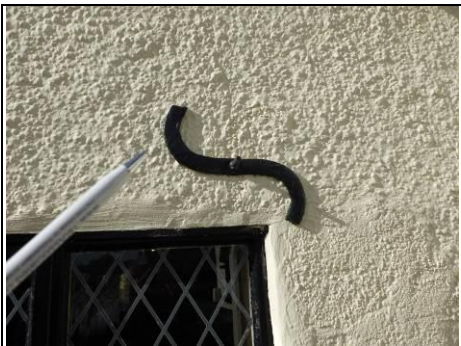
We noted historic movement in the property. We noted tie bars externally and internally to the kitchen/utility building.

S-shaped tie bar

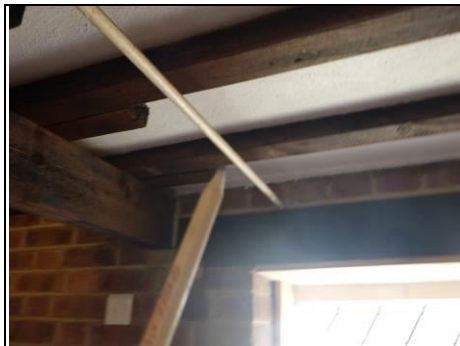
Tie bar running through internally

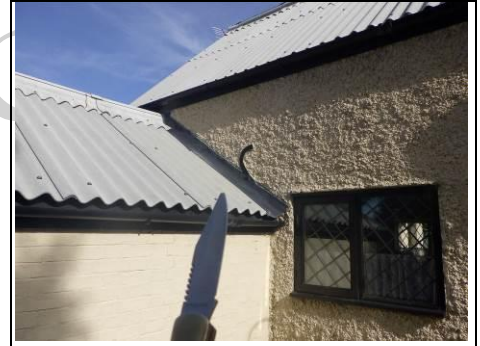
Other side of tie bar

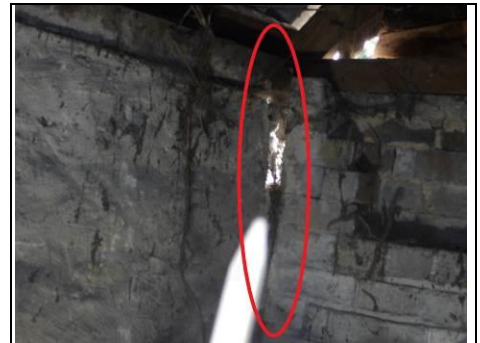
The rear wall of the kitchen/utility building is hidden by vegetation. From what we could see within the roof the wall is opening up.

Rear wall opening up

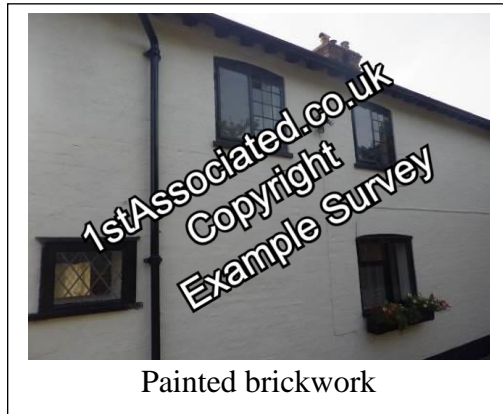
Painted brickwork

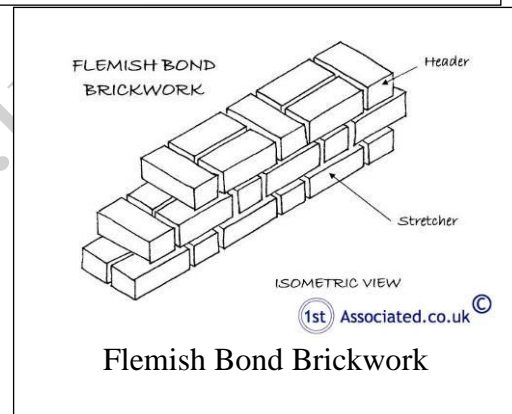
Flemish Bond Brickwork

In this case the brickwork looks in average condition, particularly when compared with the other elevations.

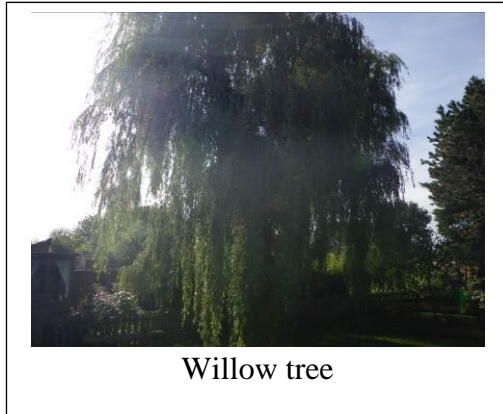
There are trees within what we would term as influencing distance but you do need to speak to your insurance company as they may have a different interpretation for insurance reasons.

Willow tree

You need an Arboriculturalist (not a tree surgeon) to view the trees and give a ten year plan for maintenance of the trees and some thought and consideration as to what trees may need to be planted here due to the generally wet location.

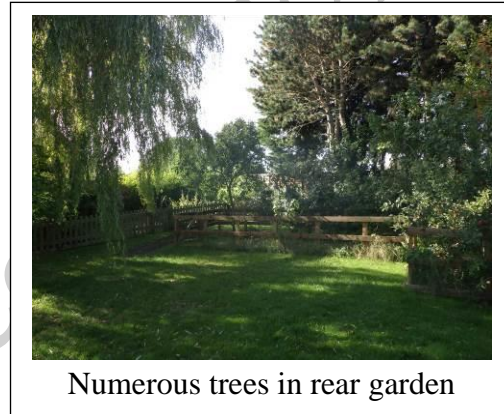
Numerous trees in rear garden

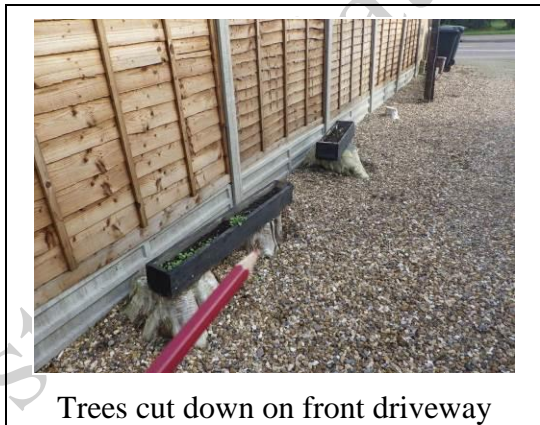
Trees cut down on front driveway

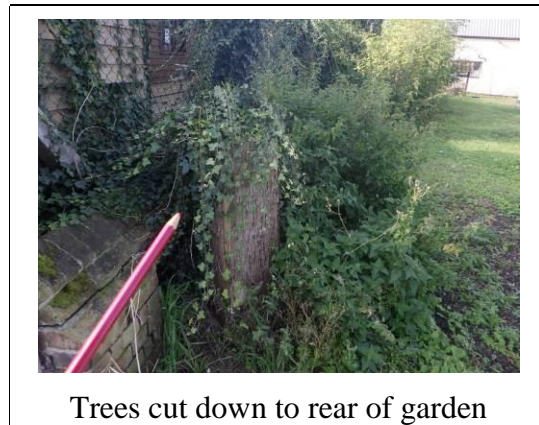
Trees cut down to rear of garden

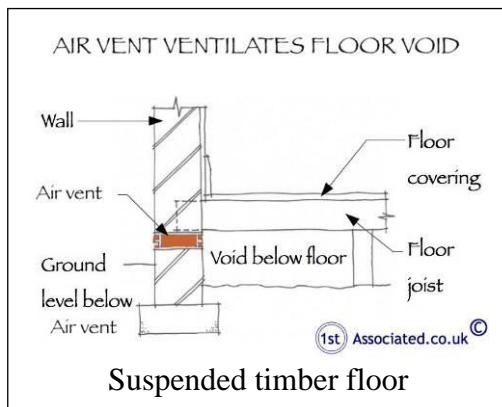
Air vents are essential to have a through flow of air as this helps to reduce the chances of wet rot, dry rot and woodworm. In this case, we noted air vents to the front and rear. Some of the air vents to the front need clearing. We also think water is discharging towards the air vents.

**ACTION REQUIRED:** Ensure air vents are clear.

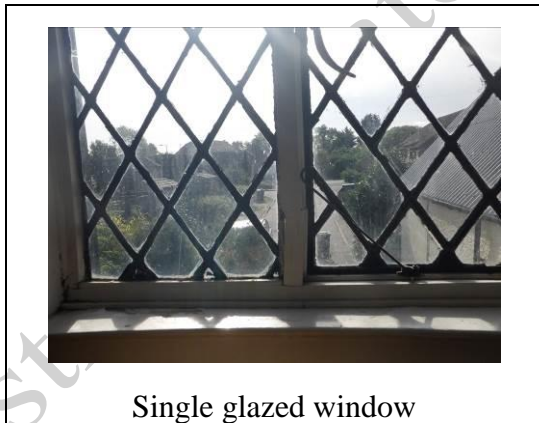
Generally we would comment they are below average quality for their age, type and style, with deteriorating timbers and some missing with missing glazing.

Single glazed window

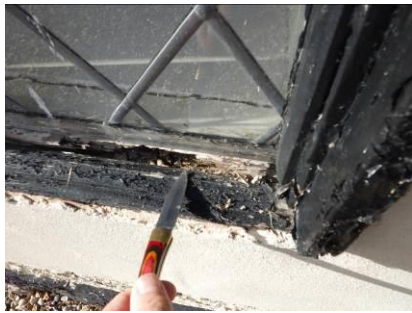
Knife test into timber

**ACTION REQUIRED:** Please see our comments in the Executive Summary.

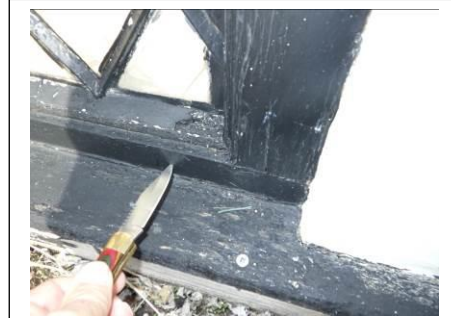
Knife test

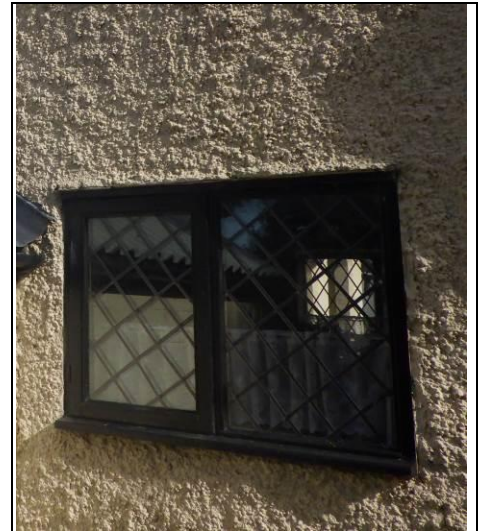
We would draw your attention to the fact that sealed double glazed units can fail in timber frame buildings, where they have seasonal movement.

Failure of the seal leads to condensation between the two panes of glass and simply replacing the affected units may not provide a satisfactory long-term solution.

Double glazed kitchen window

**ACTION REQUIRED:** The owners need to identify exactly what windows they have and have not replaced. Then we would speak to the Conservation Officer about this.

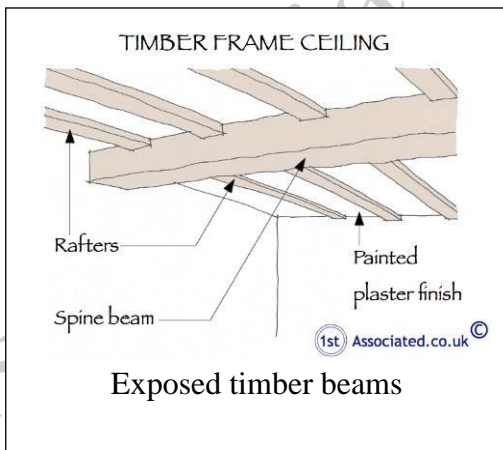
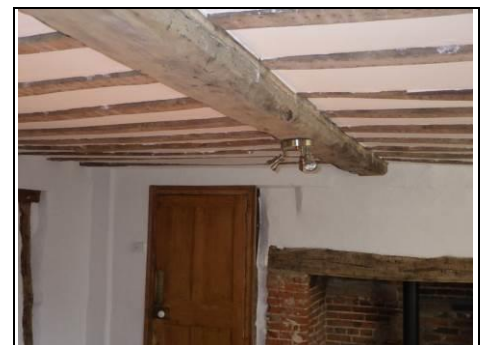
Spine beam in reception room one

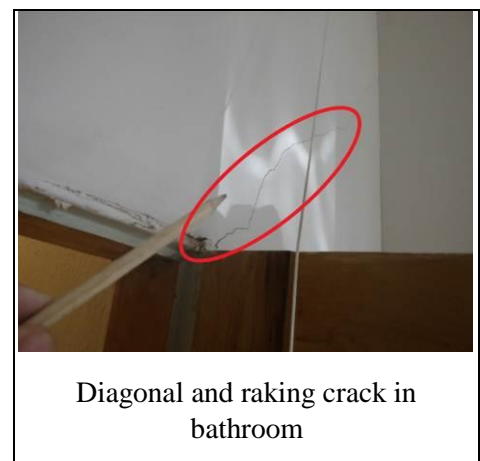
We noted cracking internally.

**ACTION REQUIRED:** Please see our comments in the Executive Summary regarding cracking and movement.

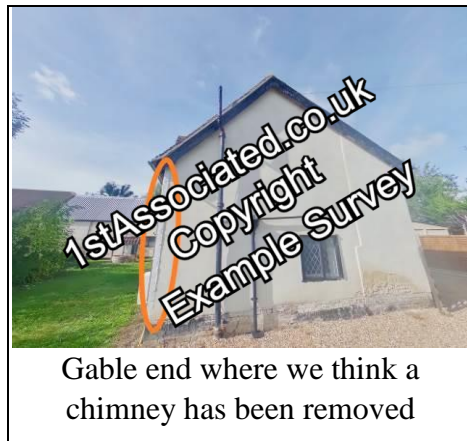
This is slightly concerning as often chimneys in this age of property can also be structural and help support the property.

Gable end where we think a chimney has been removed

**ACTION REQUIRED:** Your legal adviser to specifically the existing owners whether they have removed any chimneys, or if they know of any chimneys that have been removed, and advise us further.

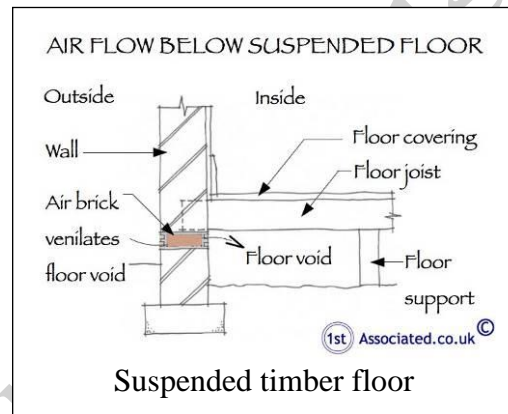
Unfortunately, we think that this area has become damp over the years, as mentioned elsewhere in the report this is a relatively damp area.

**ACTION REQUIRED:** We recommend the floor should be opened up and checked for its condition, ideally before you legally commit to purchase the property.

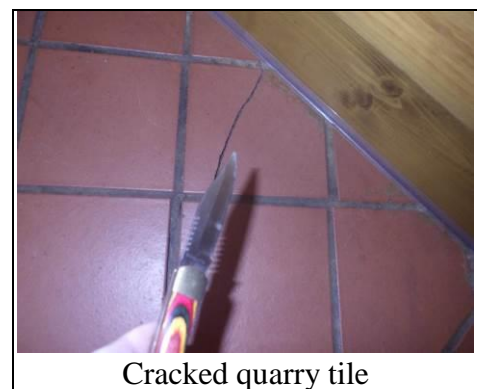
We can see some cracking in the quarry tiles in the kitchen and also some areas where they are unfinished. Our concern is that this cracking relates to structural movement in the property.

Cracked quarry tile

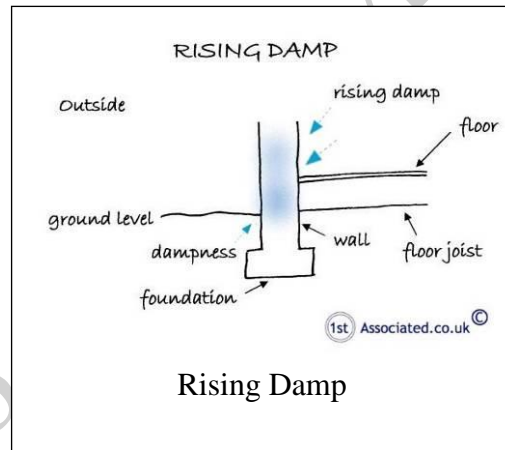
A visual inspection and tests with a moisture meter have been taken to the perimeter walls. In this particular case, we have found some rising damp readings in the kitchen.

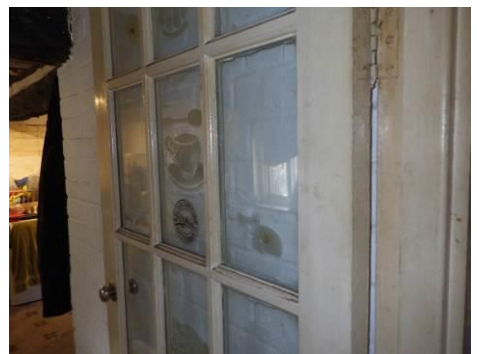
The glazed doors looks to have older style glass.

Glazed door

**ACTION REQUIRED:** You may wish to replace glass with safety glass.

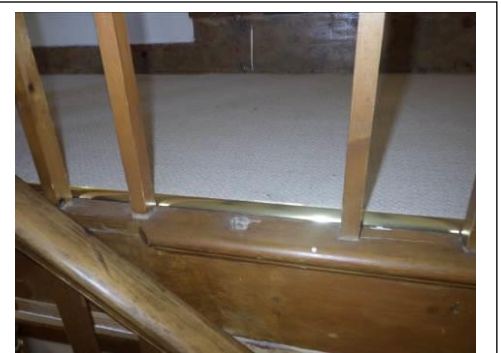
Some of the newel posts on the staircase are missing.

Missing newel posts to stairs

**ACTION REQUIRED:** Repair, prepare and redecorate.

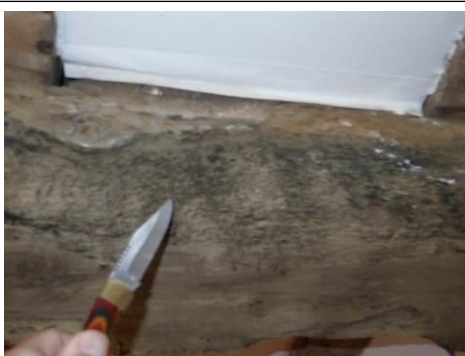
Signs of historic damage (as is often the case) in lounge from wood boring insects

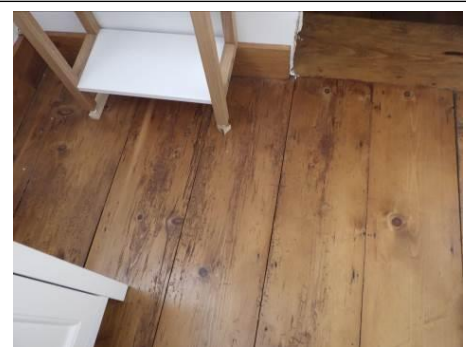
Signs of historic wood destroying insects to floor in lounge

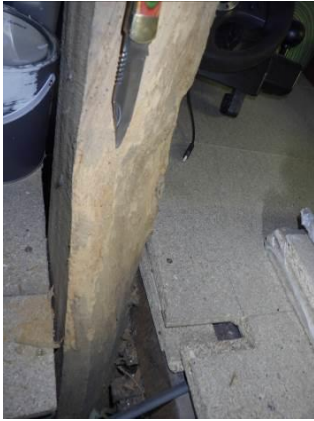
The roof is usually the main area where we look for wood destroying insects. Within the roof and in other timbers in the house we found visual signs of wood destroying insects activity, although not generally what we would term as causing 'significant damage', although we are concerned in the roof it may be significant in as much as it could be hidden by the screwed down floor boards.

Signs of damage from wood destroying insects in main roof

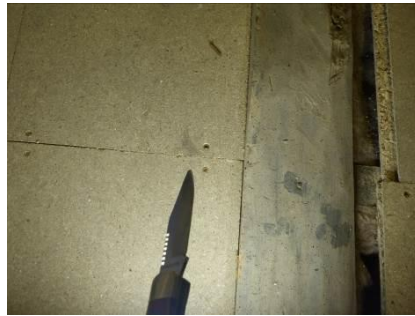
Screwed down floorboards limited our view

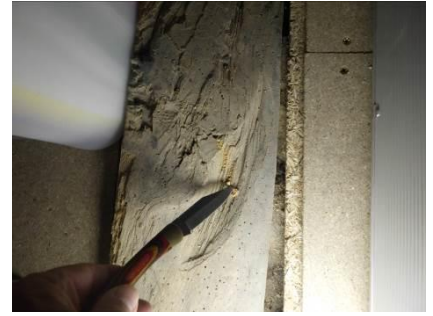
Frass from wood destroying insects

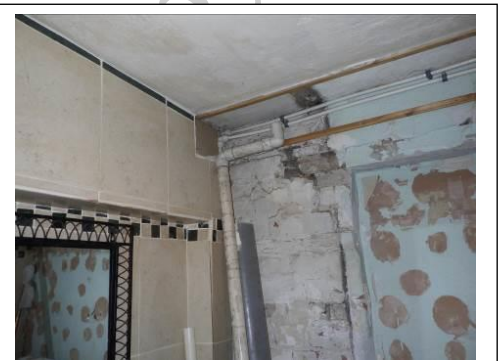
The internal decorations are in average condition. You may wish to redecorate to your own personal taste and areas that need to be finished off, such as the cloakroom and en-suite shower room.

Unfinished Cloakroom

**ACTION REQUIRED:** Please see our comments in the Executive Summary.

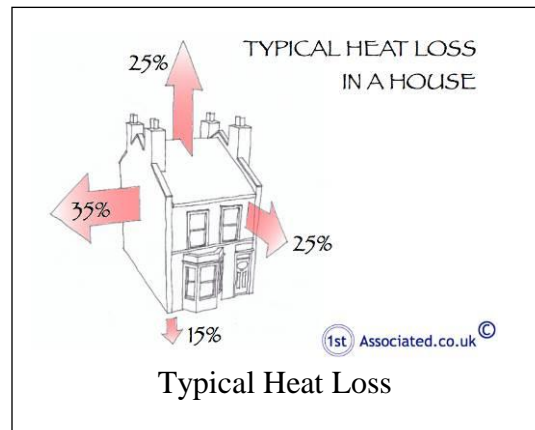
Some roof insulation was present although not to current Building Regulations requirements of 300mm. In this instance there is 100mm to 200mm.

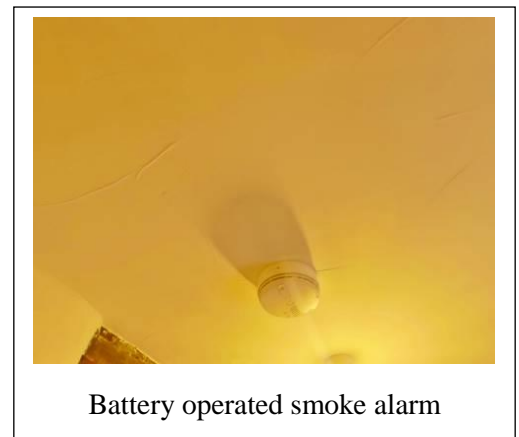
Some battery operated smoke detectors were noted; we prefer detectors to be hard-wired into the main power supply. Obviously in a property of this age this is difficult, as it would mean having surface mounted wires or cutting wiring into the plaster.

Battery operated smoke alarm

**ACTION REQUIRED:** We would recommend, for your own safety, that smoke detectors be installed. We would always recommend a hard-wired fire alarm system and are also aware that some now work from a wireless signal which may be worth investigating. Whilst fire is relatively rare it is in a worst case scenario obviously devastating.

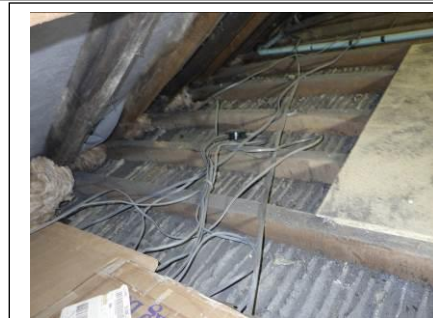
The electric fuses and consumer units were located in the hallway. Whilst the fuse board is 2000's plus in a metal fire resistant casing there does look to be old wiring in the main roof. It may be that this is redundant but we think it is best to have your own electricians test carried out, particularly as there is a fair amount of what we would term as inflammable material in the area above the kitchen.

Oldish wiring and Bakelite fitting in kitchen/utility roof

**ACTION REQUIRED:** We recommend, based upon what we have seen, and also as the property is changing occupancy that you have a test and report carried out by a NICEIC registered, or equivalent, approved electrical contractor or similarly approved. The Institution of Engineering and Technology (IET) also always recommend this when a property is changing hands.

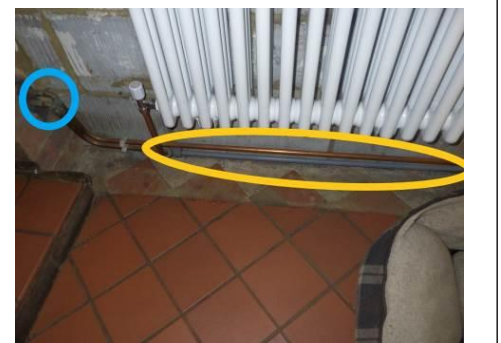
The plumbing, where visible, comprises a mixture of copper and plastic piping. We are not keen on a mixture of plastic and copper piping as they can be prone to leaks where they join. No significant leakage was noted on the surface, although most of the pipework is concealed in floors, walls and ducts.

Mixture of copper and plastic pipework to radiator and possible leak

**ACTION REQUIRED:** Please see our comments in the Executive Summary.

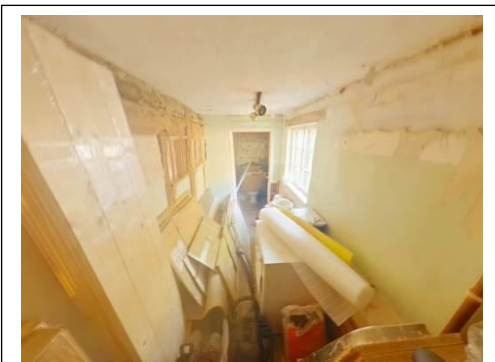
The property has a cloakroom, which was under construction at the time of the survey.

Cloakroom under construction

**ACTION REQUIRED:** Please see our comments in the Executive Summary about unfinished work.

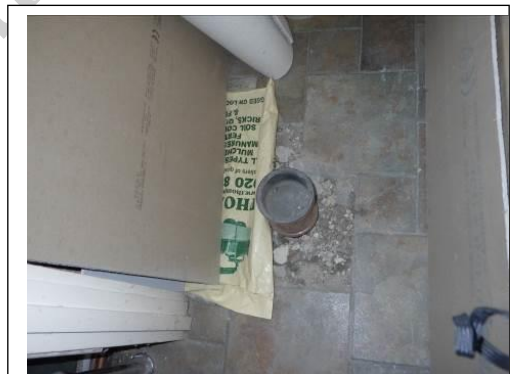
There is a soil and vent pipe in there in an unusual place in the middle of the floor. The owner advised that they were going to amend the position of the toilet.

Soil and vent pipe in middle of cloakroom floor

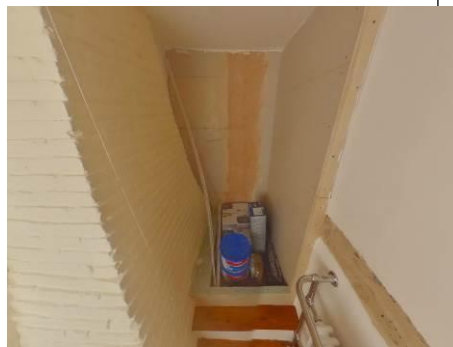
Unfinished shower

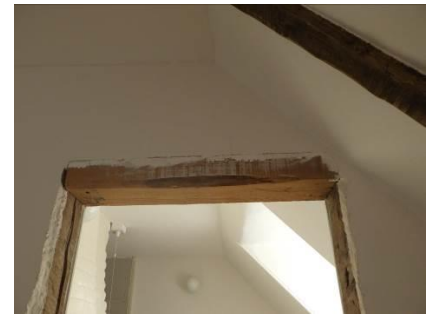
The en-suite comprises of a three-piece bathroom suite, consisting of a shower cubicle, wash hand basin and WC. The shower was still under construction at the time of the survey. The door into the shower room has a lintel that is not a lintel over the door!

The lintel that is not a lintel over shower room door

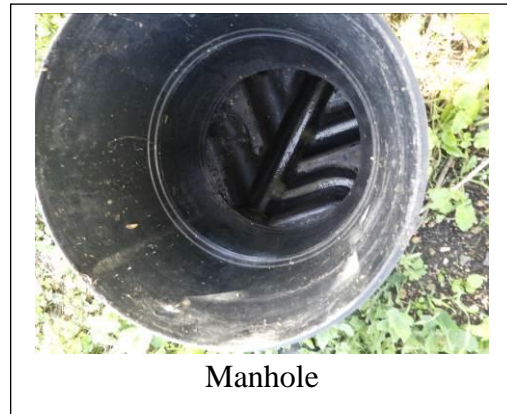
**Inspection Chamber/ Manhole One - located to the rear**

We duly lifted the cover and found it to be clear at the time of our inspection.

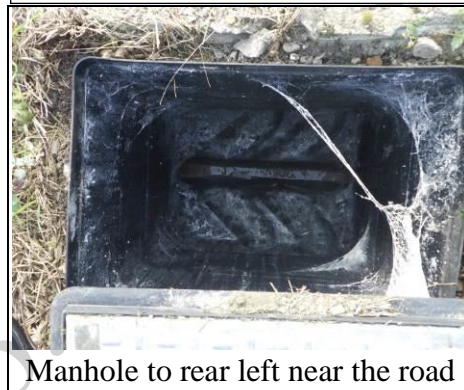
**Inspection Chamber/ Manhole Two, located to rear left**

We duly lifted the cover and found it to be clear at the time of our inspection.

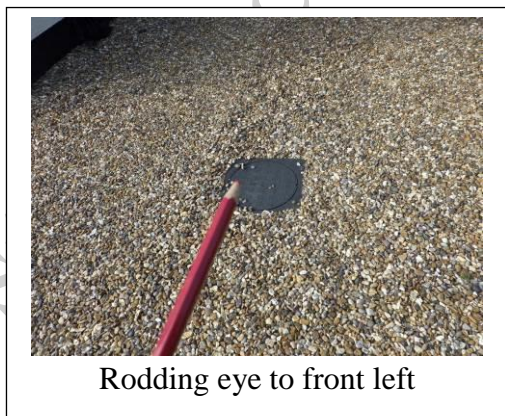
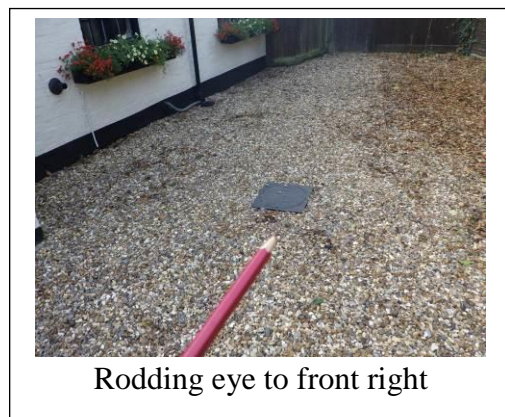
**Two Rodding Eyes, located to front left and front right**

The rodding eyes were hard to open during the course of the survey so we decided to leave them.

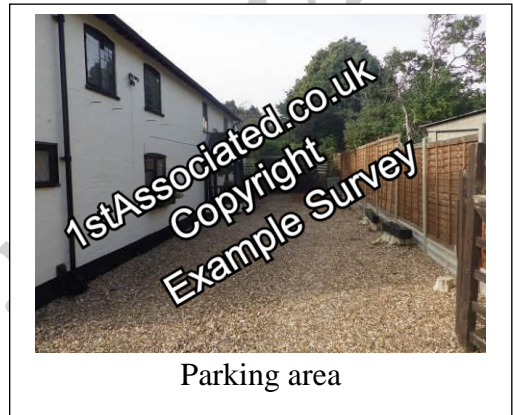
Parking area

The front of the property has a shingle drive for off road parking.

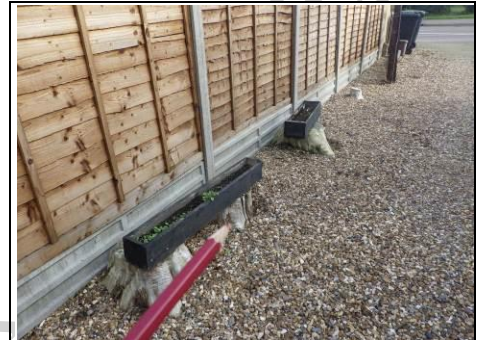
We noted a number of trees have been cut down.

Trees cut down to front driveway

**ACTION REQUIRED:** Please see our comments in the Executive Summary.

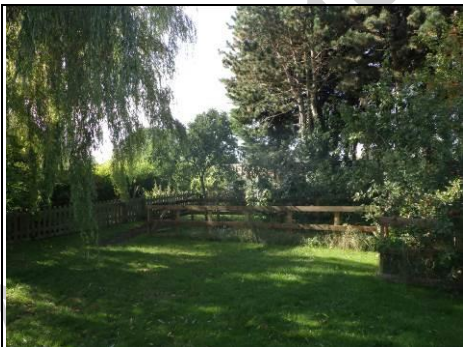
Rear garden with large trees

**ACTION REQUIRED:** Please see our comments regarding trees in the Executive Summary and Trees Section.

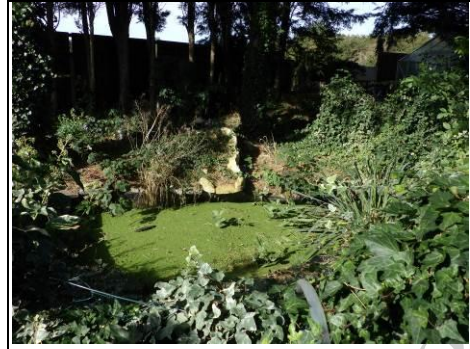
Pond, which looks to have a plastic liner

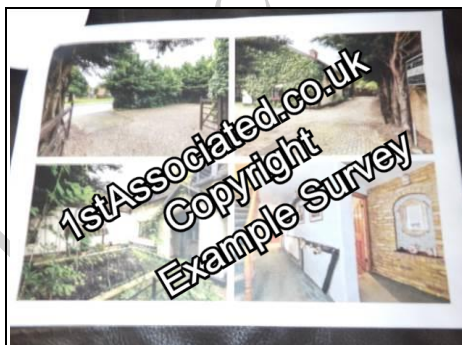
Trees lined the drive and ivy over building

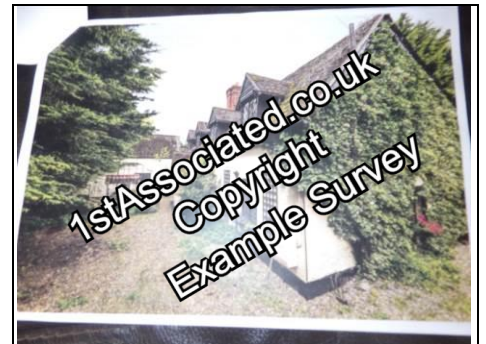
We saw a catalogue of the property, showing how it previous was. We were pleased to see the ivy has been removed from the property as it can damage the walls and cause dampness.

Ivy has now been removed

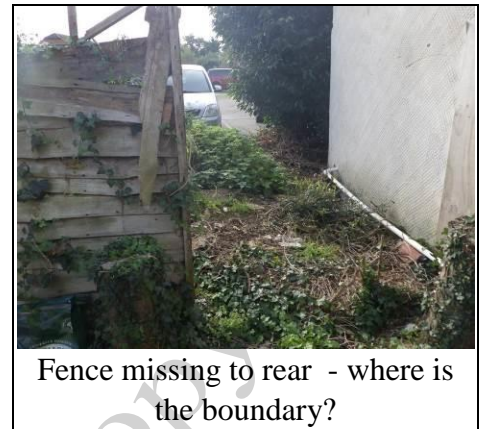
Often with older properties the boundaries are subject to negotiation and local practice. You do need to make sure that your solicitor is aware of the complications that can occur with older property boundaries.

**ACTION REQUIRED:** Your Legal Advisor to check whose boundary is whose.
