# PROPERTY REPORT AND NEGOTIATION DOCUMENT

XXXXXXXXXXXXX,  
XXXXXXXXXXXXXXXXXXXXX,  
XXXXXXXXXXXXX,  
XXXXXXXXXXXXX,  
Hampshire,  
XXXXXXX

INDEPENDENT CHARTERED SURVEYORS

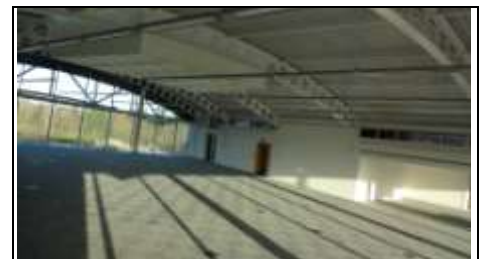
We can see that there is water damage and deterioration occurring underneath the domed roofs that are on both the left and the right of the property. We have not been on the roof but this usually relates to poor detailing and/or poor workmanship and/or poor materials. We feel that in this case it may be due to the box gutter detail allowing water into the property. Also, the edge of the roofing material looks to be delaminating.

General view of internal of right domed roof

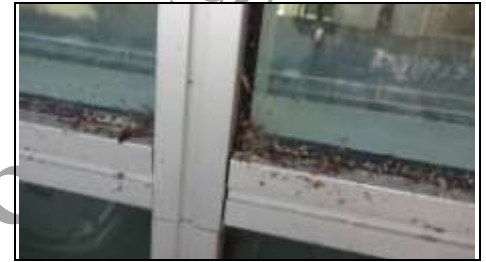
Dirty
