# SPECIFIC DEFECTS REPORT

Relating to dampness

Lincolnshire

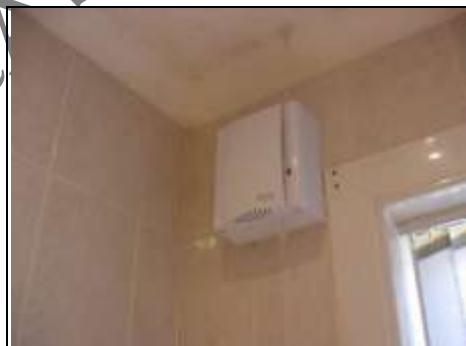
Humidity controlled extract

**ACTION REQUIRED:** We recommend large good quality humidity controlled extract fans are installed in the bathrooms and kitchen and any rooms used for drying clothes internally. It is best to have one that is a quiet/low noise fan.

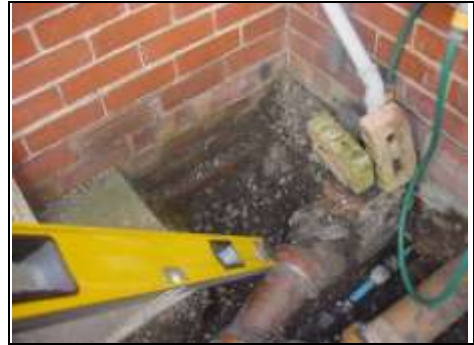
Soil and vent pipe that we believe is working

**ACTION REQUIRED:** We would just recommend that perhaps you have a closed circuit TV camera report of the drains to establish exactly where they are going, particularly in relation to the pipe that you believe is redundant. It may well have been to an old toilet like you suggested, or equally it may be from a downpipe.

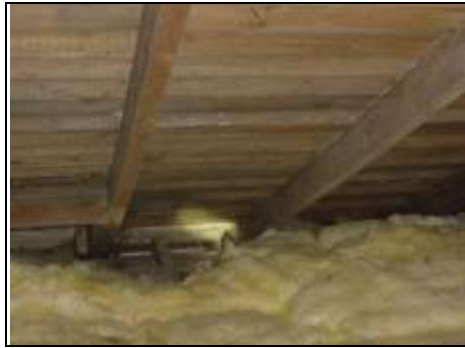
It does of course make sense to have a look to see if the roof is leaking when you have a damp problem, which we duly did. We can see where you have added the damp proof course to the edge and can also see in the roof space that there is some minor efflorescence coming through on the rear of the property which would be above the master bedroom towards the external corner.

Inside the roof

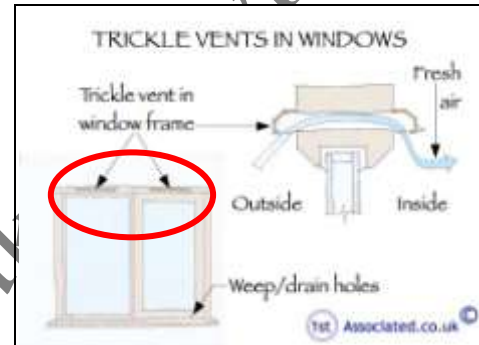
Trickle vents

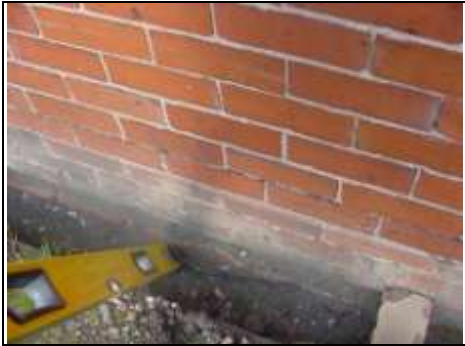
French drain being added to left side

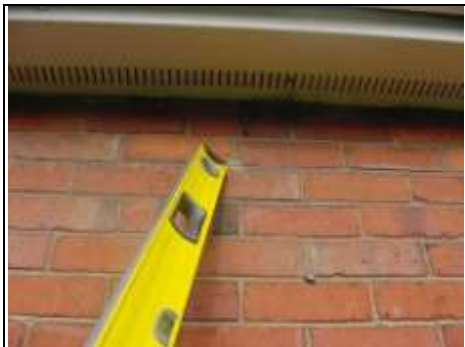
High level drill holes to left side where insulation has been added

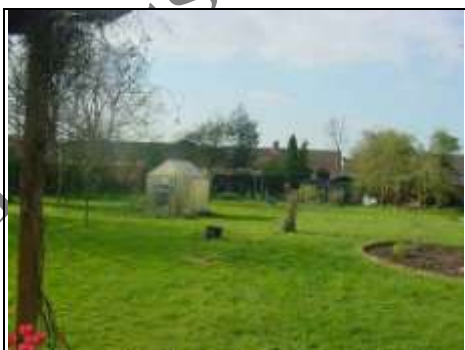
Substantial rear garden. Be aware that trees too close to a building can change the air movement around it

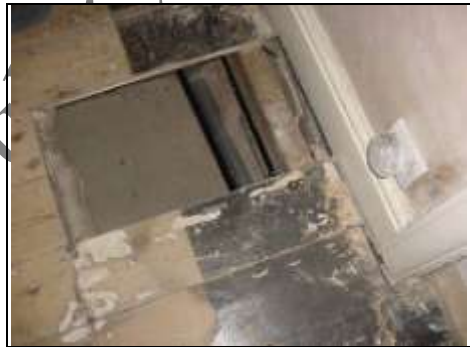
Floor opened up

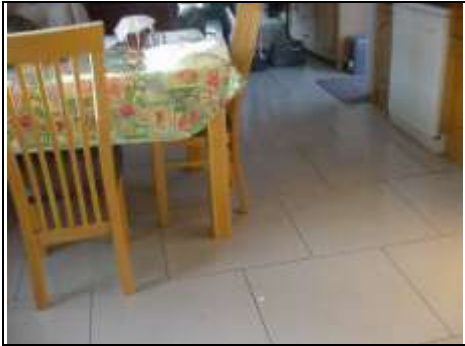
Tiled floor to rear kitchen/diner/  
lounge

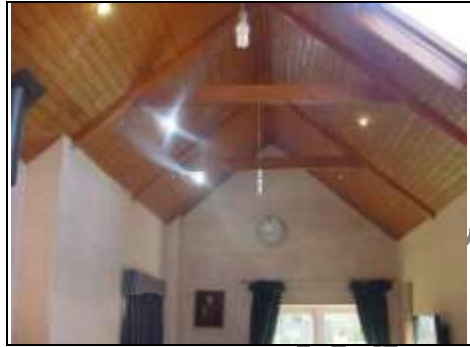
Vaulted ceiling to rear extension

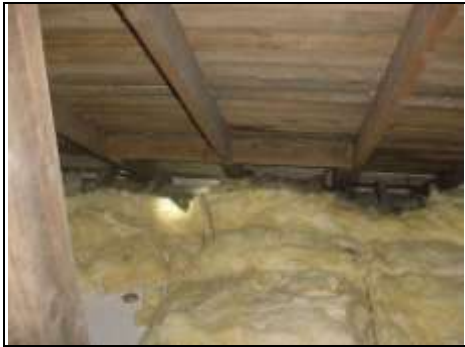
Insulation may be blocking air  
ventilations although can't be  
certain

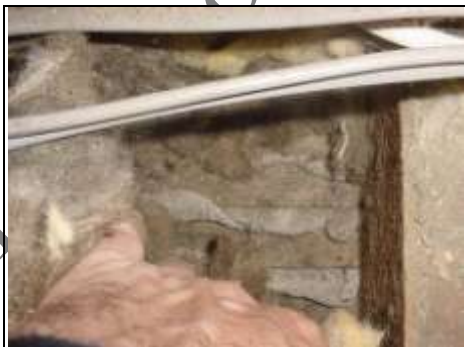
Lath and plaster ceilings

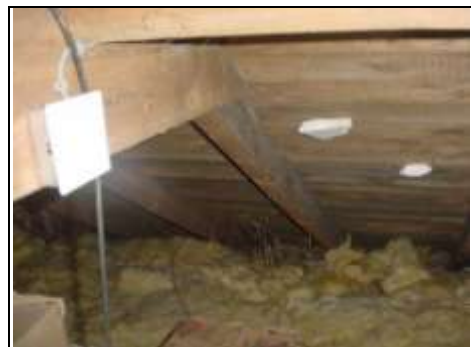
Close boarding
