# RESIDENTIAL BUILDING SURVEY

London Borough of Enfield

Mr L

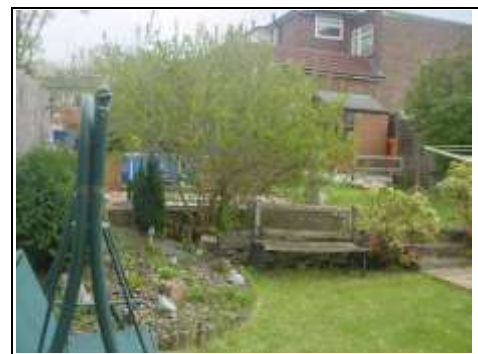
Garden on sloping site

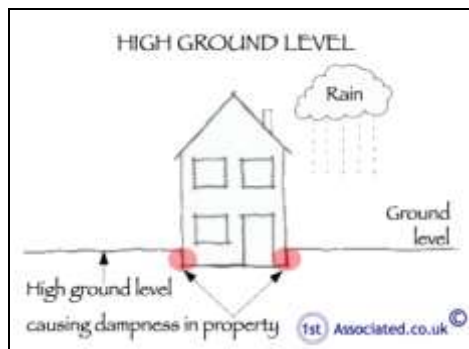
We noted the floor levels between the outside of the property and the inside are practically the same which does mean when it rains water is trying to get from the top of the site down and will tend to sit against the property.

High ground level

**ACTION REQUIRED:** Ideally stand outside the property next time it rains to see how much of a problem this is and if it is a problem we would then recommend a French drain is put around the property to direct the rainwater around the property. We would also recommend the adding of weep holes into the retaining wall. Close examination needs to be carried out to the rear structural frame.

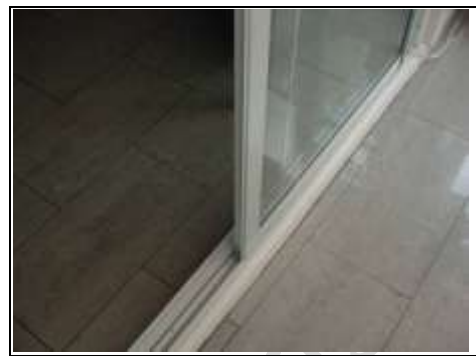
Inside and outside floor levels almost the same

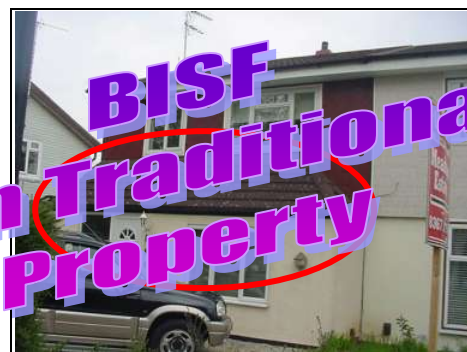
Although we haven't physically been able to see any signs of it, we are advised by the owners that the front porch and lounge extension has been built on its own structural frame. From our experience with other properties in the road this wouldn't be unusual and has been carried out due to the poor sub soil which has a clay content. We have dealt with other

Porch/front extension

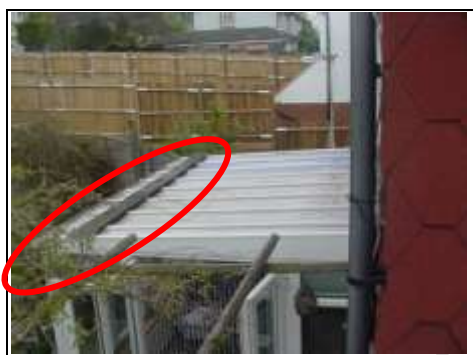
We noted the conservatory has quite a shallow roof which does tend to mean that water sits on it and you do get moss although it looked quite clean on the day of our inspection. We could also see that three of the panels on the right hand side (all directions given as you face the front of the property) have been replaced. We spoke to the owner about this during our question and answer session who advised that when the lights in the soffit board were being replaced damage was caused to the roof panels which he got the contractor to replace. We also noted that one of the windows had misted over.

Conservatory roof. We are advised wood plan on roof is used for walking on

**ACTION REQUIRED:** View the roof from time to time to check that build up of moss isn't occurring and clean as required. We would also check the flashing between the main building and the roof as this can be an area where leaks occur.

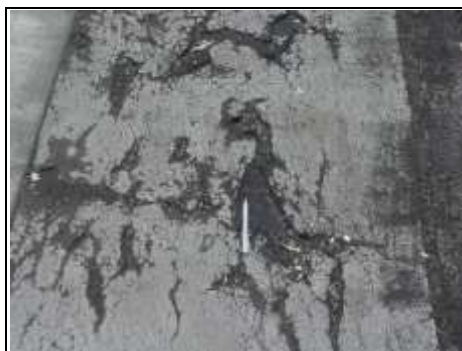
The flat roof over the garage is in a poor condition.

Flat roof in poor condition

**ACTION REQUIRED:** We would recommend patch repair in the summer of 2013 and obtain quotes for replacement with a high performance mineral felt roof and possibly add insulation as well although it may not be possible without stripping back the roof. Replacement recommended in the summer of 2014, possibly 2015 depending upon how deterioration occurs.

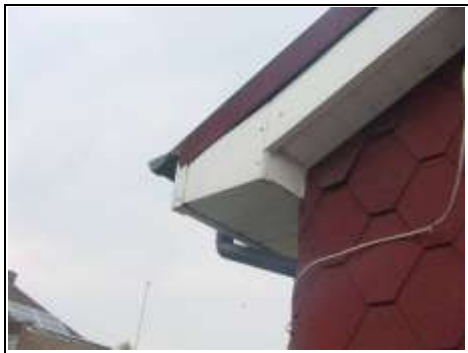
The plastic fascias and soffits around the property haven't got a vent and look to be overcladding on the original timber or asbestos fascias and soffits. We are not particularly keen on overcladding as it is normally put over timber already in poor condition which can then cause accelerated deterioration.

Fascias and soffits overclad

**ANTICIPATED COST:** If this is overcladding we would recommend complete replacement and removal of any asbestos if there is any. We would expect costs to be in the region of £2,000 - £4,000; please obtain quotations.

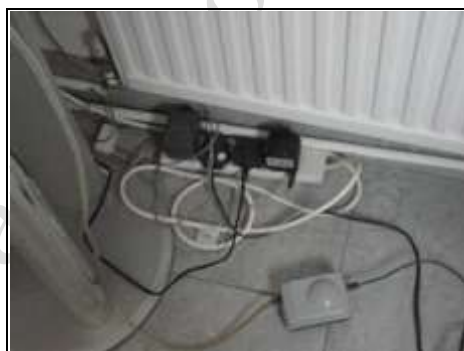
The electrics are dated and there are a lack of electric points, we noted many cable extensions being used.

Cable extensions being used

**ACTION REQUIRED:** The Institute of Electrical Engineers standards (IEE) recommend a test and report whenever a property changes occupancy. This should be carried out by an NICEIC registered and approved electrical contractor or equivalent.

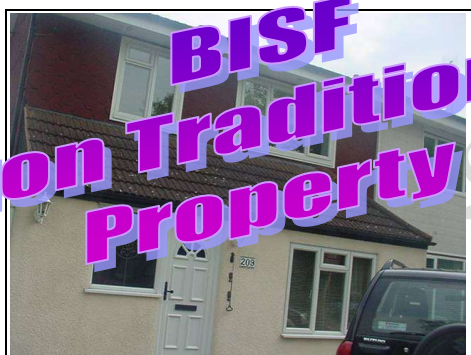
The front porch is clad in a concrete tile which has minor moss and lichens on it.

Concrete tiles to front extension

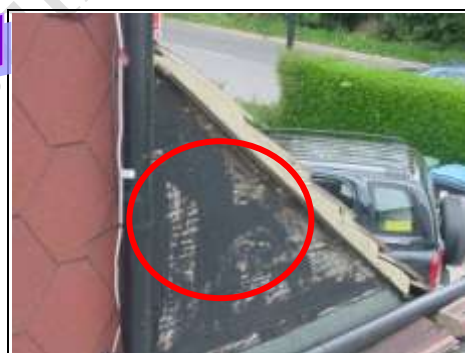
Side of porch roof

**ACTION REQUIRED:** We would add a protective layer to the side of the roof using the vertical felt tiling to marry in with the rest of the building.

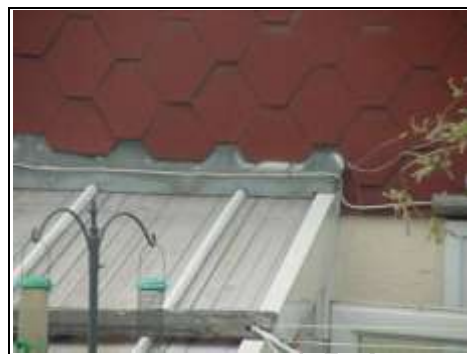
Our concern is that the conservatory has a relatively shallow pitch although it has to be said that we do see a lot that have less pitch than this. We were pleased to see a flashing where the conservatory meets the main building.

Conservatory roof links into vertical felt tiles

**ACTION REQUIRED:** Please see our comments in the Executive Summary.

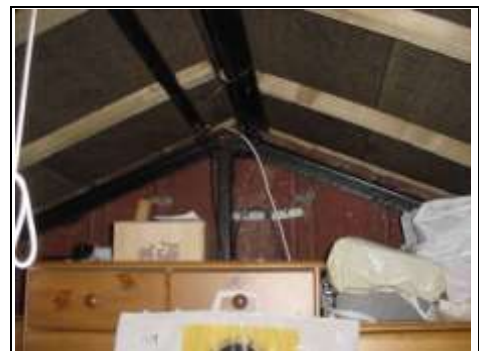
Metal roof system

Our examination was limited by the general configuration of the roof, the floor boards and stored items. What we could see was generally found to be in average to above average condition for its age, type and style. We would normally expect to see rusting to the roof frame but in this case it looks as if the entire roof truss was treated when the property was re-roofed.

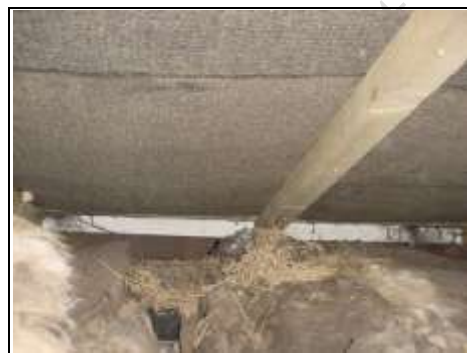
Insulation with building paper underneath and a birds nest

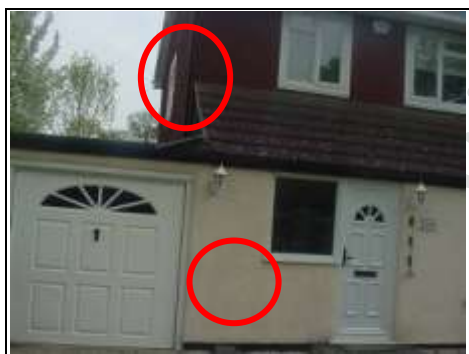
We would comment that there is a gulley to the front of the property which looks to be unused and directly above it there is pipework going into the gutter. It looks like the original downpipe has been diverted; we can only imagine this will overflow when it rains.

Pipework above, gulley below

**ACTION REQUIRED:** Ask existing owner why the gulley and downpipe have been amended. We would always recommend you stand outside the property next time it rains heavily and see how well the drains cope with the rainwater particularly looking at the guttering and the joints.

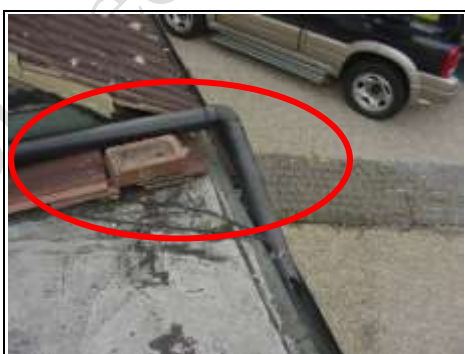
Pipework on flat roof

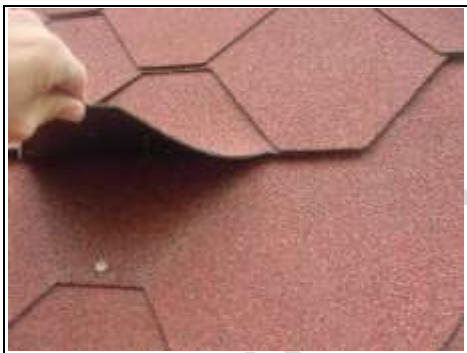
As mentioned above originally this building would have had profile metal sheeting to the upper parts. In this case we believe it has then been clad over and a vertical felt tile added.

Vertical felt tile

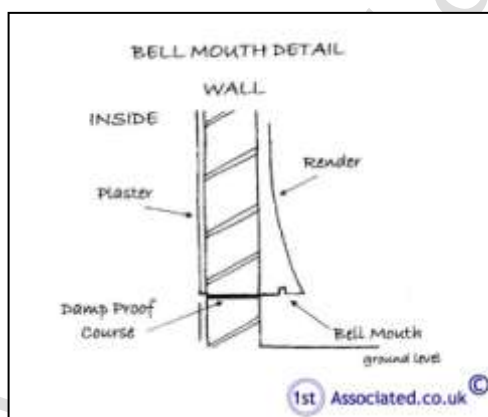
To the base of the render there was a bell mouth detail.

Bell mouth detail

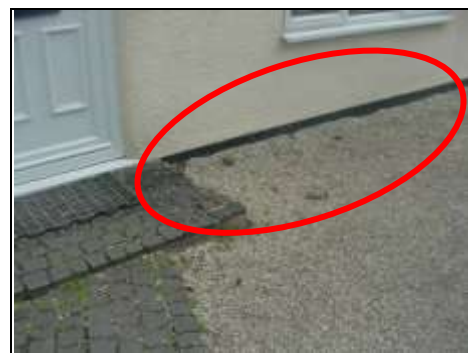
Bell mouth

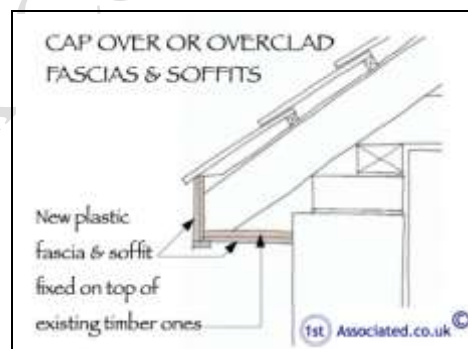
The fascias and soffits are plastic overclad.

Overclad fascias and soffits

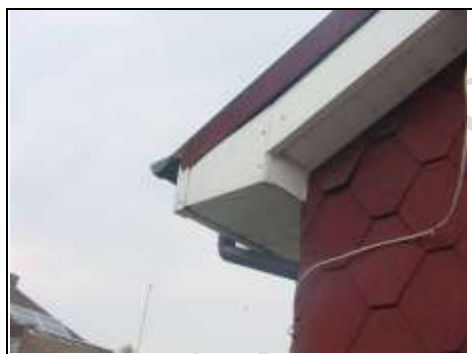
Fascias and soffits overclad

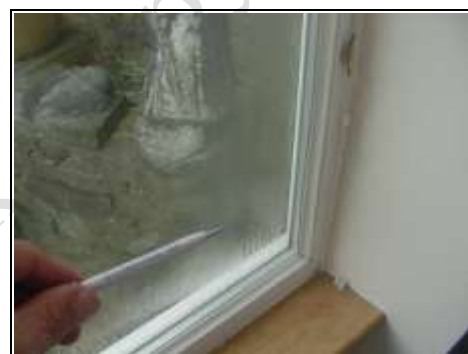
The property has plastic double glazed windows without trickle vents which generally look to be of an average quality. We would draw your attention to the fact that sealed double glazed units can fail, particularly as a result of poor workmanship during installation. Failure of the seal leads to condensation between the two panes of glass and simply replacing the affected units may not provide a satisfactory long-term solution. In this case we noted some of the seals on the conservatory have failed.

Seal has gone on conservatory window

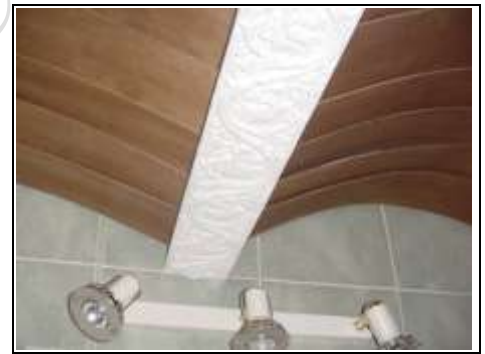
Unusual double concave ceiling in bathroom

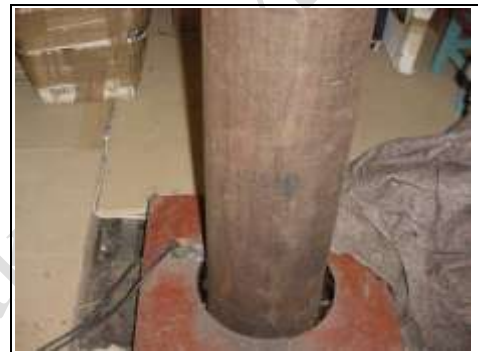
The chimney breasts are located within the front lounge centrally on the house. This is more of a flue than a traditional chimney. From what we understand it is a metal tube all the way up into the roof where we can see it.

Metal tube

It is strongly recommended that flues be cleaned and checked for obstructions prior to use to minimise the risk of hazardous fumes entering the building.

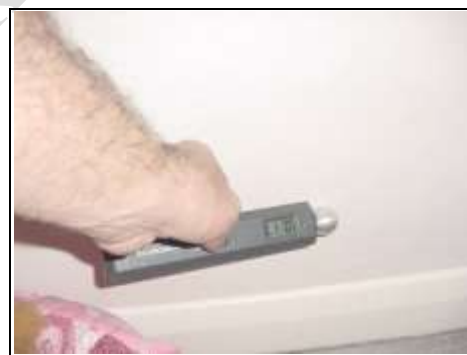
We were unable to take readings due to the dry lining.

Unable to test for dampness

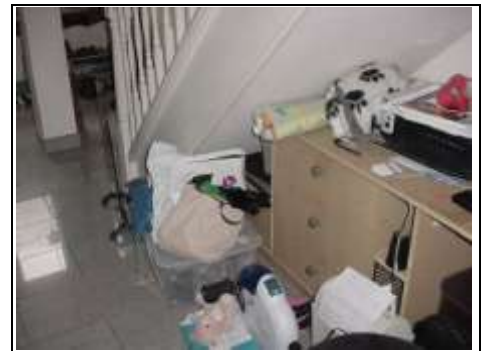
We were unable to examine the underside of the stair timbers due to it being lined, which precluded our inspection, so we cannot comment further upon the stair structure. We can, however, say that the lining gives a resistance to the spread of fire if such circumstances were to occur.

Lined staircase

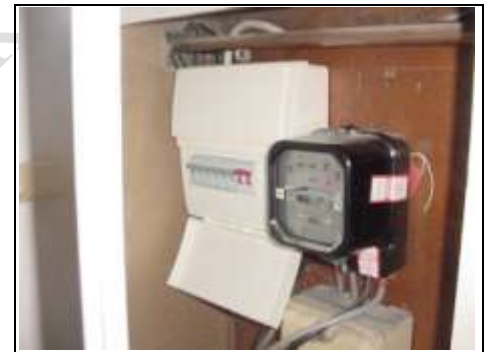
Fuse Board

**ACTION REQUIRED:** We would recommend the fuse board is changed.

**ANTICIPATED COST:** In the region of £200-£400 ; quotations required.

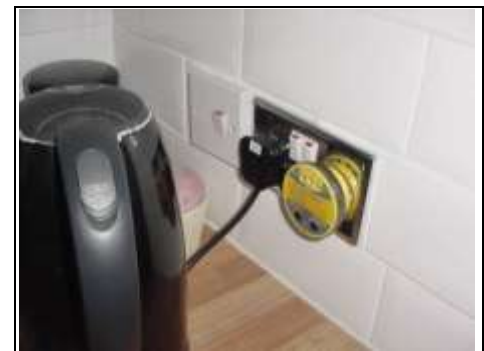
We carried out an earth test in the kitchen area to the socket point that is normally used for the kettle, this proved satisfactory.

Earth Test

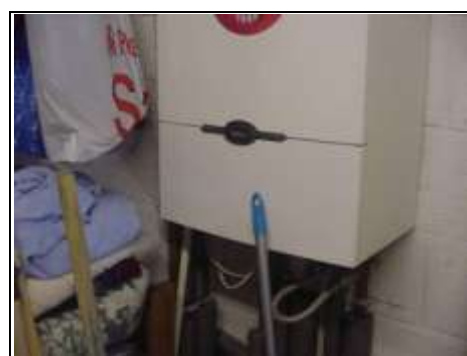
The boiler was located in the garage it is manufactured by Baxi and is wall mounted.

Wall mounted Baxi boiler

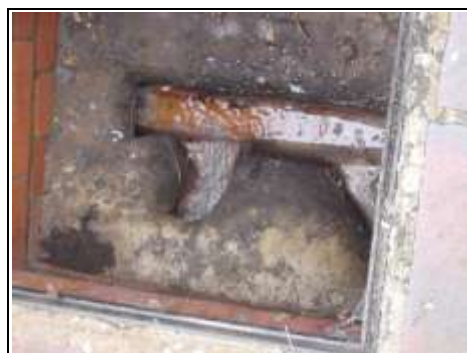
Manhole one

We duly lifted the cover and found it to be free flowing at the time of our inspection.

From what we could see it is brick built.

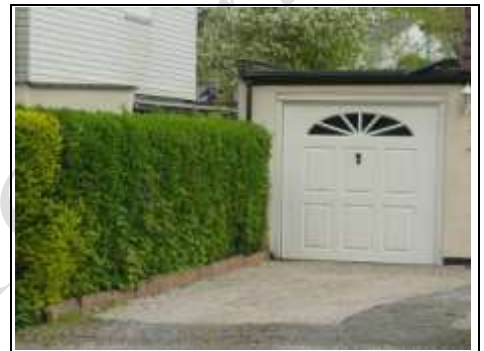
Garage/parking

The property has a single garage and off road parking to the front of the property with a drop kerb.

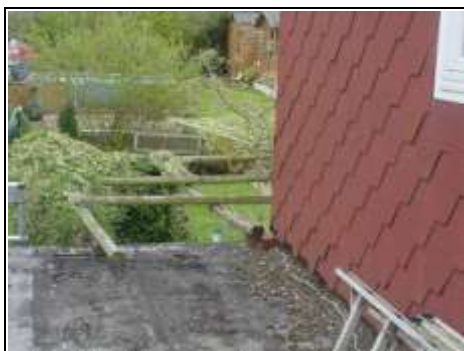
Wooden trellis to front is not secure and is balanced in place by a brick and is only held by luck and gravity as far as we can see

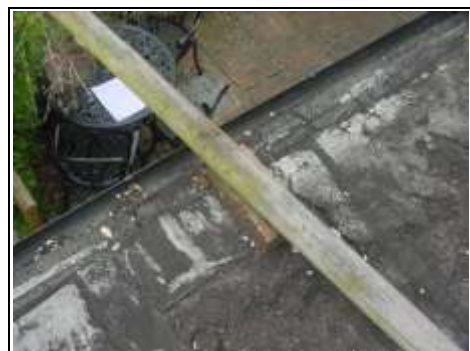
Wooden trellis balanced on bricks

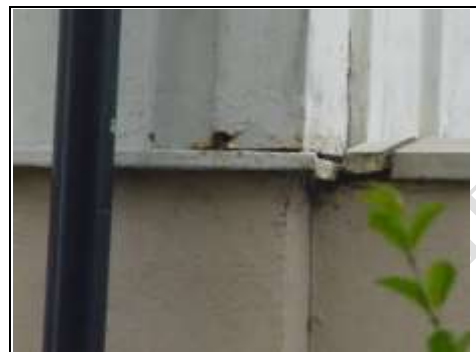
Rusting to profile metal cladding

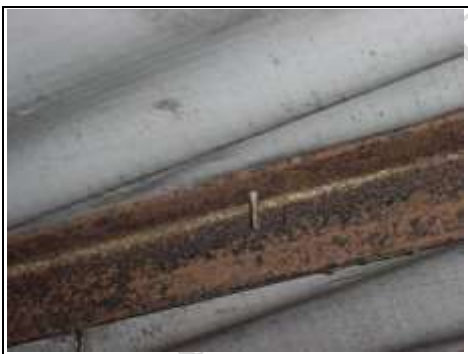
Example of rusting that we have seen in the roof of a metal framed building

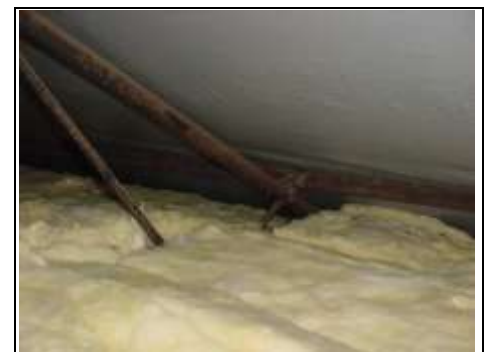
Example of over insulation of a metal framed property which causes condensation

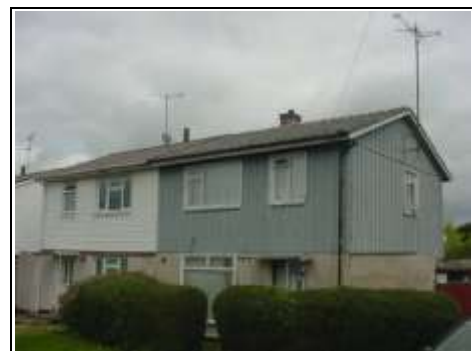
Asbestos roof on BISF house

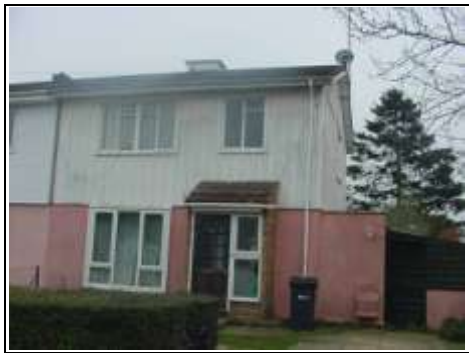
Painted cladding to non-traditional property

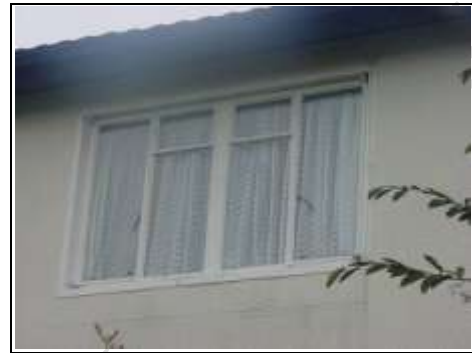
Close up of old metal windows in a non-traditional house

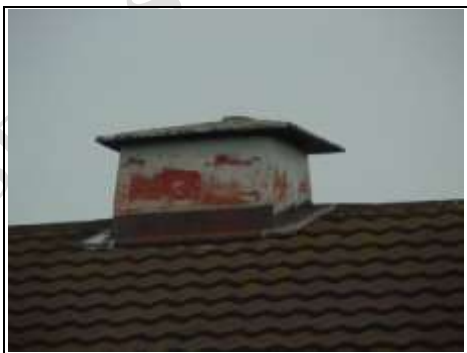
Asbestos original chimney non traditional house

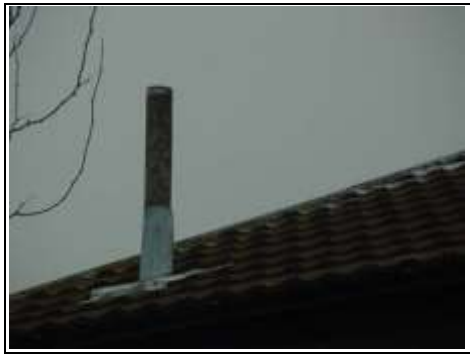
Original asbestos soil and vent pipe  
on a non-traditional house

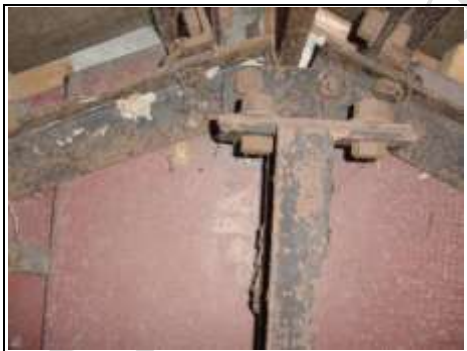
Rusting to a lightweight metal  
frame or damage or deterioration to  
the metal frame of a non-traditional  
house

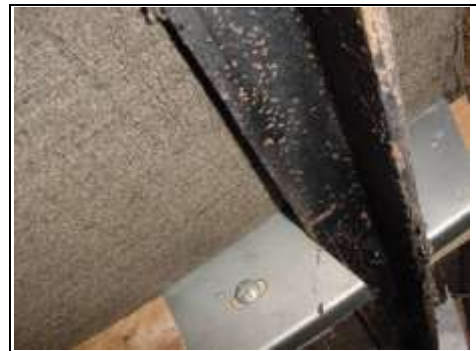
Some fixings replacements/repairs  
to a non-traditional house

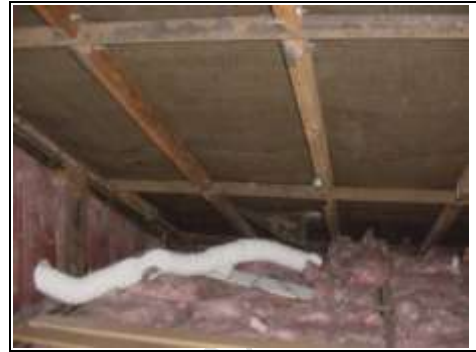
It is very common these days to have a shower/bathroom with an extract system. Does that extract system discharge into the roof or does it discharge out of the building? If it discharges into the roof then there can be problems with rusting and corroding of metal and dampness to timber.

Extract vent to outside often discharges into roof which is essential that they do not in this type of roof

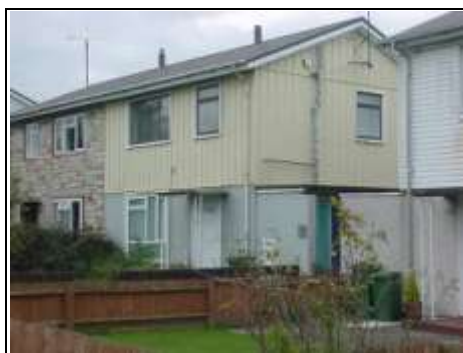
Marketing by:  
BISF property with metal profile sheet roof  
(has asbestos roof been removed or has it  
been overclad?) and the 1st floor sheet at  
first floor level and render at ground floor  
level and modern styled double glazed  
windows.

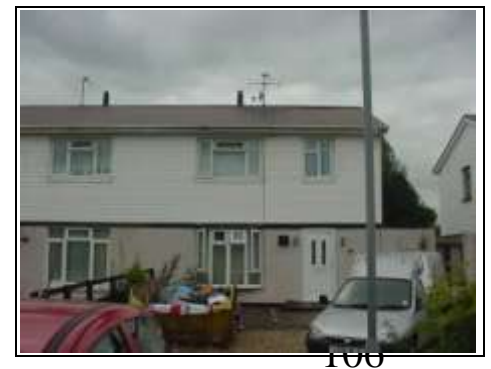
BISF house with a profile metal roof, (again  
has asbestos roof been removed?), plastic  
cladding at first floor level (is there insulation  
between the profile metal sheets and the  
plastic cladding that is causing condensation)  
with pebbledash render at ground floor level  
and modern double glazed windows

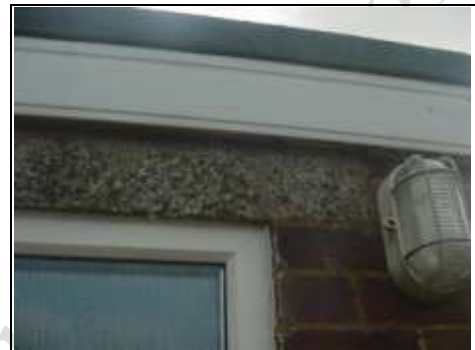
A close up view showing there is a concrete lintel over the door and window. This is where the cold bridging occurs causing condensation inside.

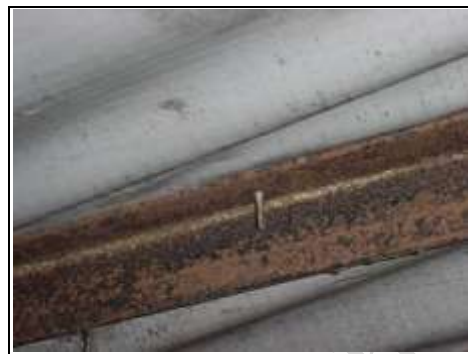
Example of rusting that we have seen in the roof of a metal framed building

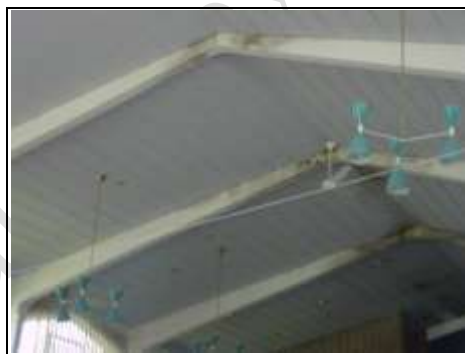
Cold Bridging in a commercial property with a concrete frame.

This can look like the roof has leaked and can lead to wrongly diagnosing a problem as being a roof leak. This can result in great time and expense being wasted repairing a roof that was not leaking and indeed in some cases has led to a new roof being fitted which has costs tens of thousands of pounds. This happened because it wasn't understood what the problem was.

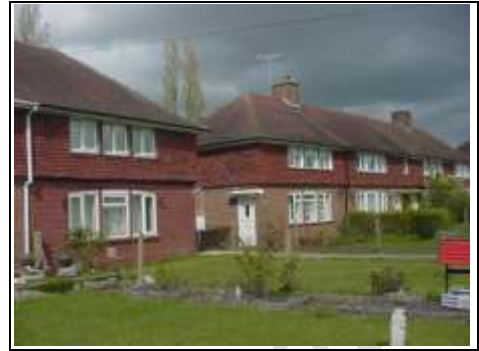
Post war 1960's properties with plastic double glazing without trickle vents that have been added can cause condensation.

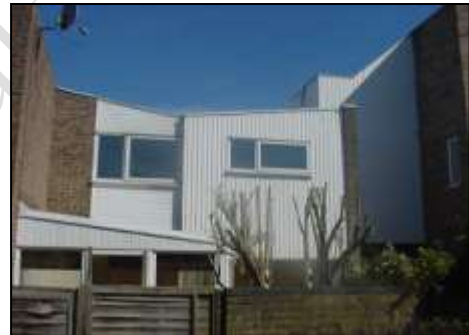
1970's property with cold bridging to the roof beams and the lintels

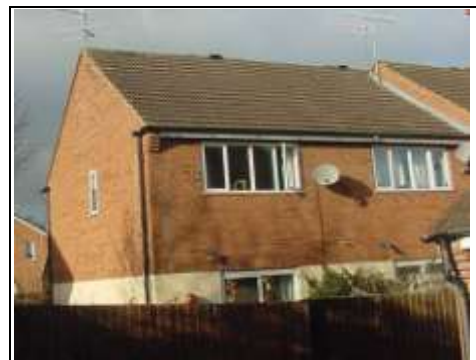
1980's property, cold bridging was found in the lintels

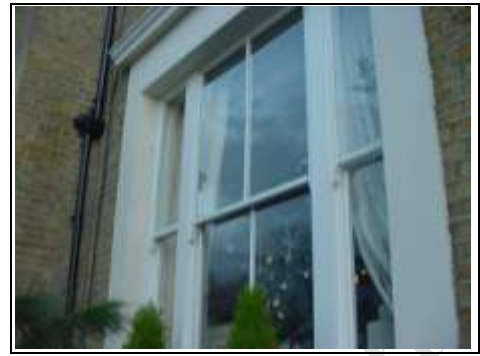
Sliding sash windows can swell in the winter months
