RESIDENTIAL BUILDING SURVEY

Pre-Cast Concrete Frame House Wiltshire

Mrs X

Prepared by:
INDEPENDENT CHARTERED SURVEYORS

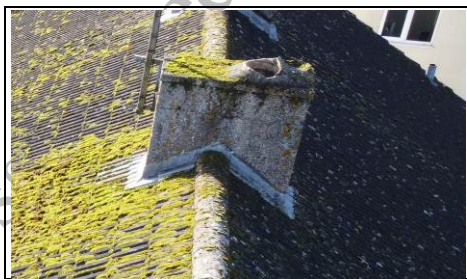
Left chimney
Aerial view – 360 photo

This chimney is render finished with a lead flashing. The chimney pots appear to be missing and there is a crack to the rear. Just as importantly, within the roof space we can see that the front part of the chimney has been removed. From what we can see of the external of chimney it is in below average condition considering its age, type and style.

ACTION REQUIRED: Please see our comments in the Executive Summary.

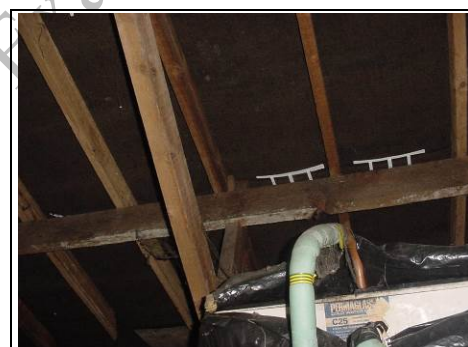
Water tank

The water tank looks old and we would recommend it is replaced.

ACTION REQUIRED: We recommend you replace the water tank.

We would always recommend that water tanks at the very least be drained down and cleared of any debris etc. (we have seen dead birds and other unmentionable things in these tanks). As you are often cleaning your teeth with this water it is best that it is as clean as possible!

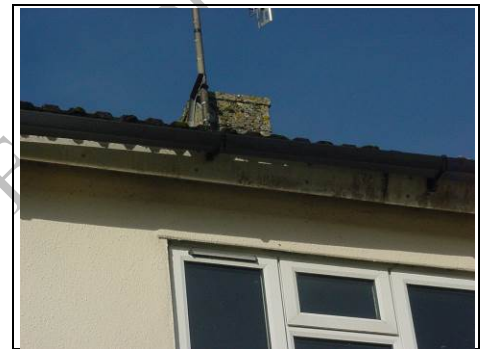
The gutters and downpipes are profile plastic. They are in average condition for their age, type and style. There does look to have been some replacement plastic, based upon the different colours, so you may have some of the older plastic which does tend to get affected by sunlight and become more brittle over time.

Profile plastic gutter

Generally we would comment there may be some minor leaks but most people would be happy to live with these providing repairs are carried out within the next six to twelve months.

ACTION REQUIRED: We would always recommend you stand outside the property next time it rains heavily and see how well the drains cope with the rainwater particularly looking at the guttering and the joints.

We also recommend that the gutters and downpipes are cleaned out, the joints are checked and the alignment checked to ensure that the gutters fall towards the downpipes.

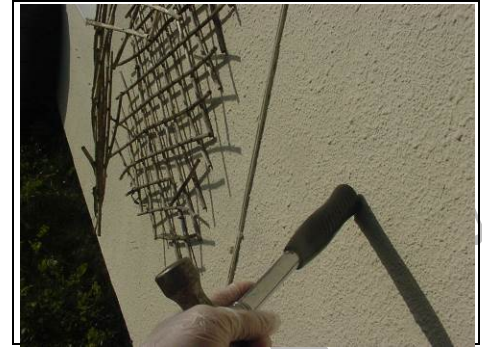
We have carried out a tap test (literally hitting the render with the back of a hammer). We found it to be in average condition for its age, type and style.

Tap testing the render

ACTION REQUIRED: Please see our comments in the Executive Summary regarding the thin render.

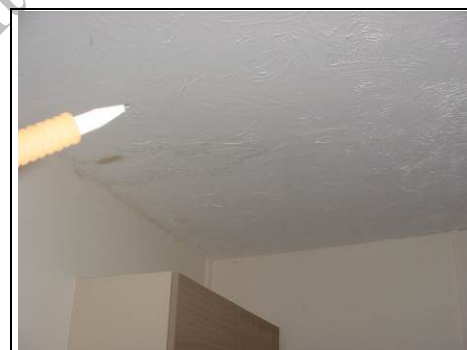
Many of the ceilings have textured paint (commonly known by their trade name of Artex). We believe there is an outside chance of some of this being older type of textured paint, which often had Asbestos content.

Older style textured paint

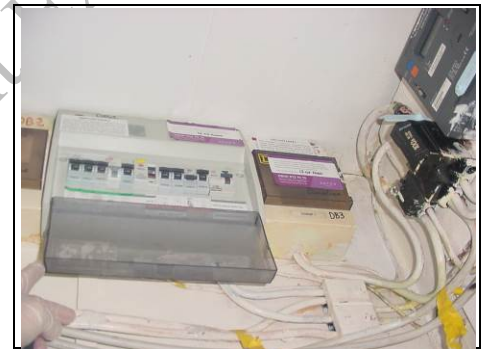
The electric fuses and consumer units were located in the hallway. The fuse board looked 1980's-2000's and better are now available.

Fuse Board

We recommend you upgrade the fuse board to a modern one in a fire resistant casing.

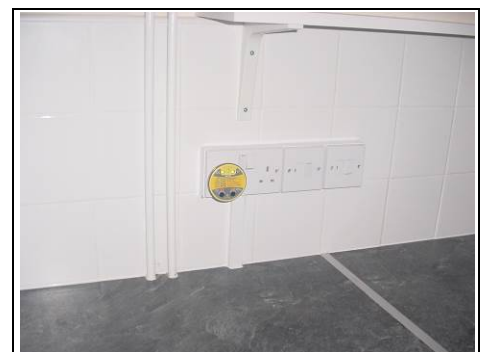
We carried out an earth test in the kitchen area to the socket point that is normally used for the kettle, this proved satisfactory.

Earth test

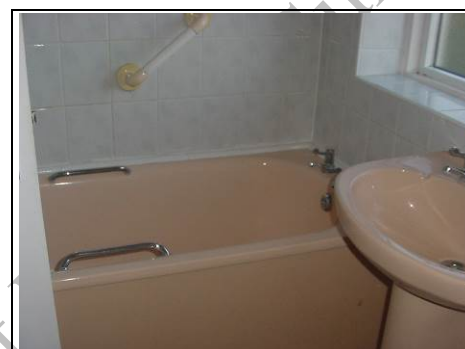
The property has a pink/salmon colour three piece bathroom suite, consisting of a bath, wash hand basin and WC, which looks average condition, subject to some day-to-day wear and tear, as one would expect.

Pink/salmon coloured
bathroom suite

ACTION REQUIRED: We recommend a humidity controlled extract fan is added.

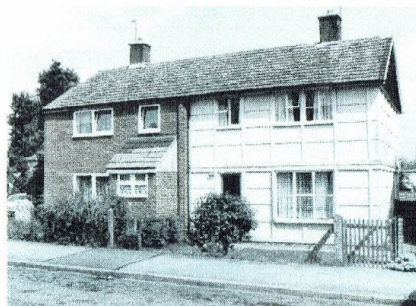
Cornish Unit Type II (upper) and Airey (lower) houses before and after repair.

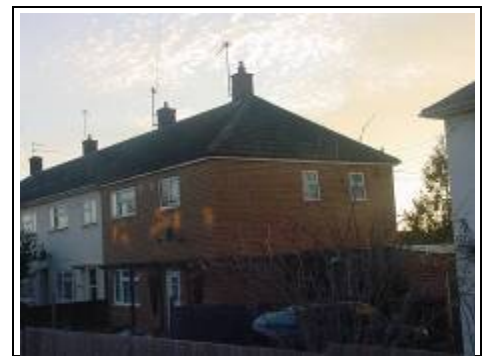
Brick cladding and other alterations make a non traditional house mortgageable

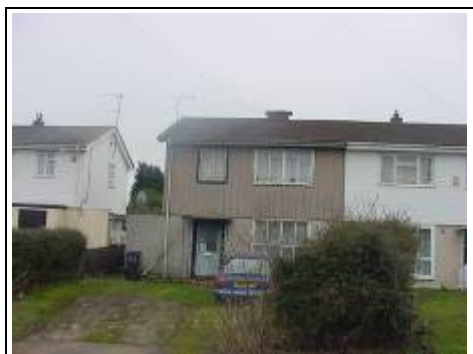
Original condition of non-traditional house with roof replacement

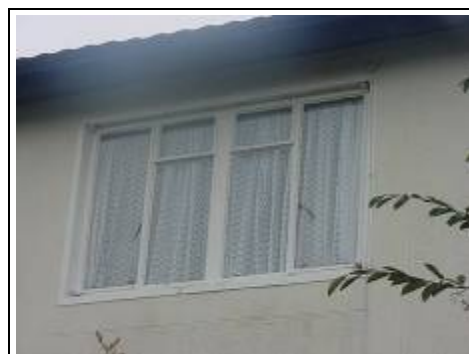
Close up of old metal windows in a non-traditional house

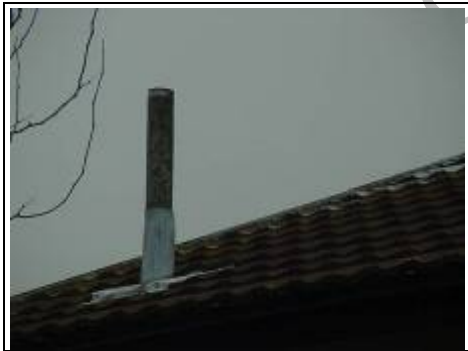
Original asbestos soil and vent pipe on a non-traditional house

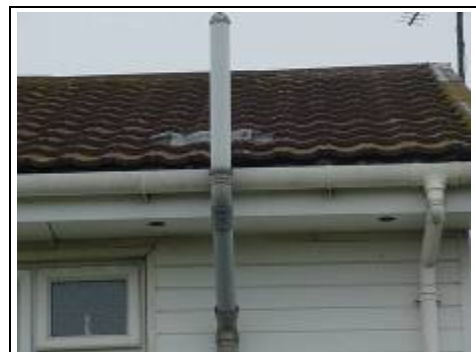
New plastic soil and vent pipe on a non-traditional house

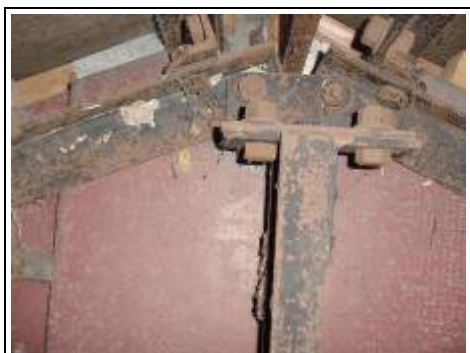
Rusting to a lightweight metal frame or damage or deterioration to the metal frame of a non-traditional house

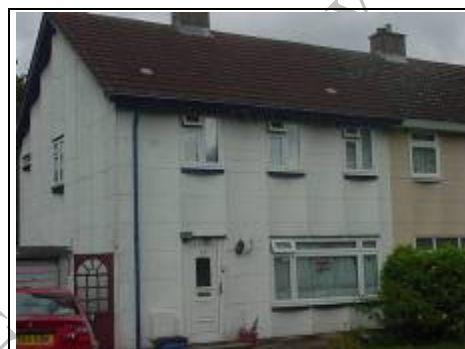
Non traditional house mainly asbestos

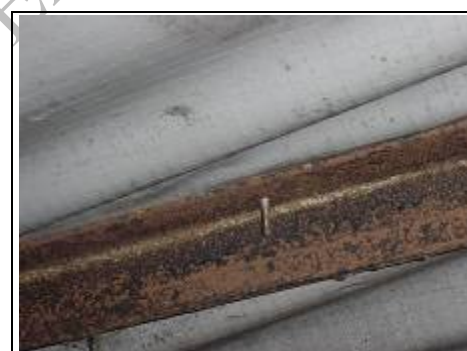
Rusting within the roof between the insulation and plastic protective underlayer
